Date: 27 April 2023  
Client: City of Carmel  
Subject: Carmel Beach Coastal Protection Assessment  
Reference: Carmel Beach Adaptation Plan  
Project No.: 12176

## **CARMEL BEACH COASTAL PROTECTION ASSESSMENT REPORT**

Coastal Protection Evaluation 22 December 2022 thru 30 January 2023

Carmel Adaptation Plan - Carmel Beach All Areas

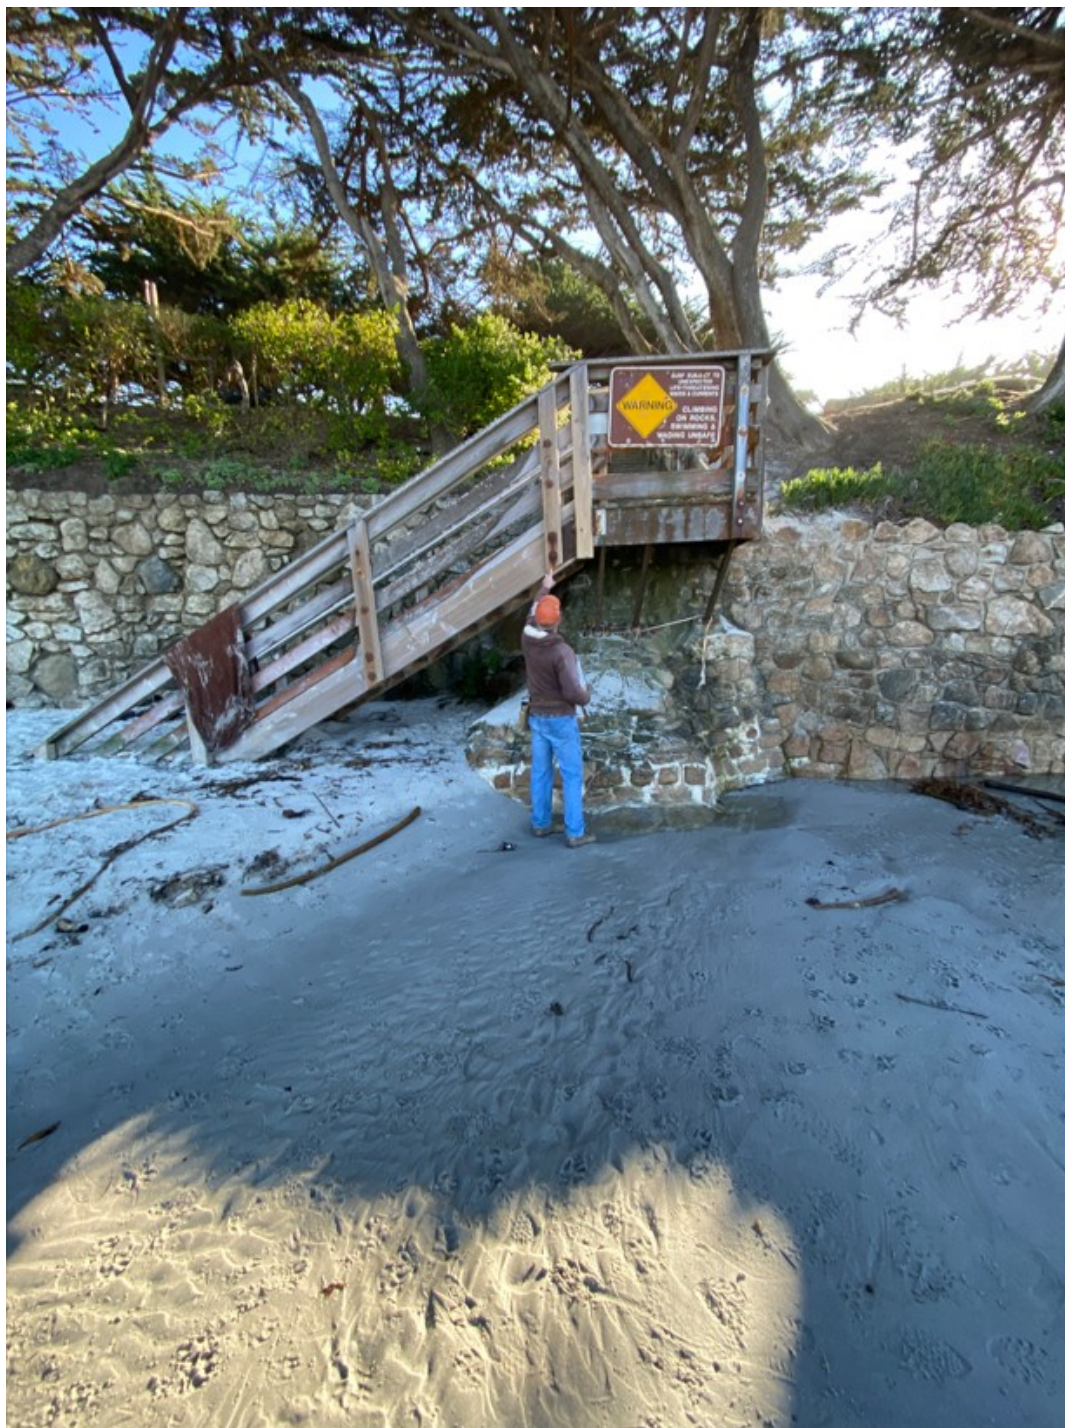
**Photograph 3: Seawall S2 on December 22, 2022**

Photograph 3 shows a view looking north at Seawall S2, which extends from the Frank Lloyd Wright home to Santa Lucia Avenue, on December 22, 2022. This seawall is in good condition.

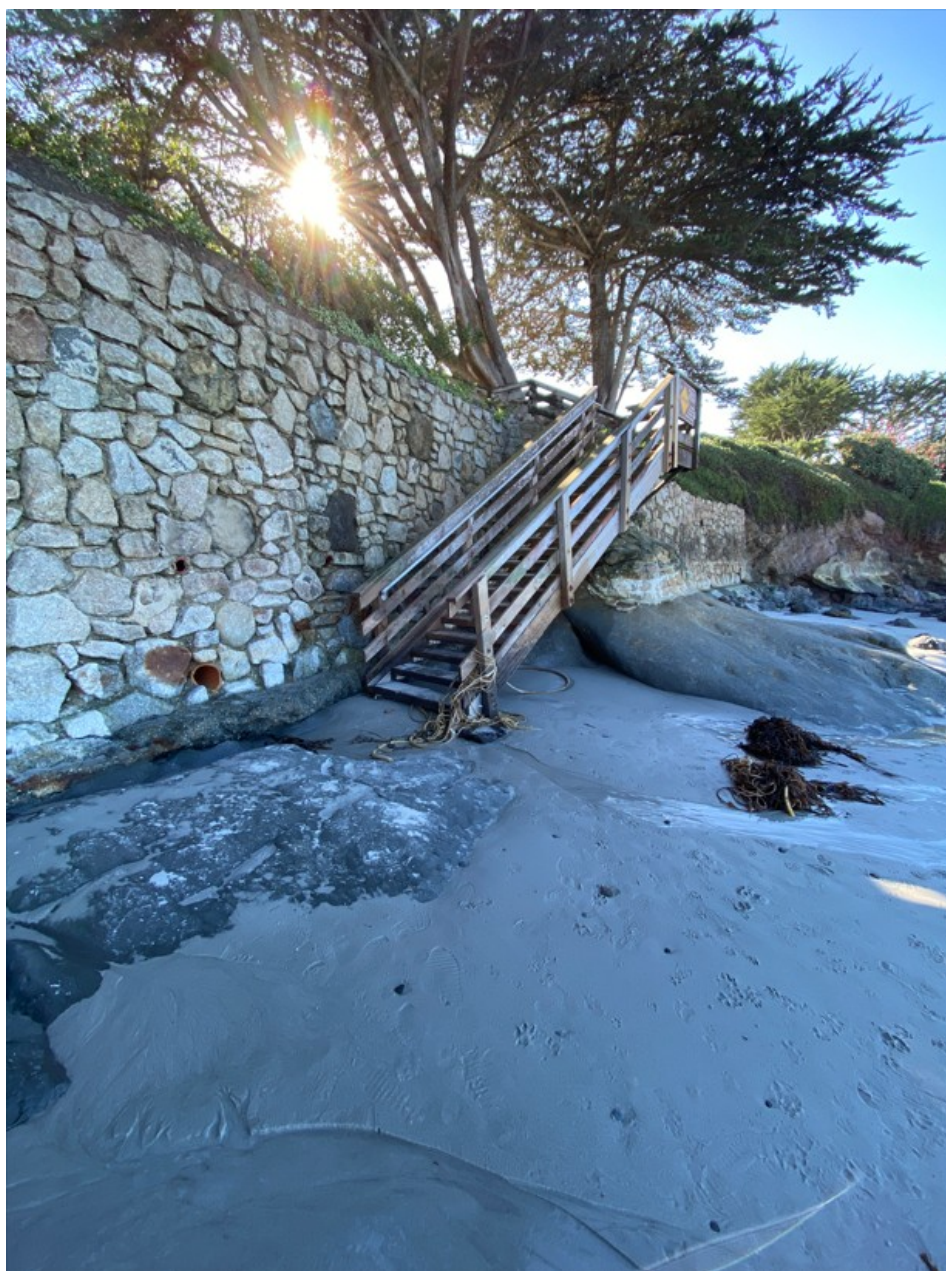
Photograph 5 shows Public Access Stairway ST1 on December 22, 2022. Corrodible fasteners and brackets were used on this stairway and those are deteriorating. At some point it will need maintenance and/or repair. Visually it appears satisfactory to us at this time. Further evaluation of the structure by an independent licensed structural engineer (and if need be a licensed corrosion engineer) should be scheduled to verify the structure is safe for public use, and recommend any needed repairs.

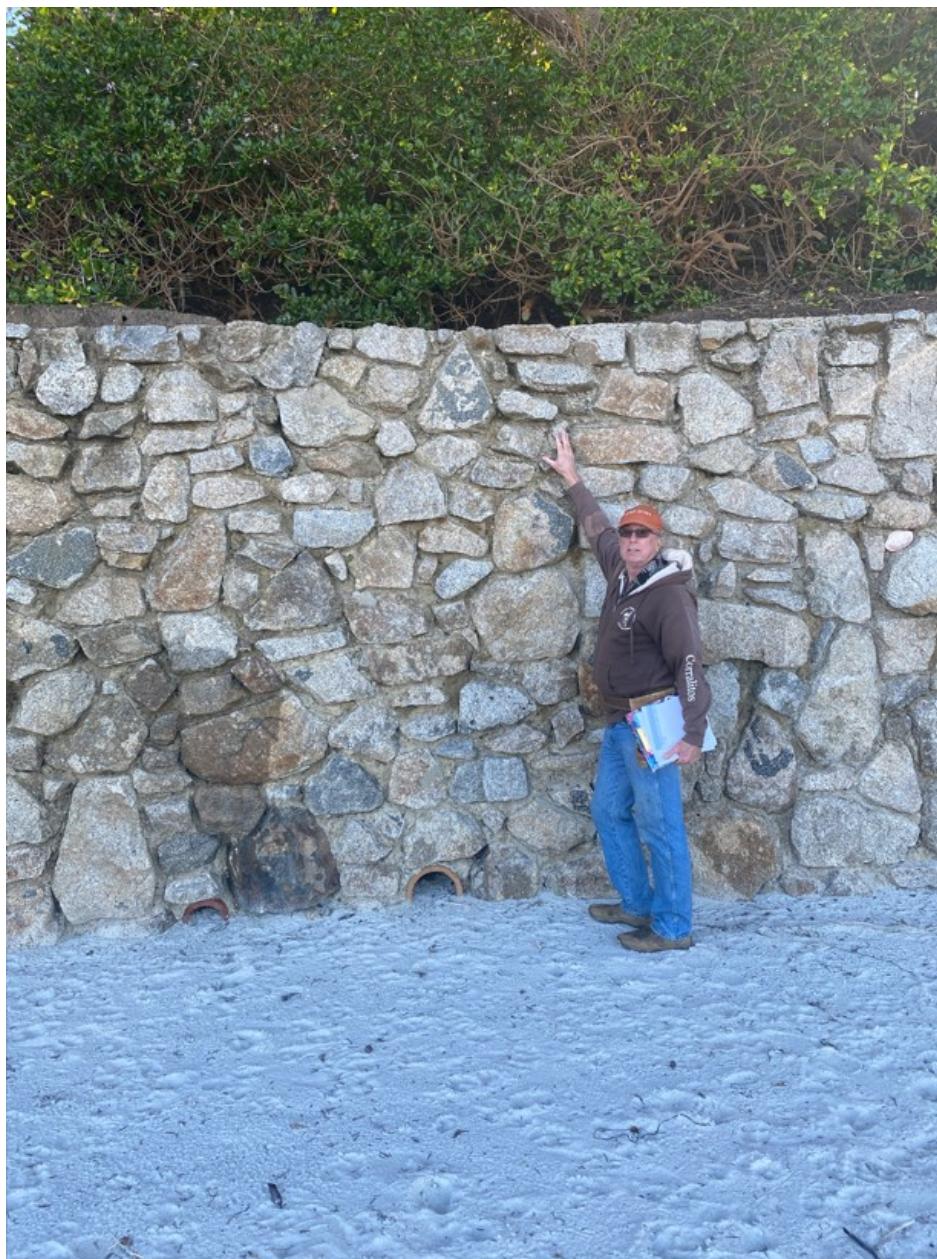
**Photograph 8: Showing Seawall S2 on January 30, 2023**

Photograph 8 shows Seawall S2 on January 30, 2023 inspection. No rip riprap revetments seaward of the seawall were evident during our inspection. Some bedrock platform exposures are observed seaward of seawall, indicating scour levels were near the bottom of the sand deposit.

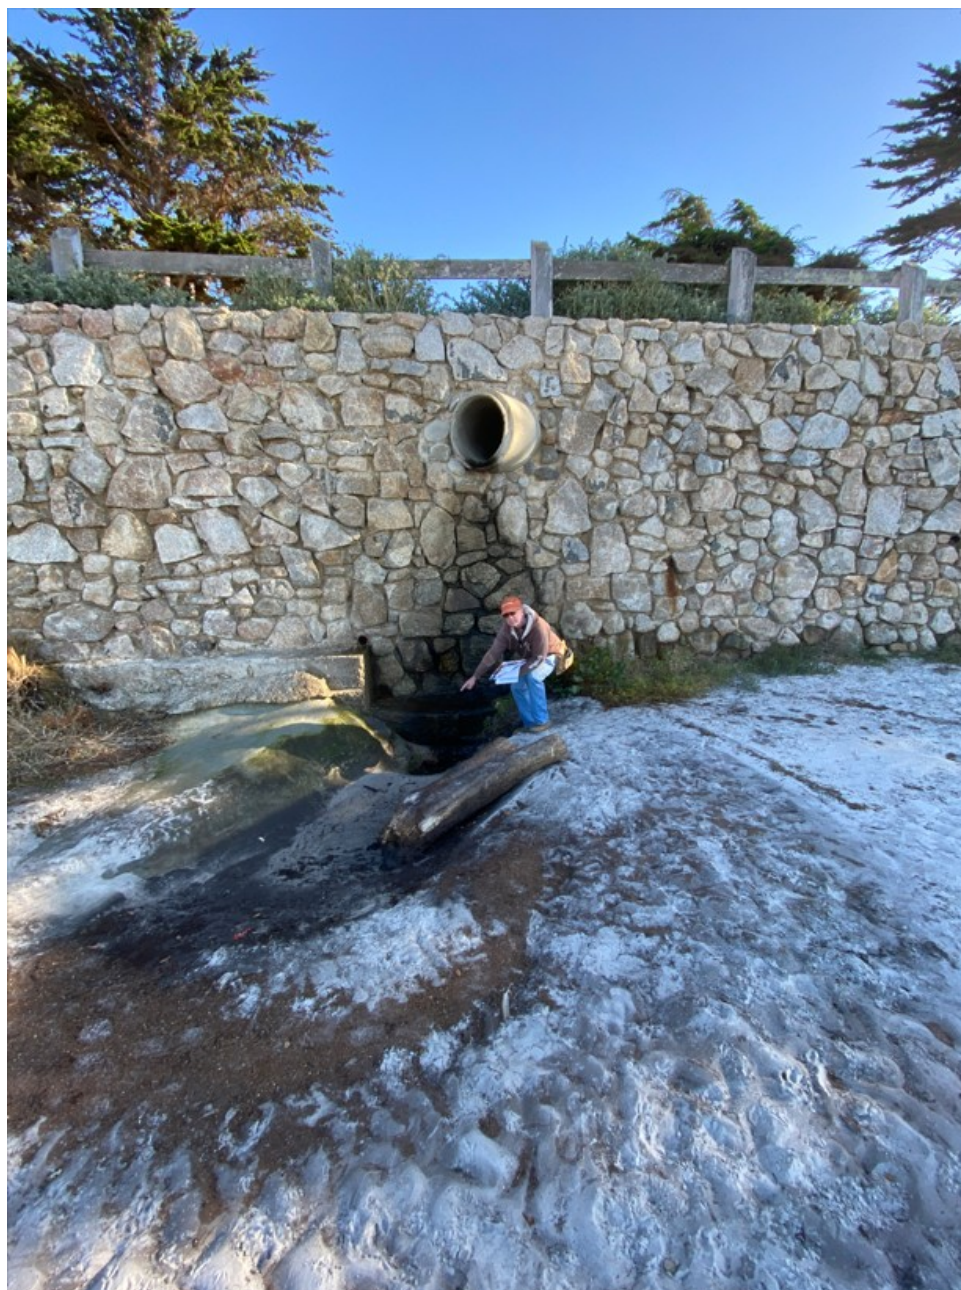
**Photograph 9: Seawall S2 on December 22, 2022**

Photograph 9 shows Public Access Seawall S2 on December 22, 2022. The exposed portion is in excellent condition. The seawall foundation is buried by beach sand, which is normal. After severe ocean storms in January 2023 we revisited this location and almost all of this seawall's foundation was still buried by beach sand. Whenever it is next exposed by natural beach sand scour processes, it should be inspected. That may not be for a decade, but could be possible this winter. No repairs appear needed at this time and the seawall does not pose any extraordinary risks to beach users. This seawall appears to have more than 30 years of remaining life.

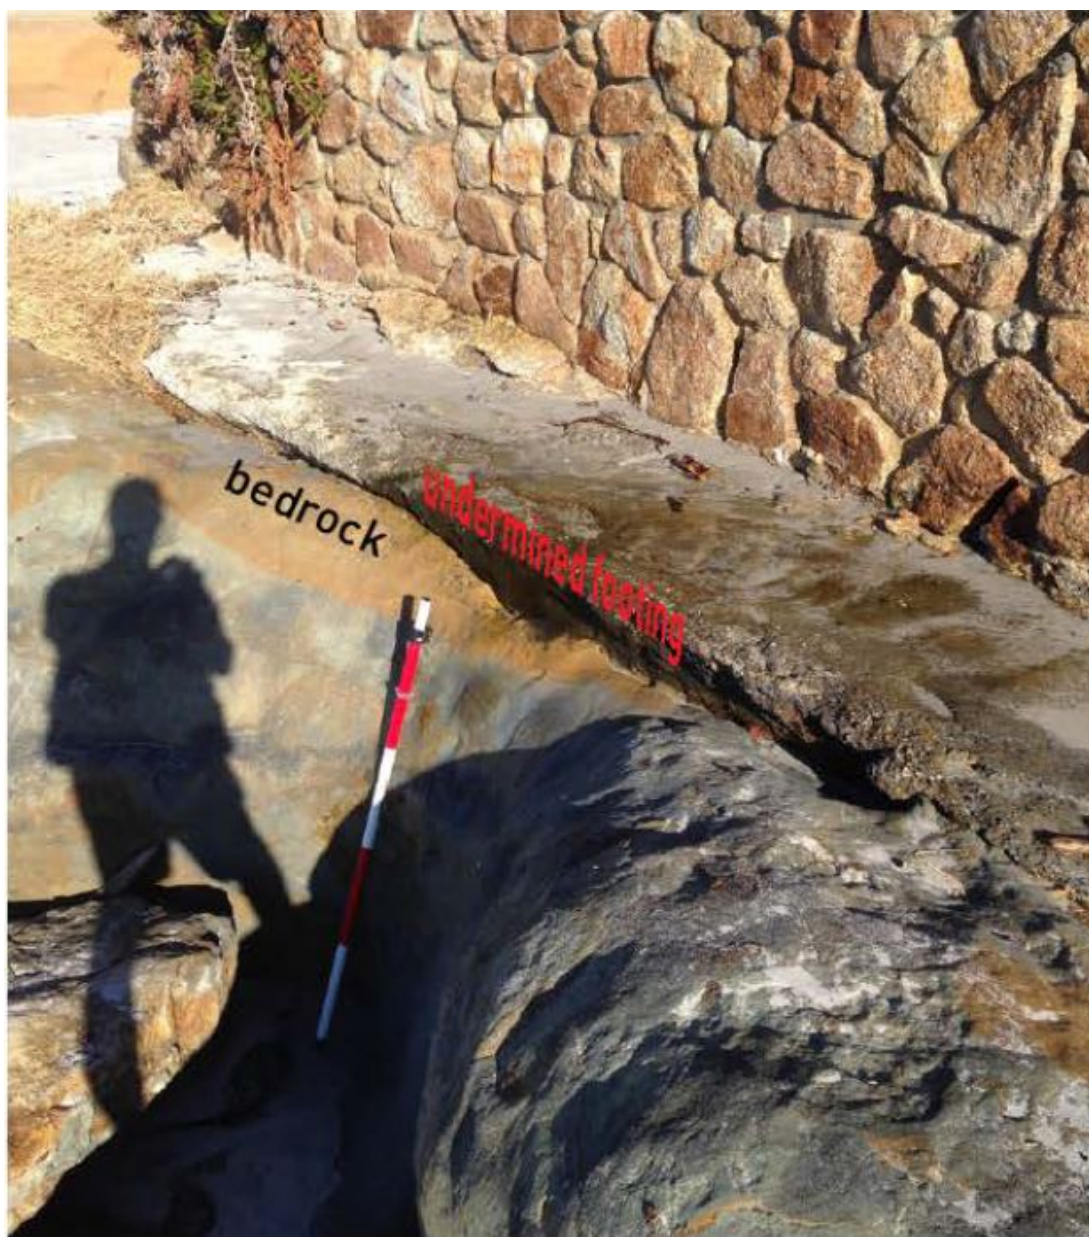
Photograph 11 shows an area at the northern end of Seawall S2 on December 22, 2022, where the edge of the seawall footing is exposed and it has been slightly undermined. Easton Geology inspected this location as well. Photograph 12 (below) is an Easton Geology photograph of the north end of Seawall S2 showing it was undermined in 2016. Comparison of that photo with the 2022 photo (above) shows there has been very little change in the conditions; there has been no continued undermining during that 7 year period. It is likely that this area was buried in beach sand during most of those 7 years; when the bedrock supporting the footing is buried, wave action does not contact the bedrock and no erosion or bedrock retreat occurs under the footing.

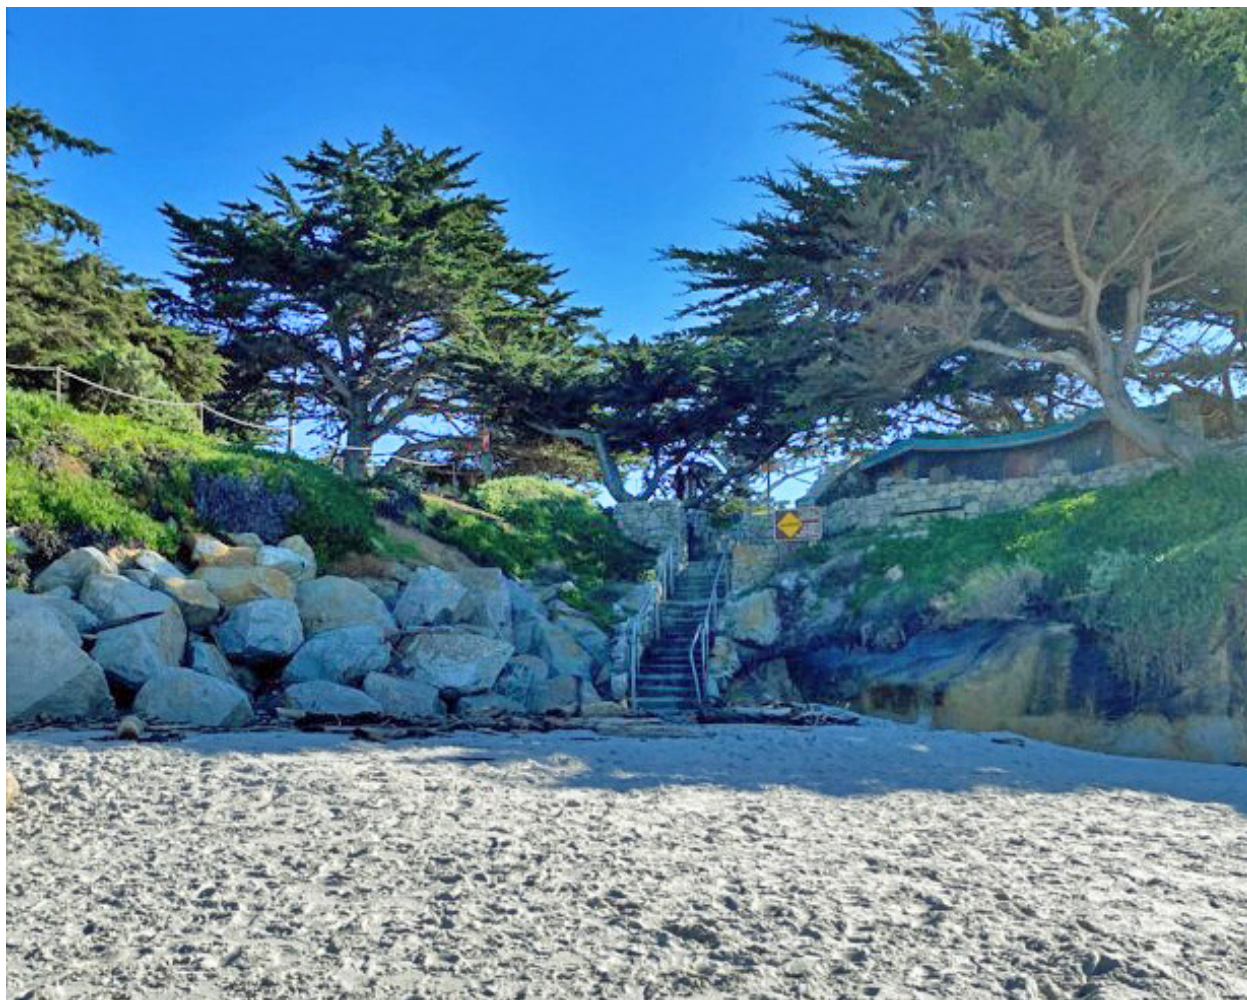
**Photograph 14: Public Access Stairway ST2 on December 22, 2022**

Photograph 14 shows the seaward portion of Public Access Stairway ST2, located at Santa Lucia Avenue, on December 22, 2022, which is in good condition. The south handrail of ST2 is bent; likely from a wave carried log impacting it. The stairway seems functional despite this minor damage. The bottom of the stairway foundation is buried by beach sand, which is the normal condition.

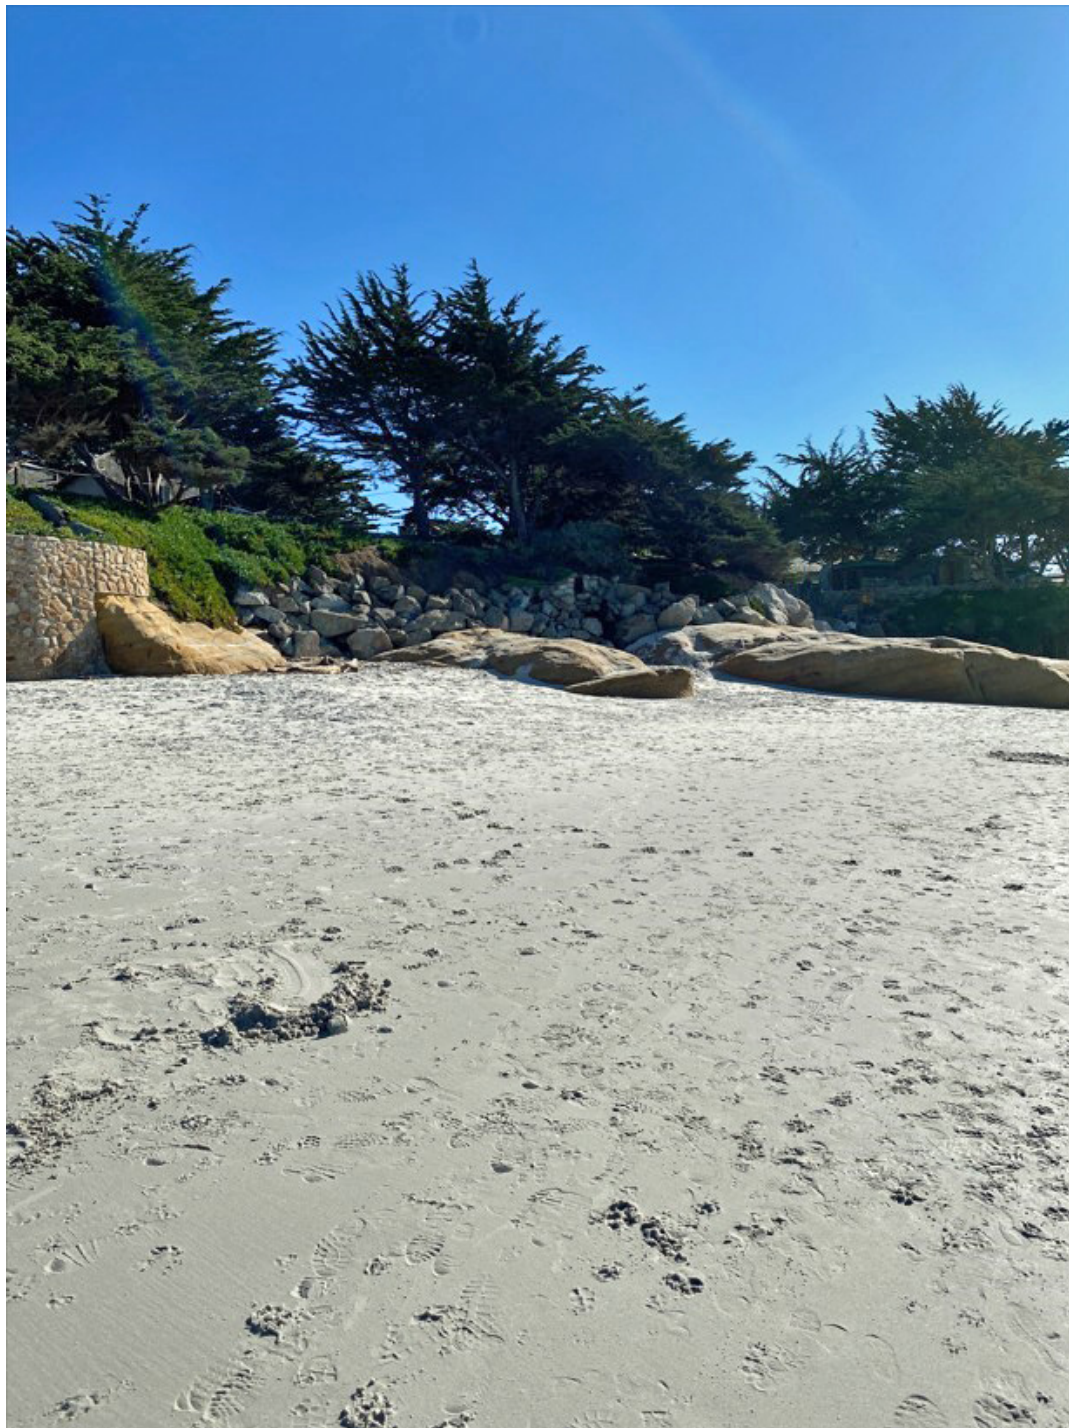
**Photograph 15: Showing Revetment R1 and Stairway ST2 on January 30, 2023**

Photograph 15 shows Revetment R1, which is located between Seawalls S2 and S3, and shows Stairway ST2 during our January 30, 2023 inspection after severe ocean storms occurred in January 2023 and it was still buried by beach sand. Whenever it is next exposed by natural beach sand scour processes, it should be inspected. That may not be for a decade but could be possible this winter. The estimated life of Stairway ST1 is 30 years or more. The south railing is bent from floating log impact. This does not pose a substantial risk to users of the stairs. We rank the repair as a low priority.

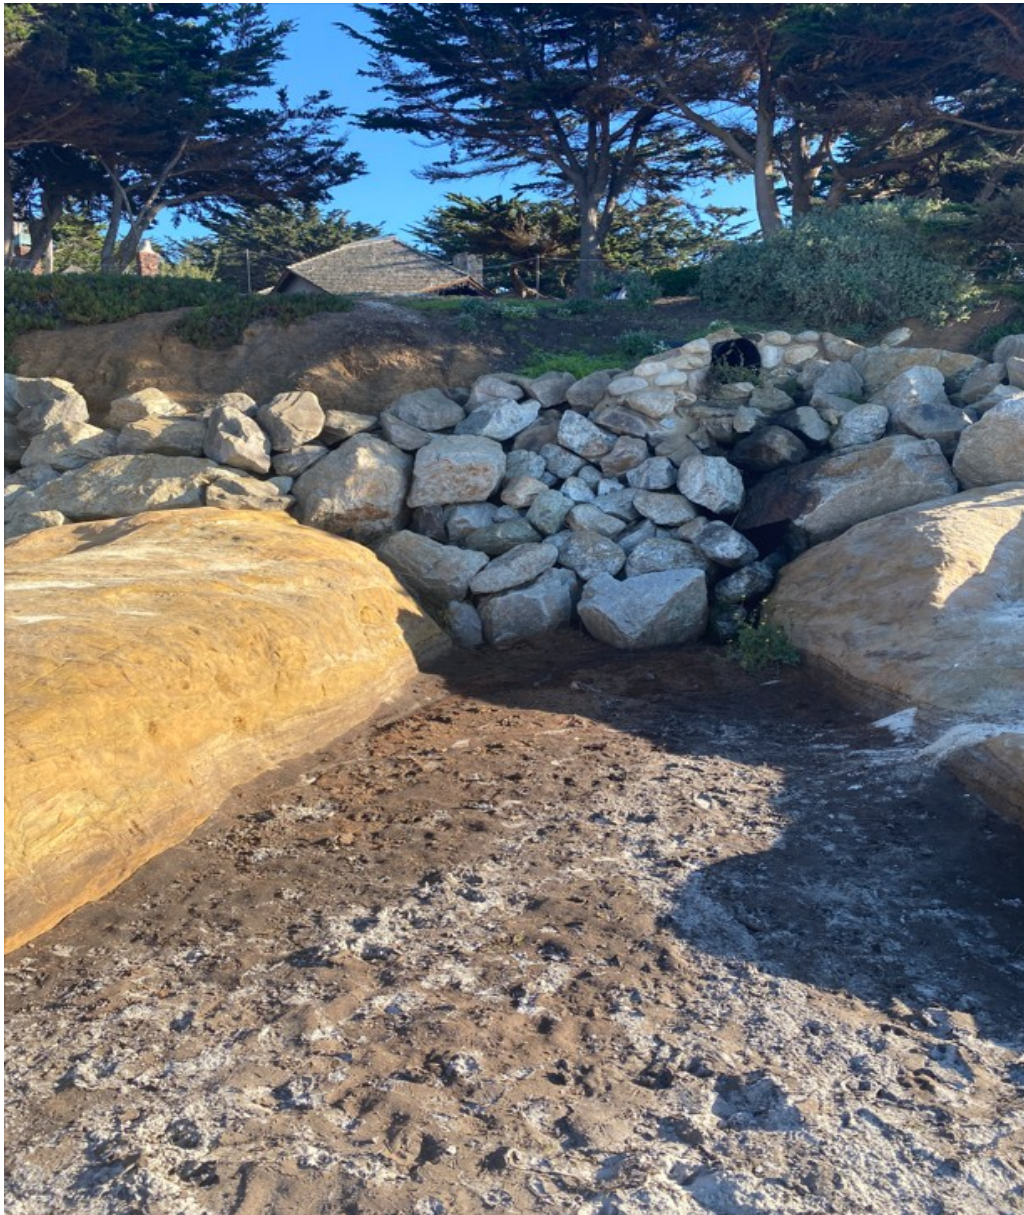
Photograph 17 shows the southern end of Revetment R1 on December 22, 2022, which consists of oversteep riprap, making it relatively unstable. One displaced boulder (a "fugitive" rock) can be seen poking out of the beach sand seaward of the revetment. Historic instability and the use of undersized boulders to construct this revetment have caused cavities to develop in the revetment and have diminished the erosion protection it provides. We recommend the holes in the revetment structure be filled and the 1 to 4 ton rocks be restacked. It is presently unsafe.

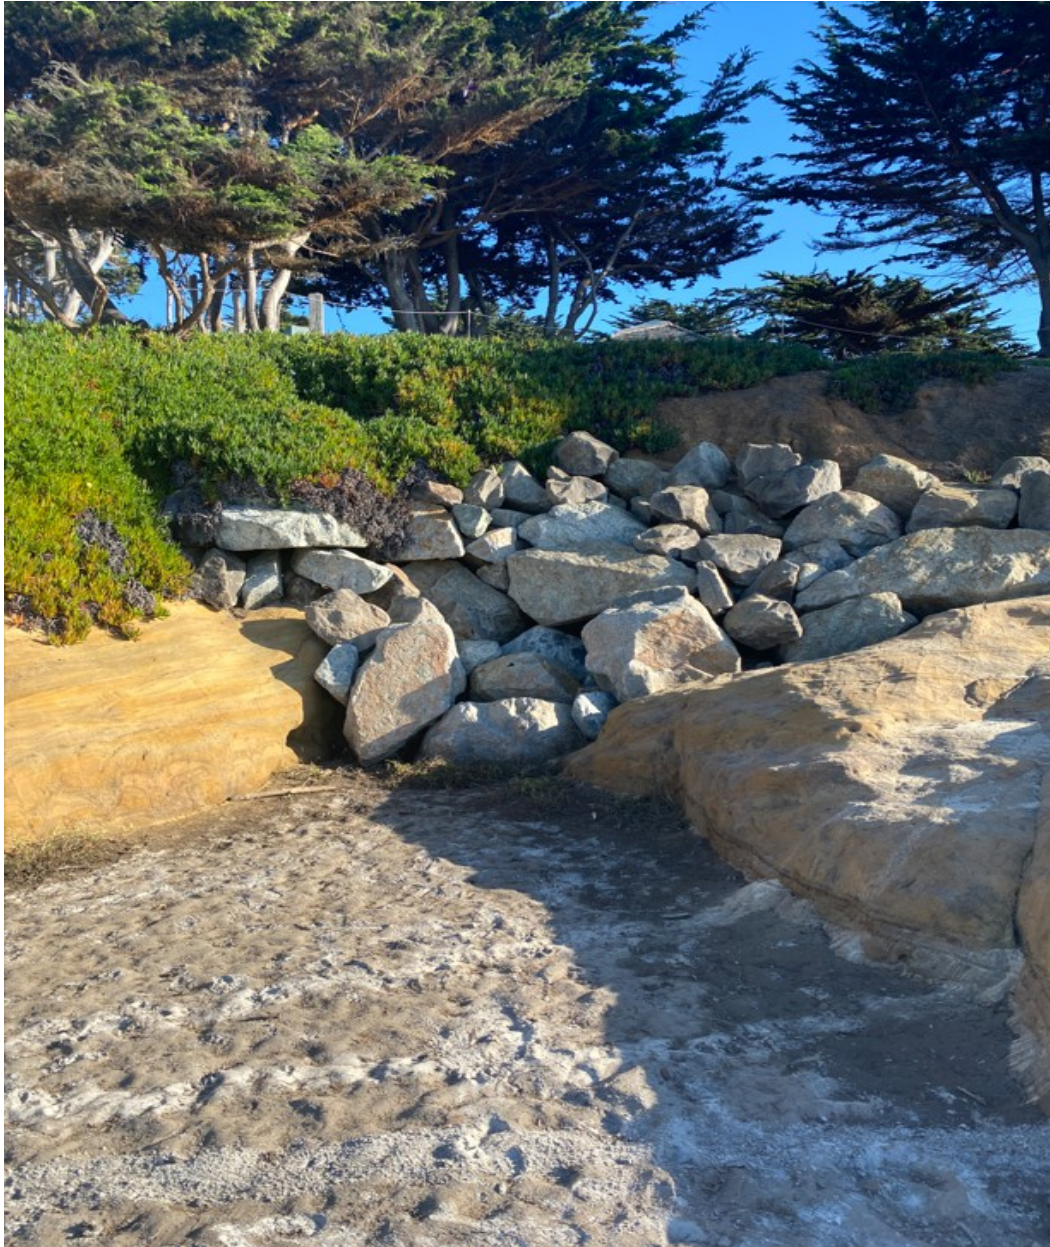
**Photograph 18: Revetment R1 Showing Undersized Overly Steep Riprap on December 22, 2022**

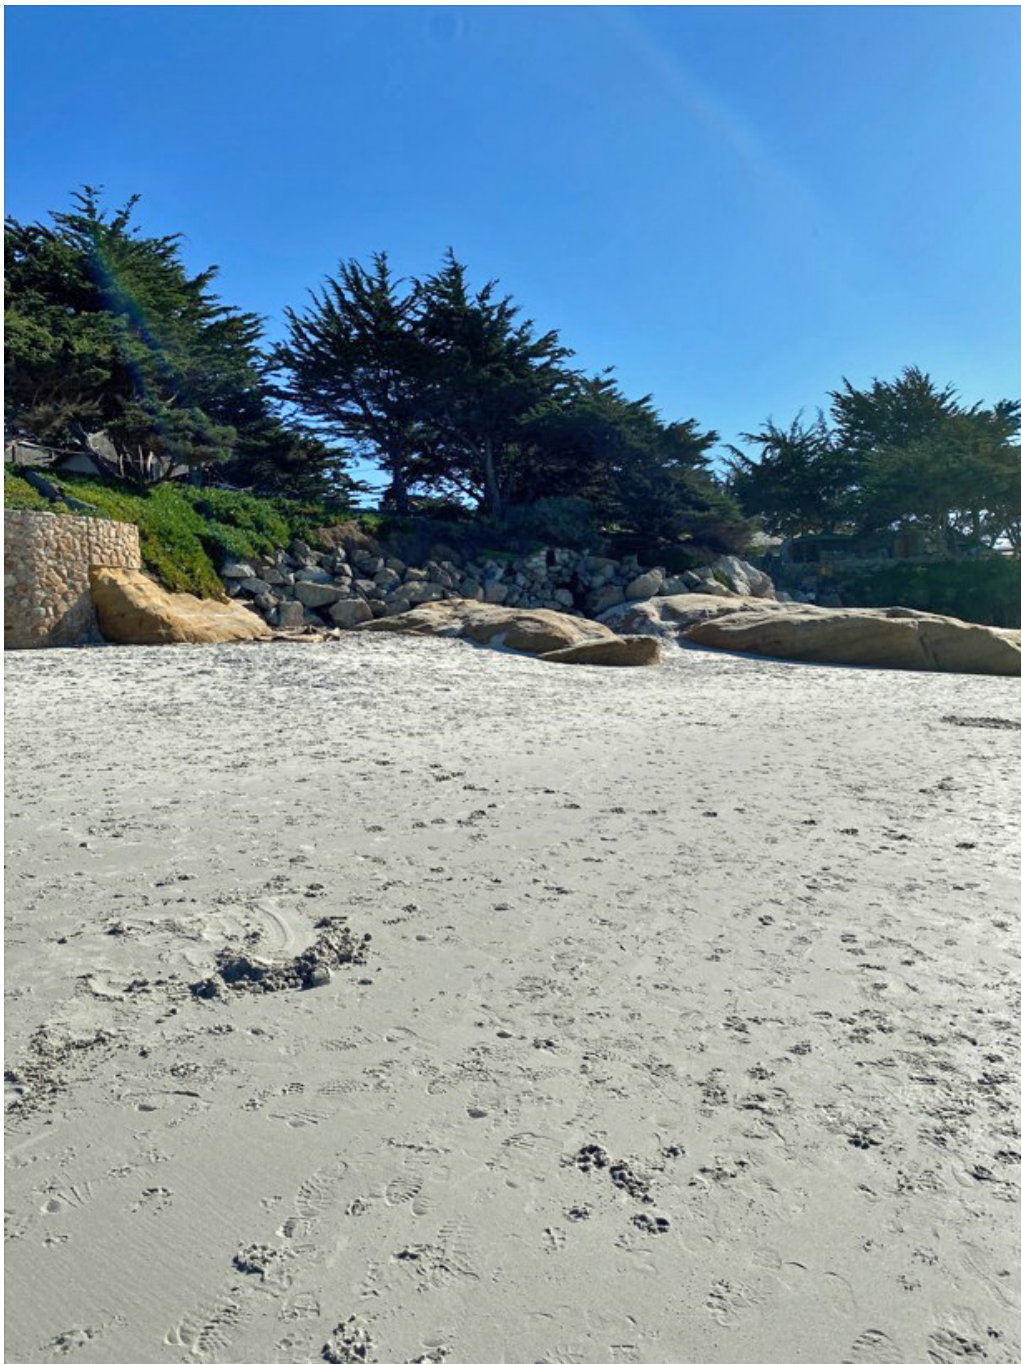
**Photograph 19: Revetment R1 on December 22, 2022**

Photograph 19 shows the northern end of Revetment R1 on December 22, 2022, which consists of overly steep riprap at a 0.5:1 (H:V) gradient. The northern 1/3 of the Revetment R1 riprap is unstable, poses risks to beach users, and we recommend it has a high priority for repair. We recommend bringing in additional larger riprap quarrystone boulders to lower the revetment gradient. Alternately the revetment could be removed and replaced with a vertical seawall to match the appearance of the other nearby seawalls along Carmel Beach.

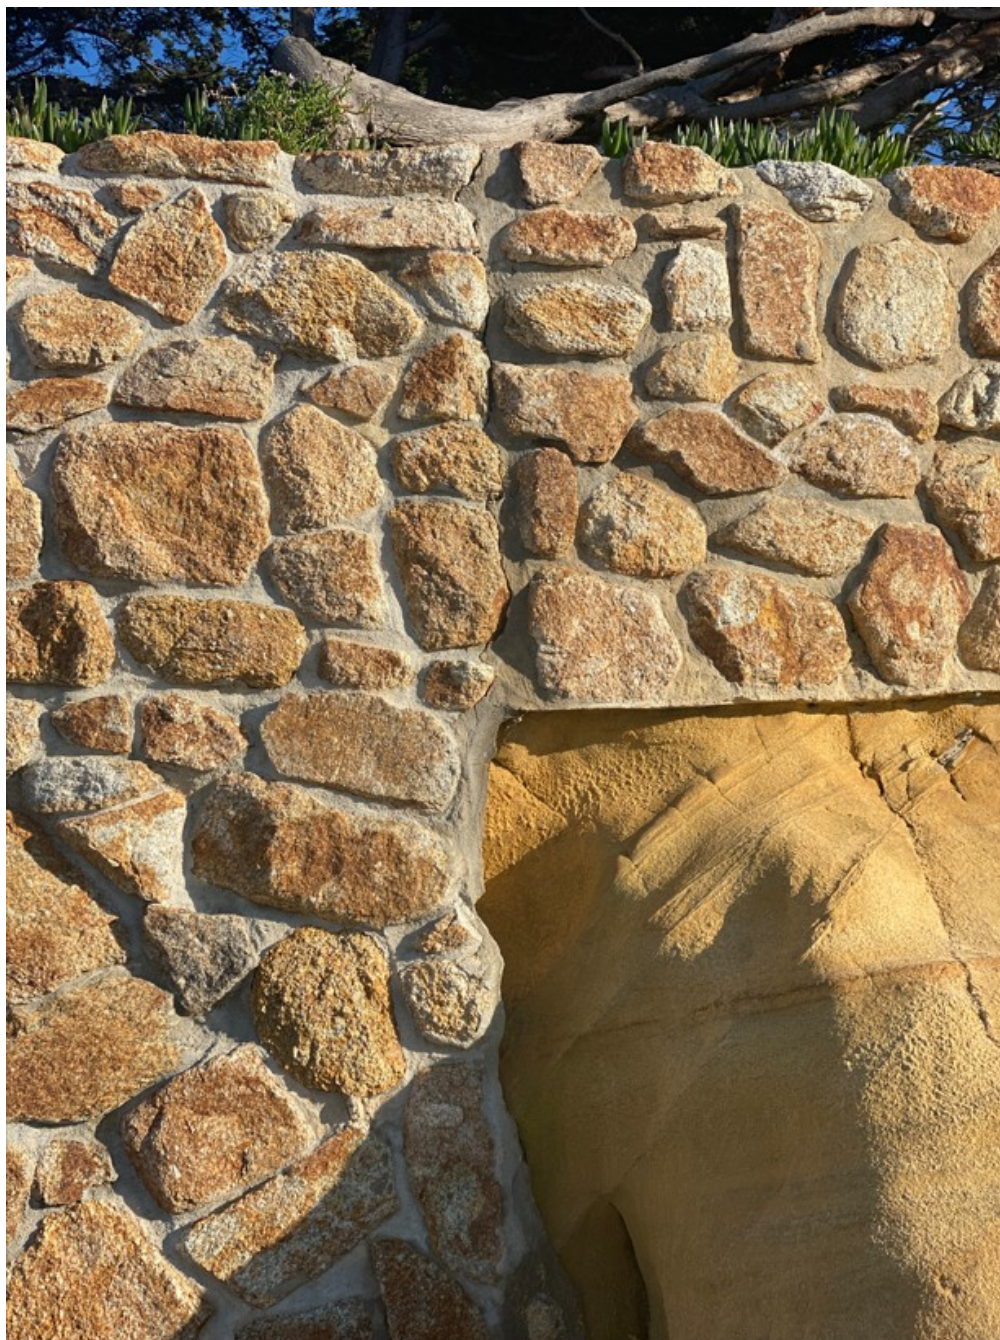
**Photograph 20: Showing Revetment R1 and the Southern End of Seawall S3 on January 30, 2023**

Photograph 20 shows Revetment R1 and the South End of Seawall S3 on January 30, 2023.

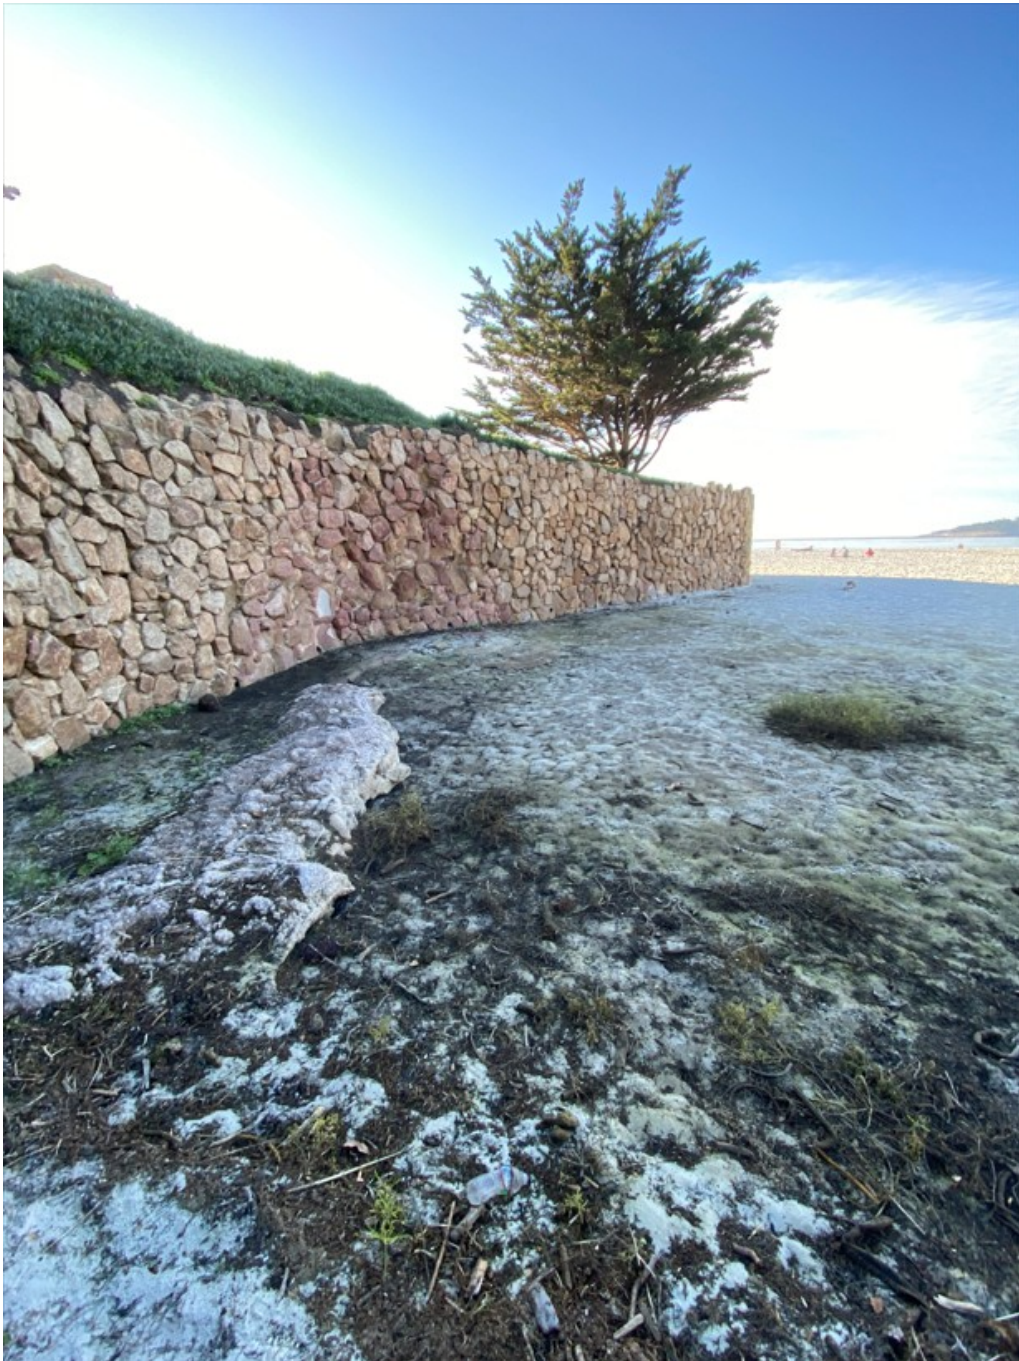
**Photograph 21: Very Southern End of Seawall S3 on December 22, 2022**

Photograph 21 shows Seawall S3 where its foundation is founded on bedrock and steps upward at the very southern end of Seawall S3, which is located near 13th Avenue, on December 22, 2022. A vertical crack, which appears to be a shrinkage crack or expansion crack, is visible, but is not of concern.

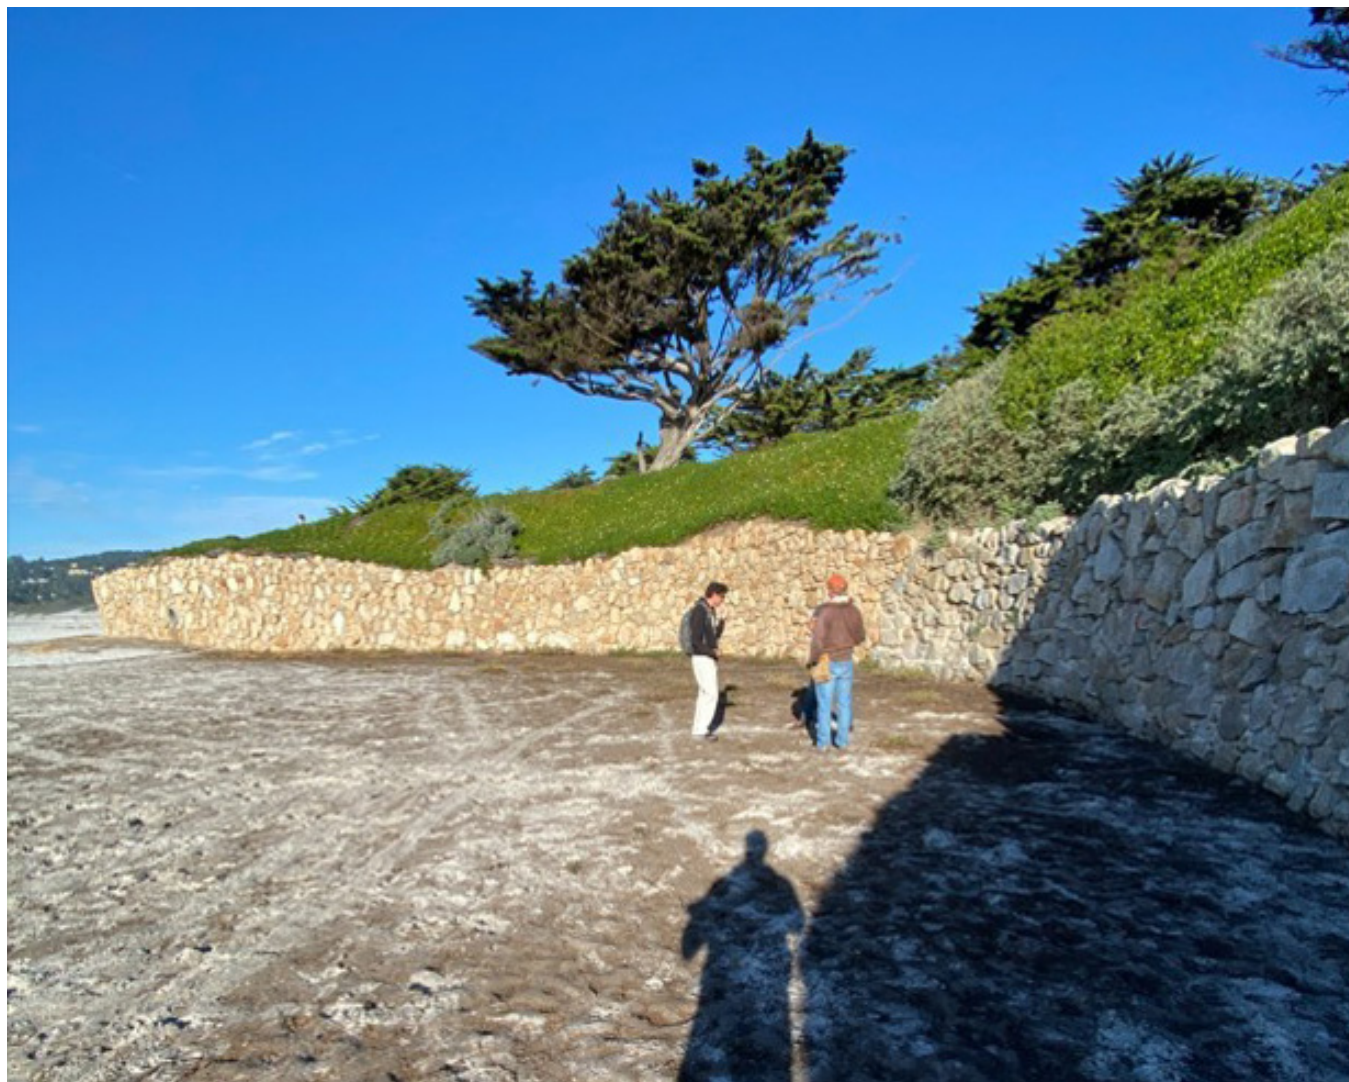
**Photograph 24: Southern End of Seawall S3 in February 2016 Photographed by Easton Geology Showing Pumped Concrete Repair of Undermining of Seawall S3**

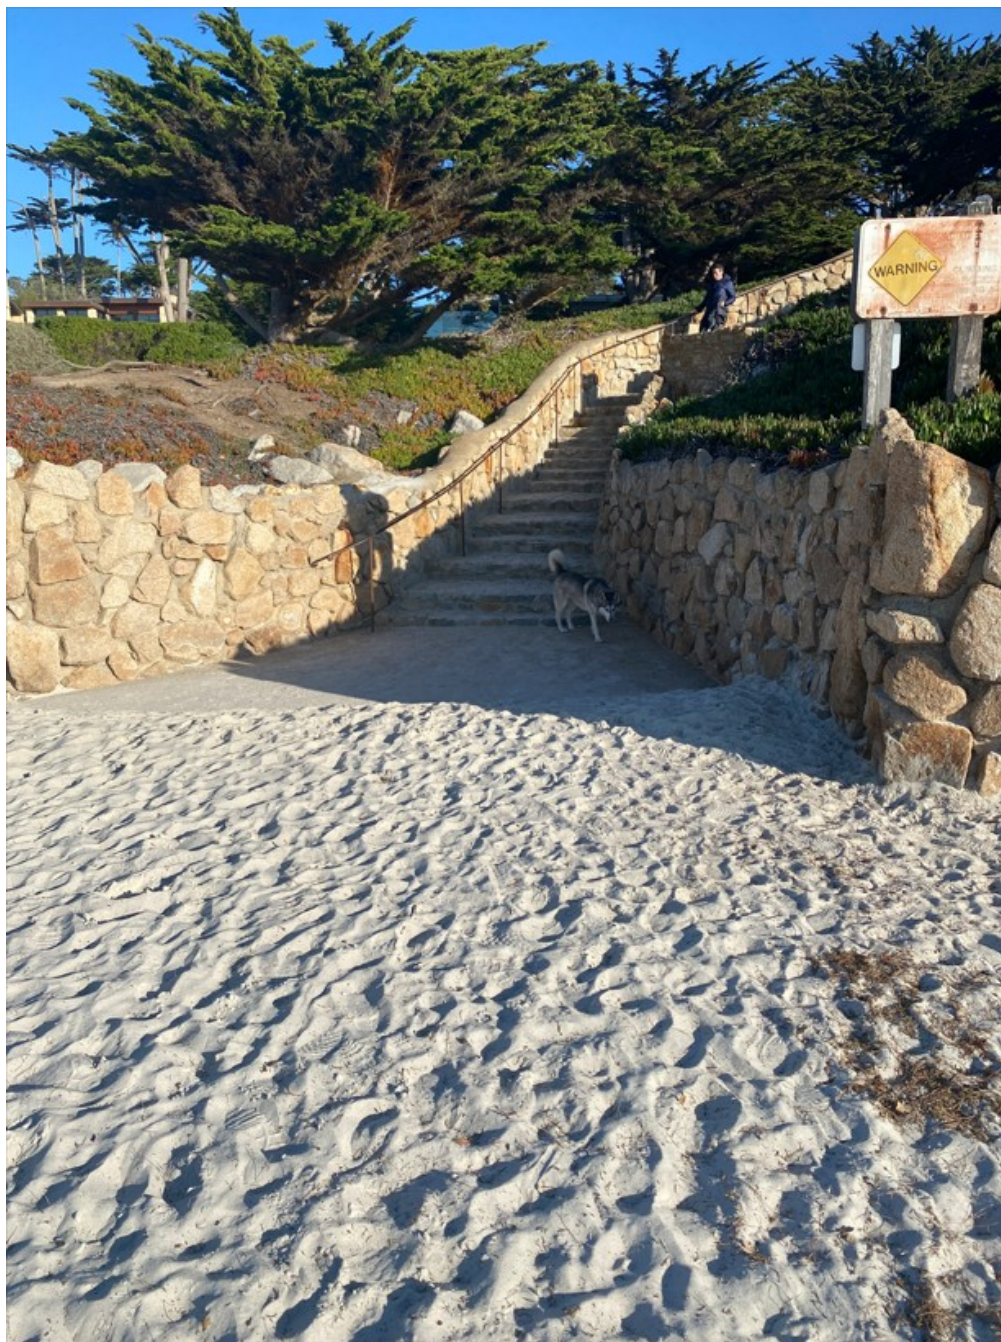
**Photograph 26: Seawall S3 Showing Missing Rock on December 22, 2022**

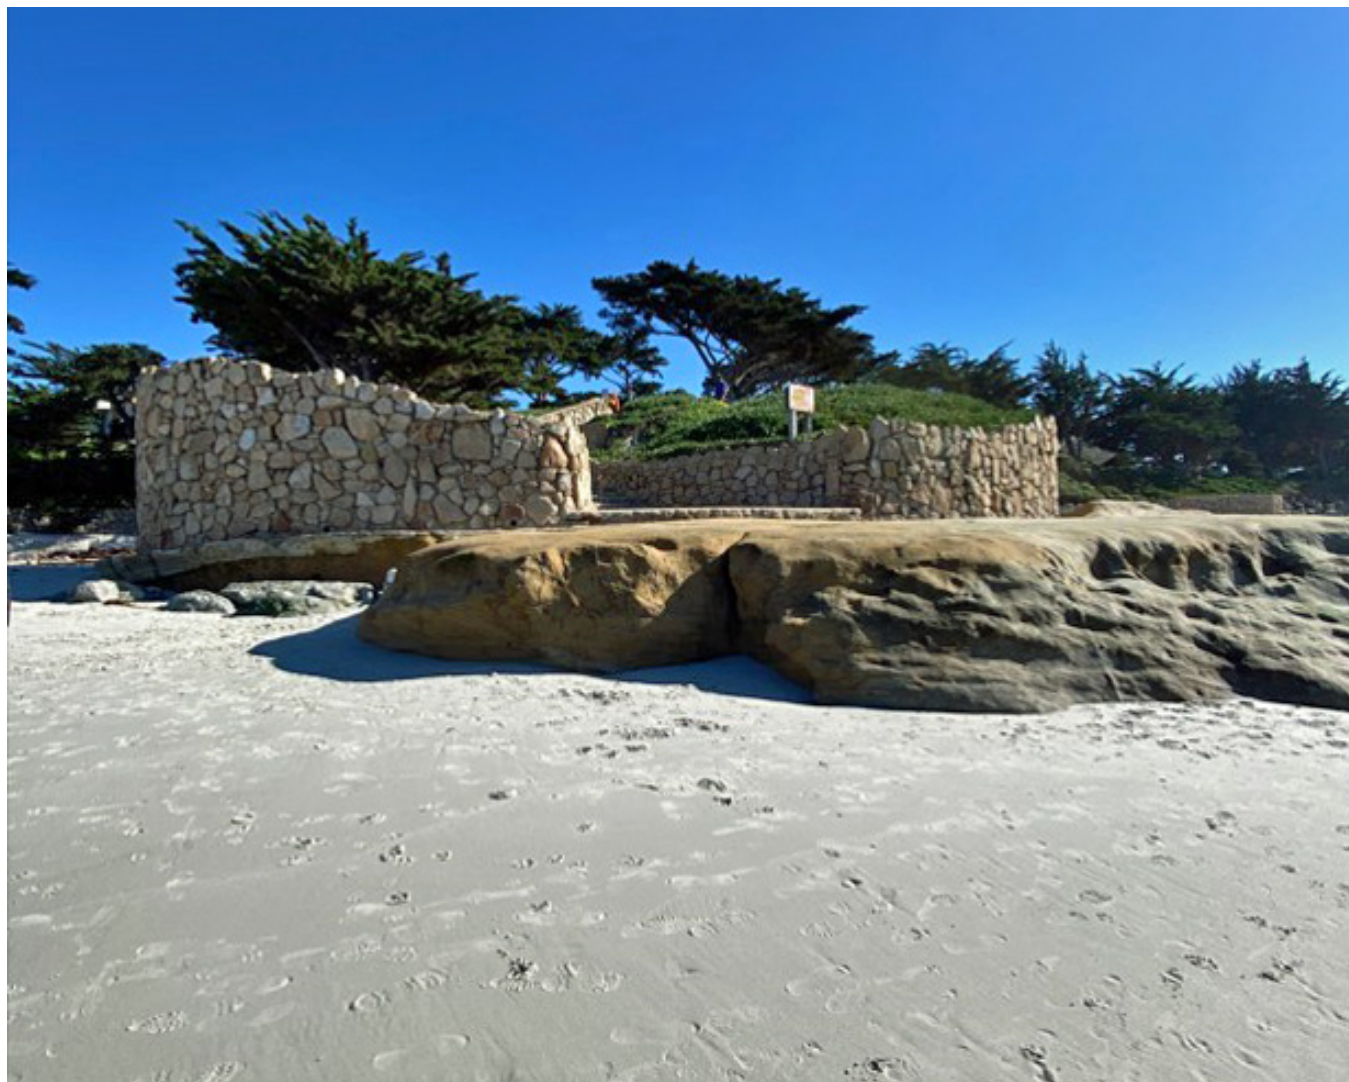
**Photograph 27: Public Access Stairway ST3 on December 22, 2022**

Photograph 27 shows the seaward portion of Public Access Stairway ST3 located at 13th Avenue, on December 22, 2022, which is in good condition. Seawall S3 is on both sides of ST3.
