Date: 27 April 2023  
Client: City of Carmel  
Subject: Carmel Beach Coastal Protection Assessment  
Reference: Carmel Beach Adaptation Plan  
Project No.: 12176

## **CARMEL BEACH COASTAL PROTECTION ASSESSMENT REPORT**

Coastal Protection Evaluation 22 December 2022 thru 30 January 2023

Carmel Adaptation Plan - Carmel Beach All Areas

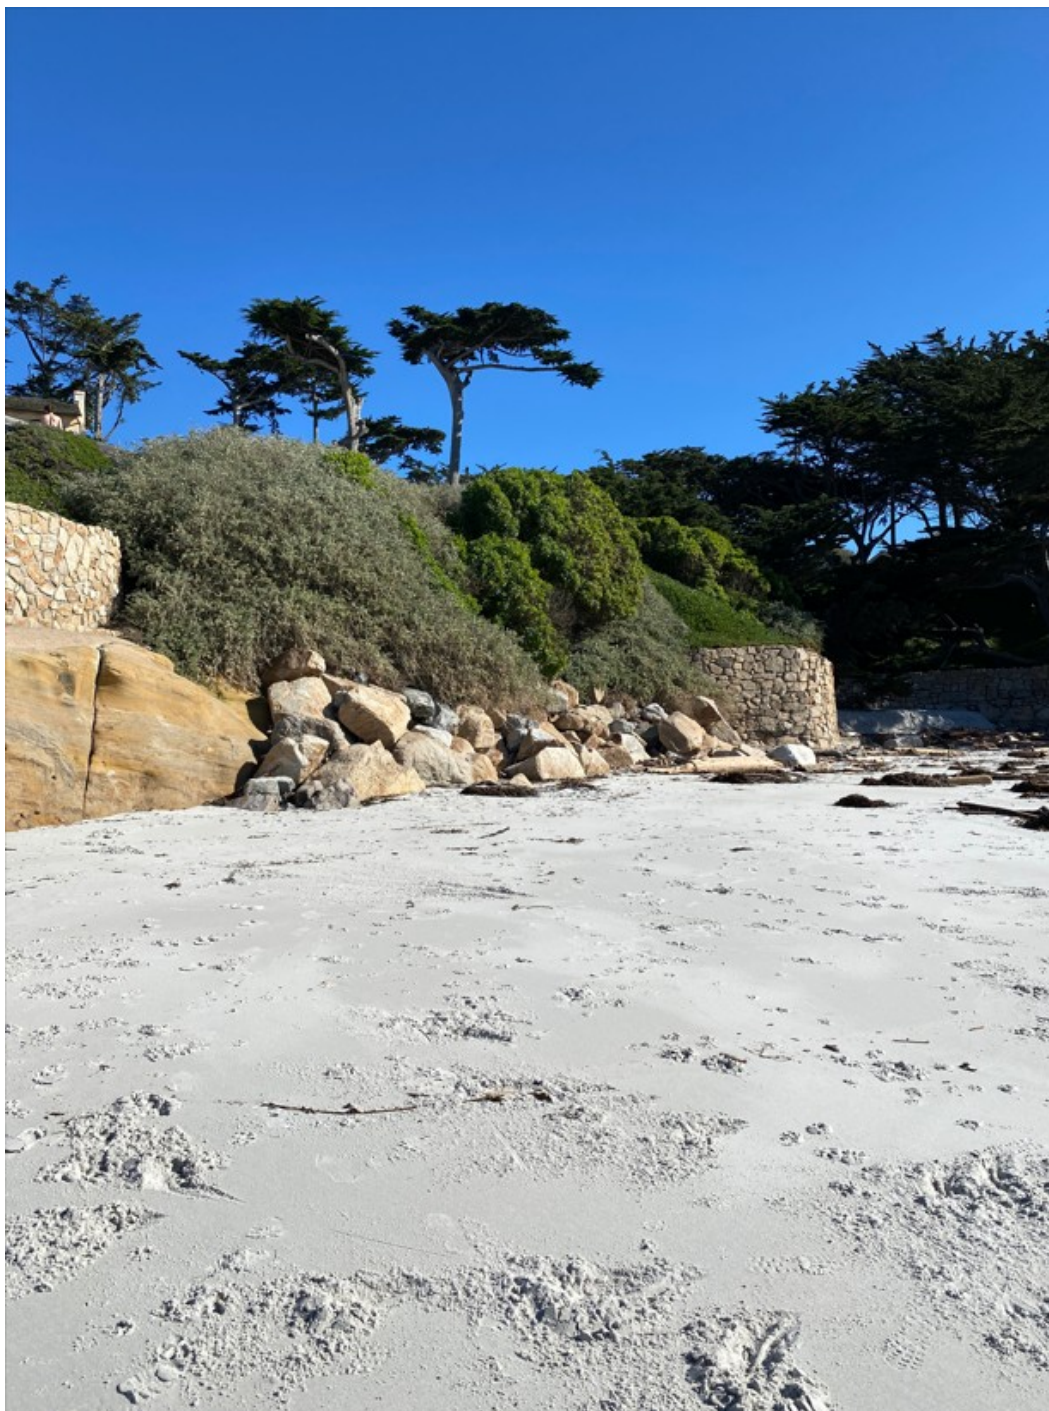
Photograph 32 shows the north end of Seawall S3 where it adjoins Revetment R2 on December 22, 2022. The north end of Seawall S3 was historically slightly undermined, and the resultant cavities have been repaired with concrete patchwork, and or grouted riprap. The north end of Seawall S3 appears to be stable.

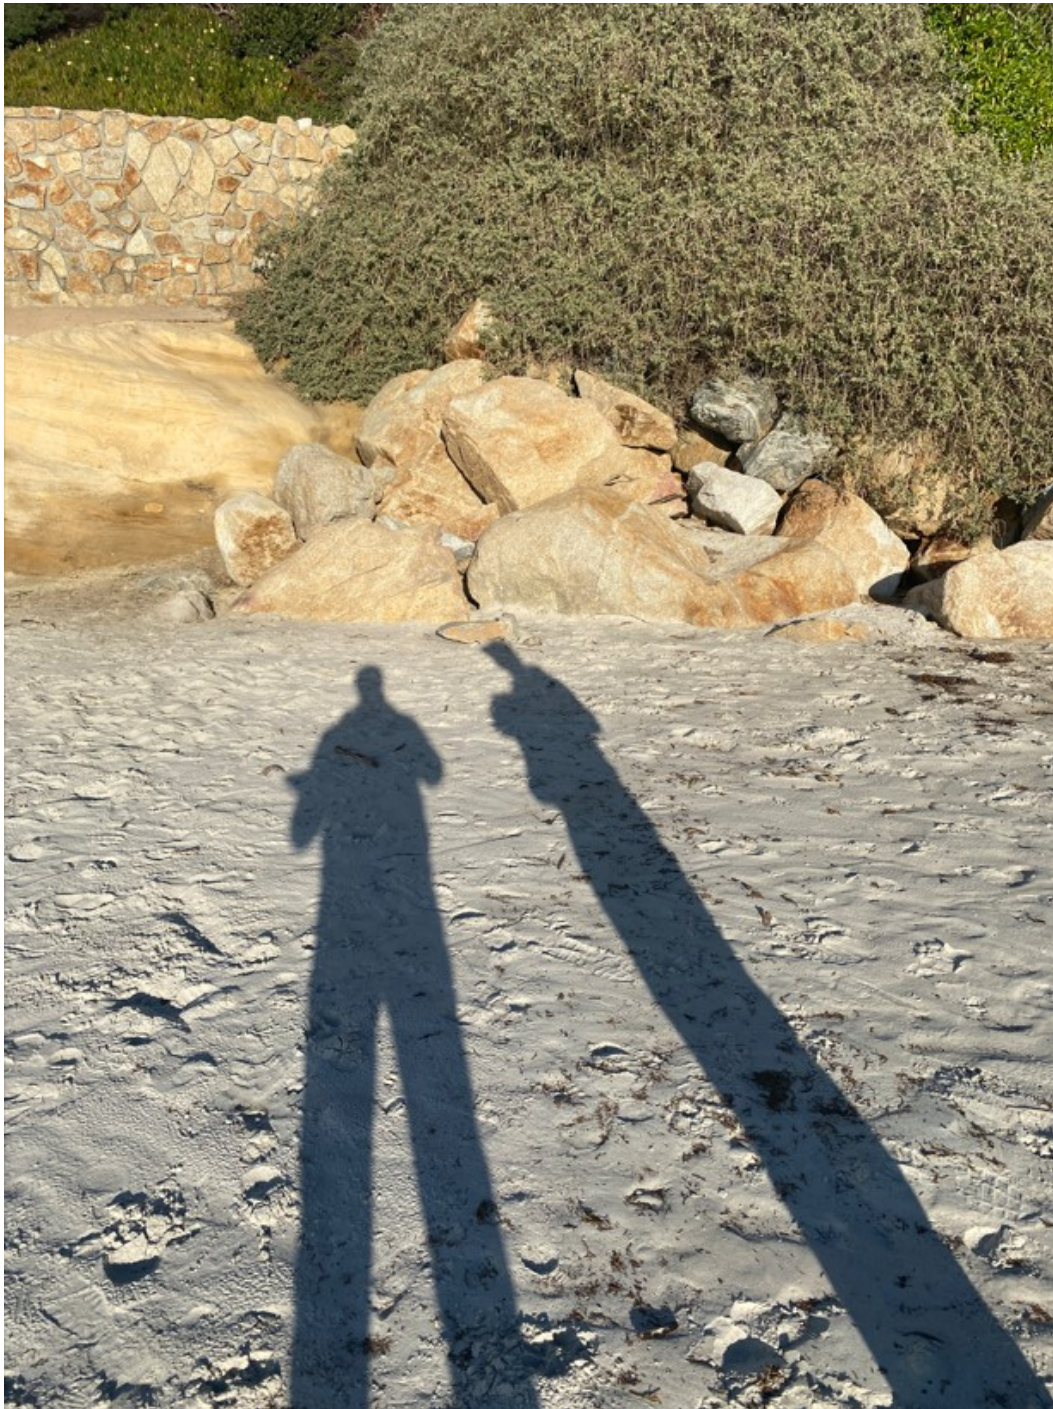
Photograph 33 shows the south end of Revetment R2 on December 22, 2022, which has some displaced fugitive riprap. The revetment surface gradient is not uniform and the coastal erosion protection this revetment provides could be improved from restacking the riprap boulders. Revetment R2 includes a large volume of undersized riprap, which is vulnerable to plucking from wave attack. Revetment R2 poses risks to beach users, and we recommend it as a high priority for repair. The base of the revetment was buried by beach sand during our inspections and so its condition is unknown. Whenever it is next exposed by natural beach sand scour processes, it should be inspected. That may not be for a decade but could be possible any winter.

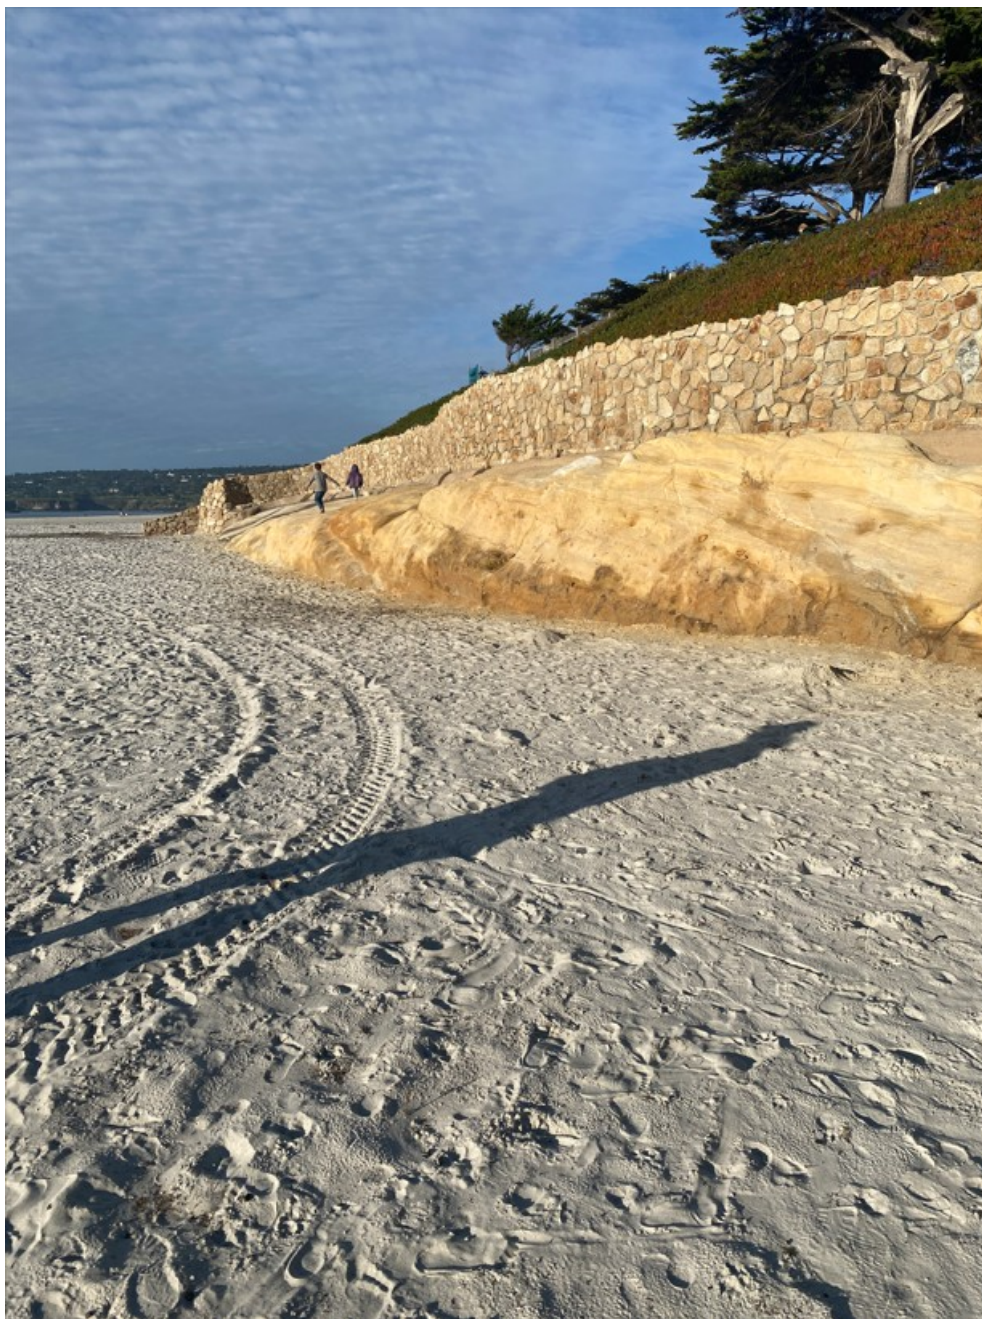
**Photograph 35: Showing Seawall S4 on January 30, 2023**

Photograph 35 shows the southern portion of Seawall S4 on January 30, 2023 which is in similar conditions to when our December inspection was done. This seawall is in good to excellent condition and is founded on the bedrock platform. No repairs appear to be needed.

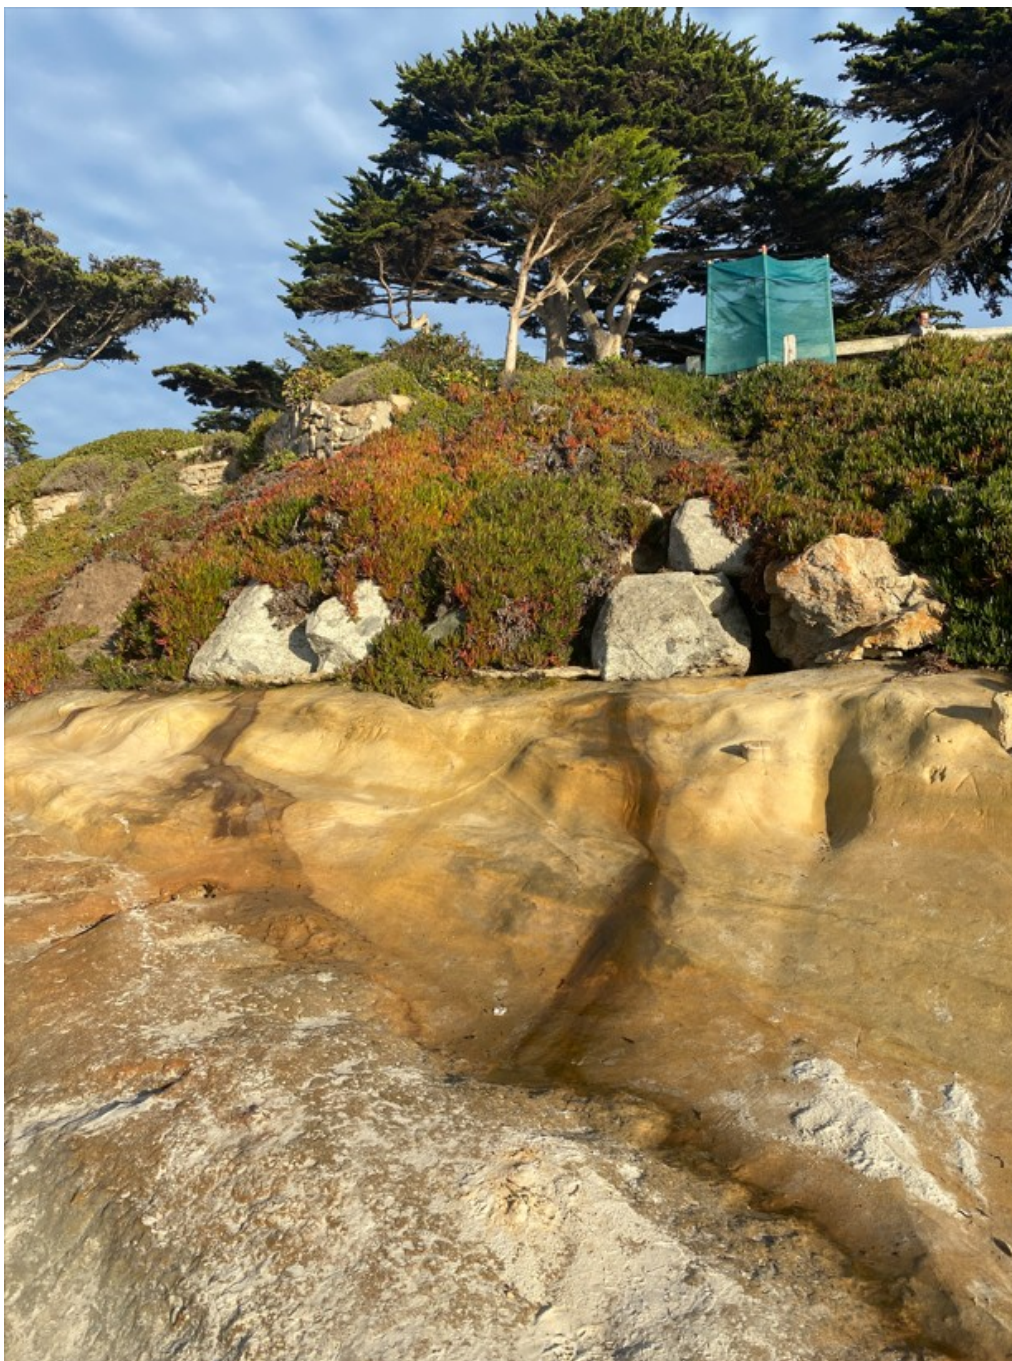
**Photograph 36: Showing North Portion of Seawall S4 on December 22, 2022**

Photograph 36 shows the north portion of Seawall S4 on December 22, 2022, which is founded on a natural bedrock platform that is elevated above the beach level. This wall was designed by Neill Engineers and constructed in 2001.

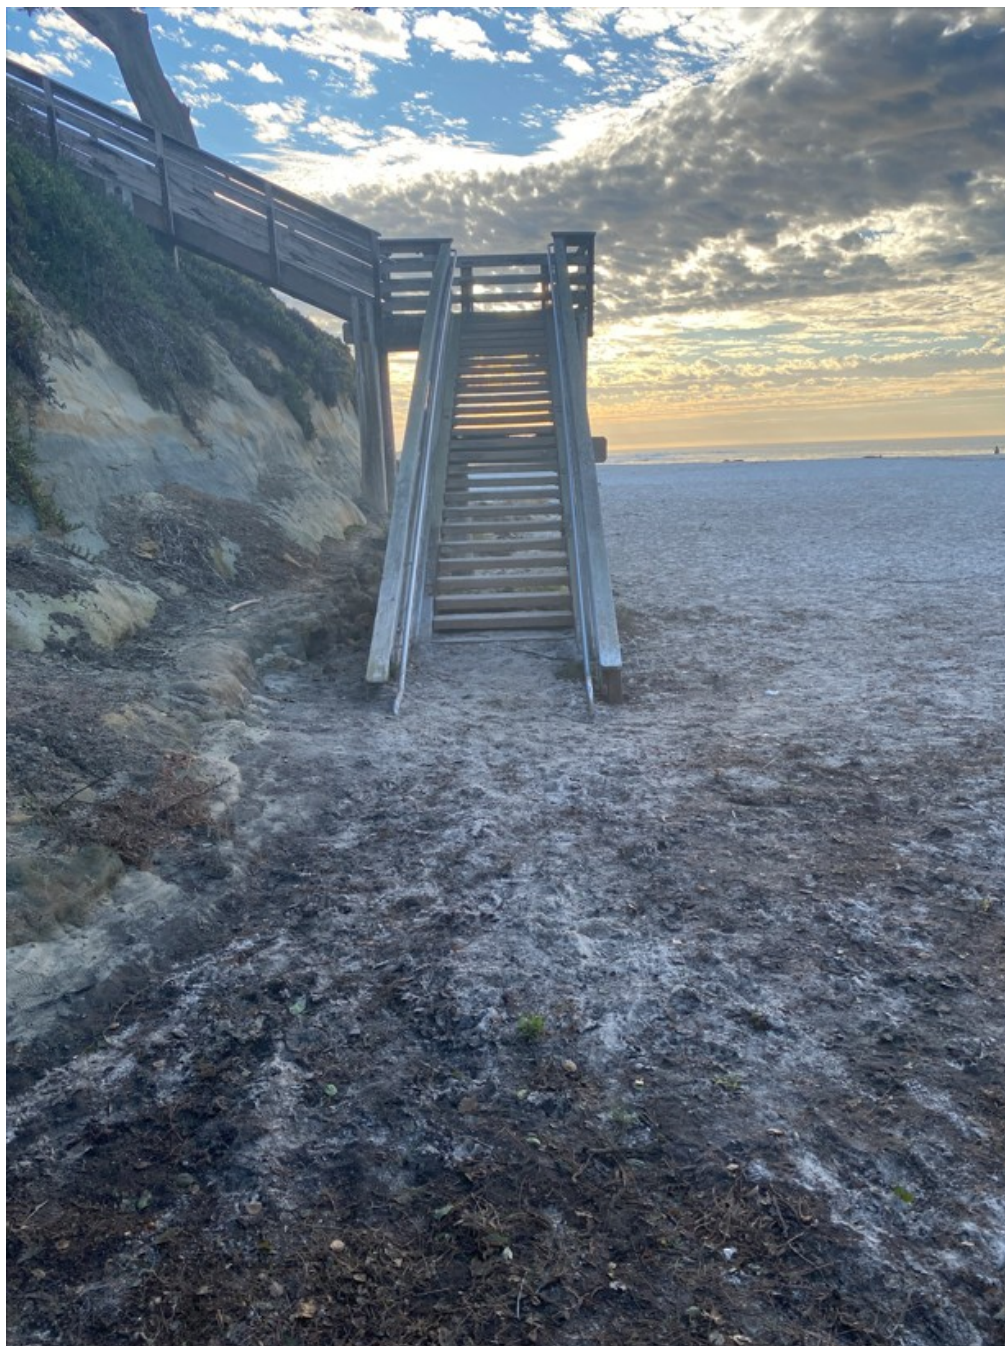
**Photograph 40: Showing Base of Stairway ST4 naturally buried in beach sand on December 22, 2022**

As shown in Photograph 40 (below) the foundation of Public Access Stairway ST4 was not exposed during either our December 2022 inspection or our January 2023 inspection. Whenever it is next exposed by natural beach sand scour processes, it should be inspected. That may not be for a decade but could be possible during any winter.

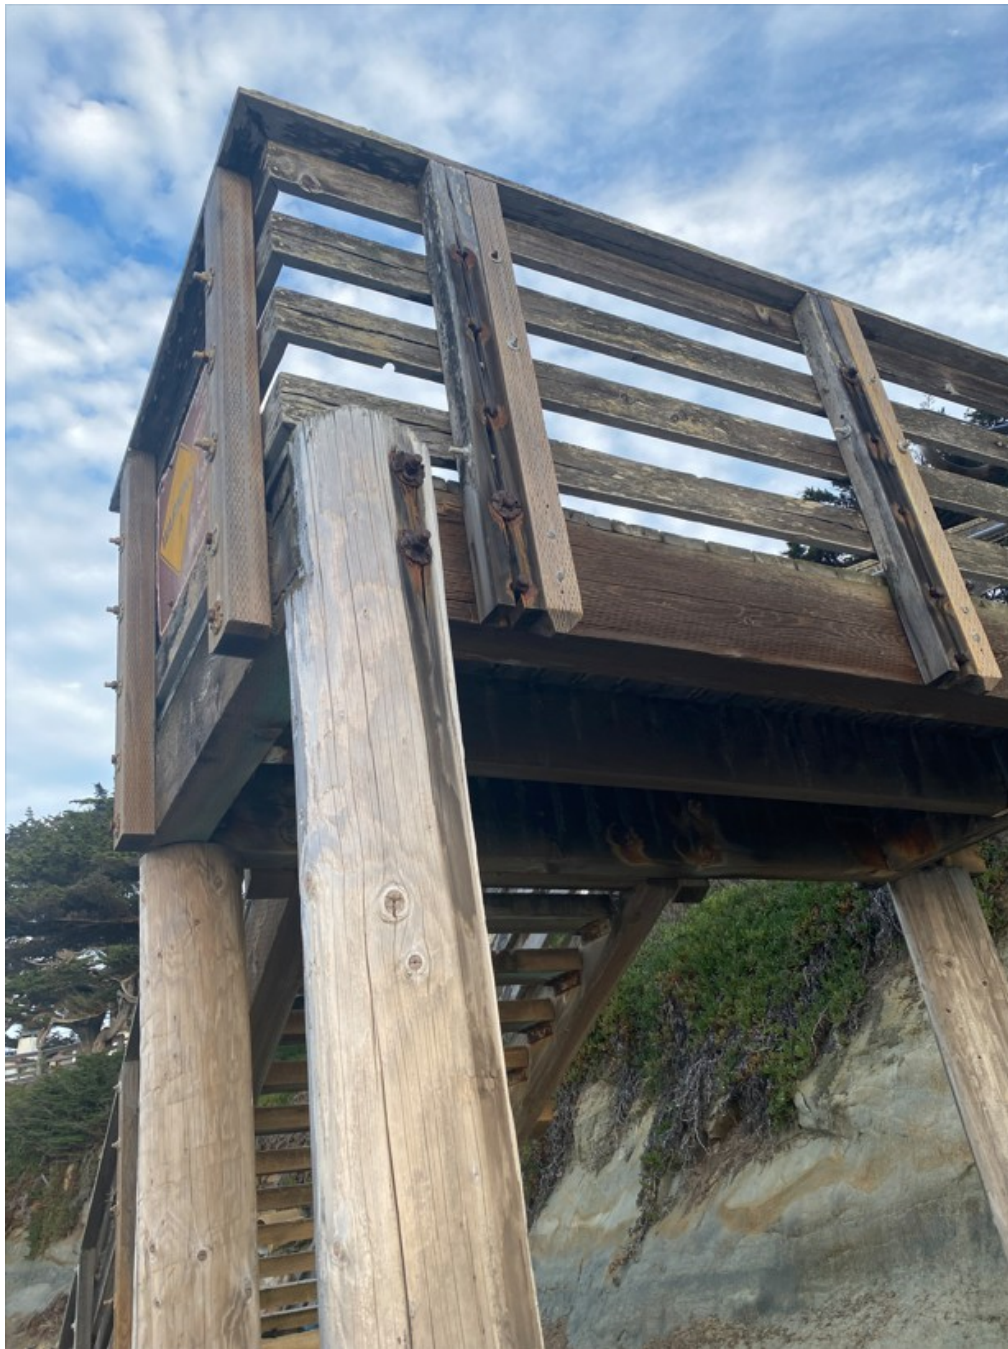
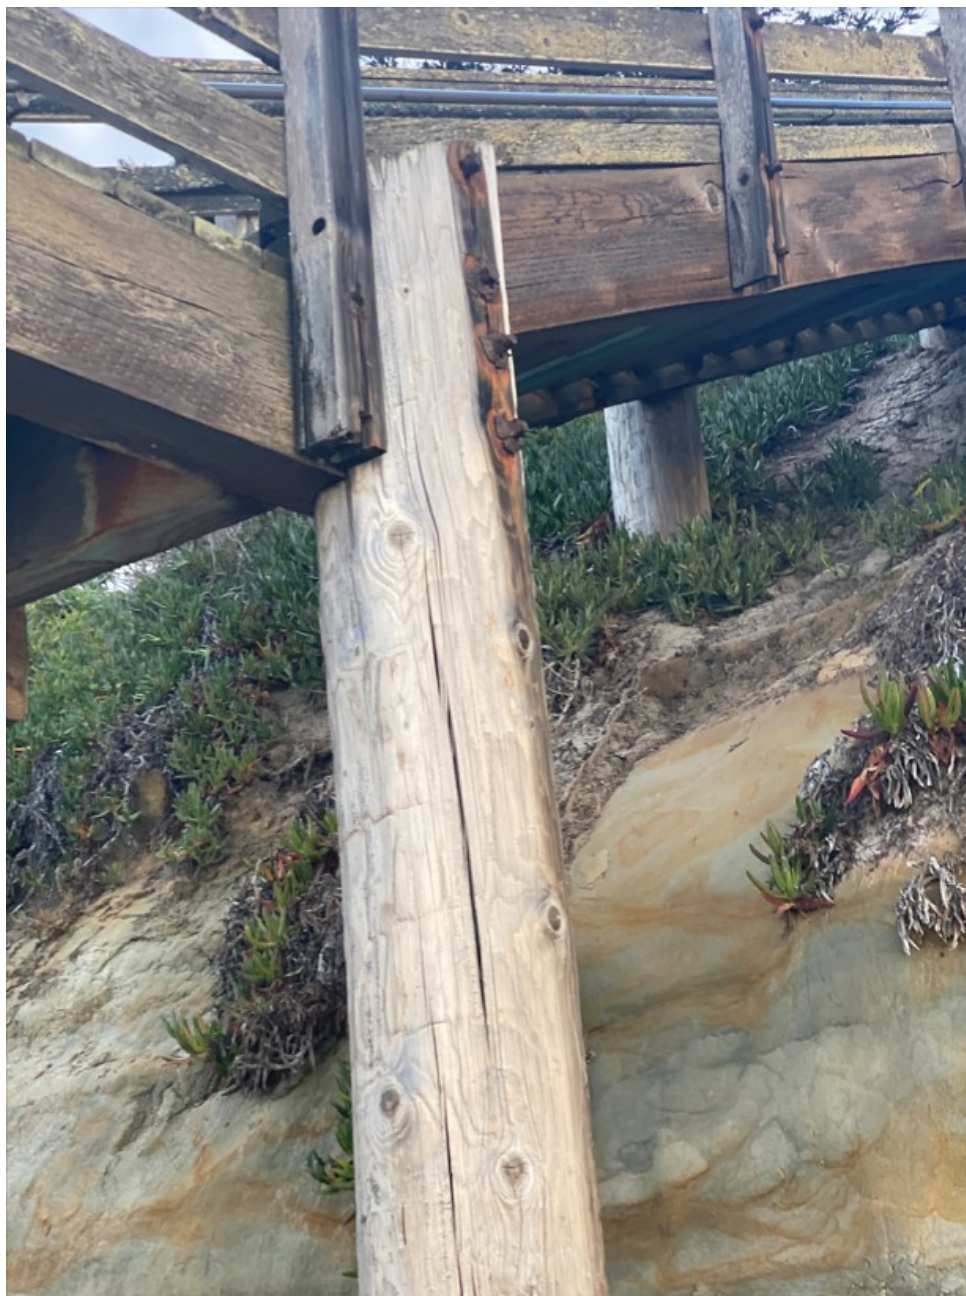
Stairway ST4 has severely corroded hardware and fasteners as well as some split timber elements, as shown in Photographs 41 and 42 below. Further evaluation of the structure by an independent licensed structural engineer (and if need be a licensed corrosion engineer) should be scheduled to verify the structure is safe for public use, and recommend any needed repairs.

**Photograph 41: Showing Corroded Hardware and Split Timbers on Stairway ST4 on December 22, 2022**

**Photograph 42: Showing Corroded Hardware and Split Timbers on Stairway ST4 on December 22, 2022**

Stairway ST4 repairs appear to be needed due to corrosion of fasteners and hardware, split timbers, and the vertical drop off and lack of foundation support at the base of the stairs during times of beach scour. Extension of the stairs does appear to be prudent. There is risk to users of the stairs because they do not extend to beach level during periods of low elevation sand levels. Due to the vertical drop off we rank extension of the stairs to beach level as a high priority and recommend prompt structural and corrosion inspection. There is a high risk to users of the stairs.

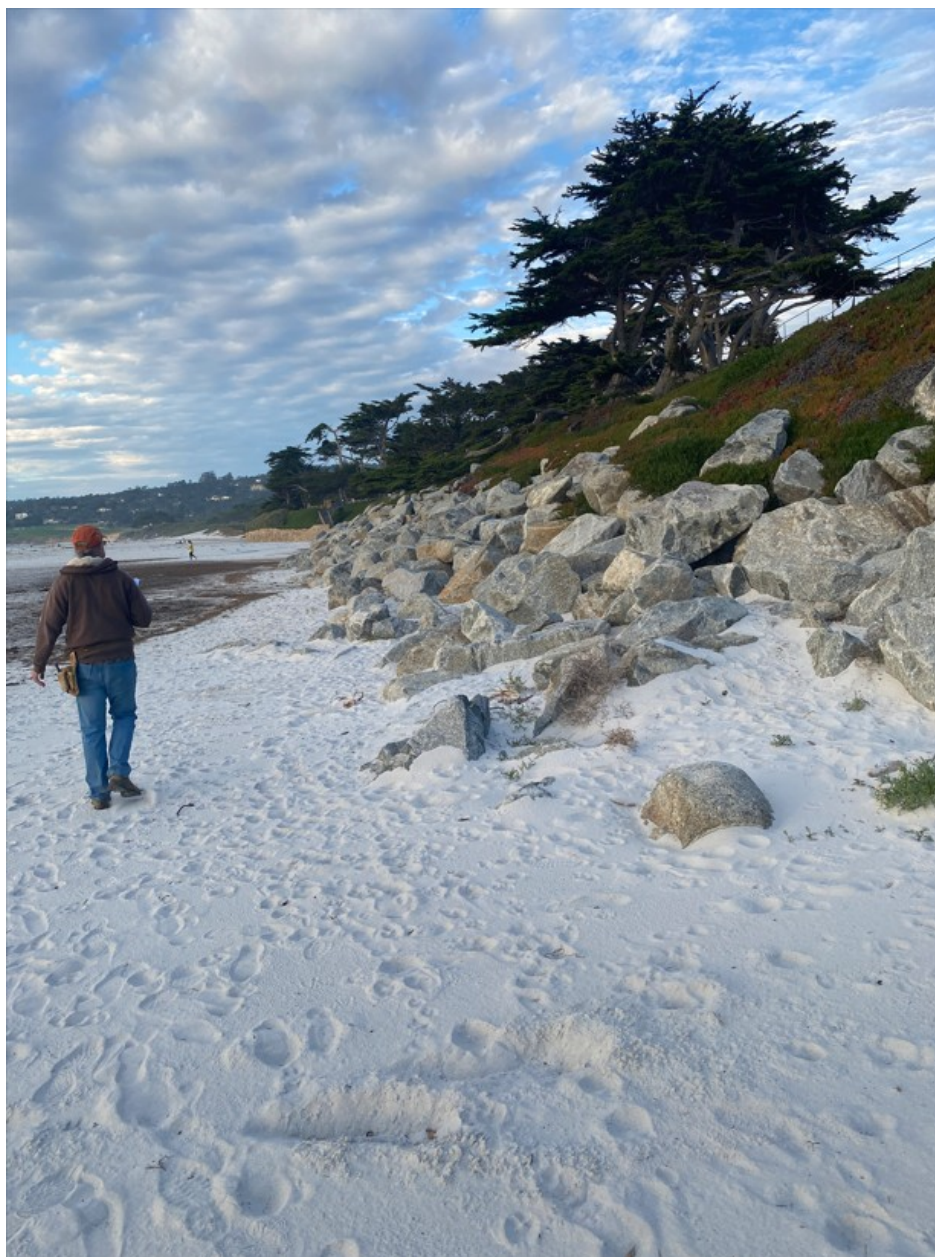
**Photograph 50: Most of Revetment R3 is in Good Condition on December 22, 2022**

The northern three-quarters of Revetment R3 is composed of 2-to-4-ton riprap stacked at approximately a 1.5 to 1.7 to 1 (H:V) gradient and looks to be performing well. No maintenance is recommended here.

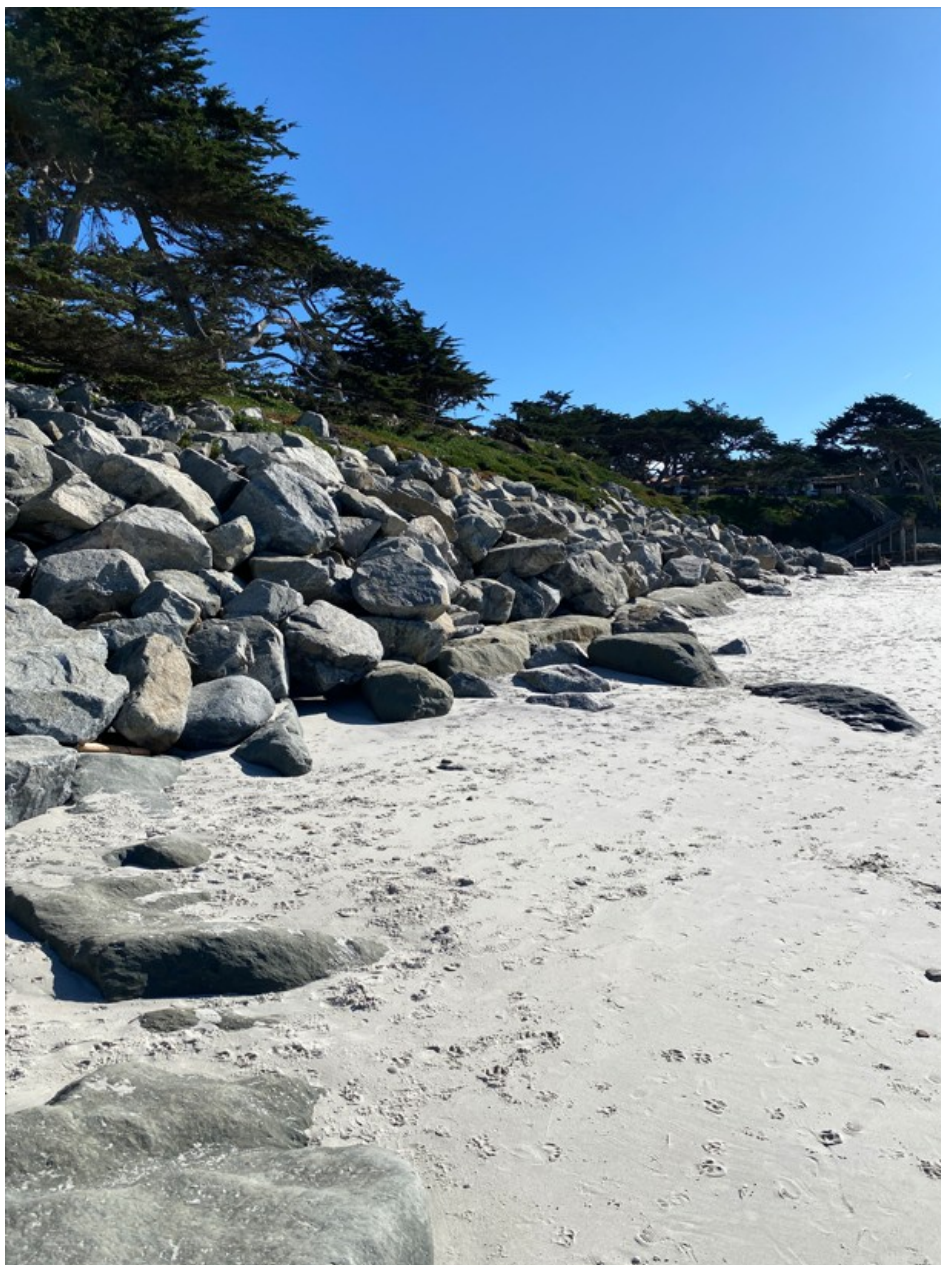
**Photograph 51: Showing the Middle Portion of Revetment R3 on January 30, 2023**

Photograph 51 shows the middle portion of Revetment R3 with bearing support on the bedrock platform and on the outboard side of keyway, with the bedrock still providing lateral support of the toe of the structure, except in a couple locations. Two over-steepened sections could benefit from re-stacking, however, this riprap revetment is in good condition and performing well.

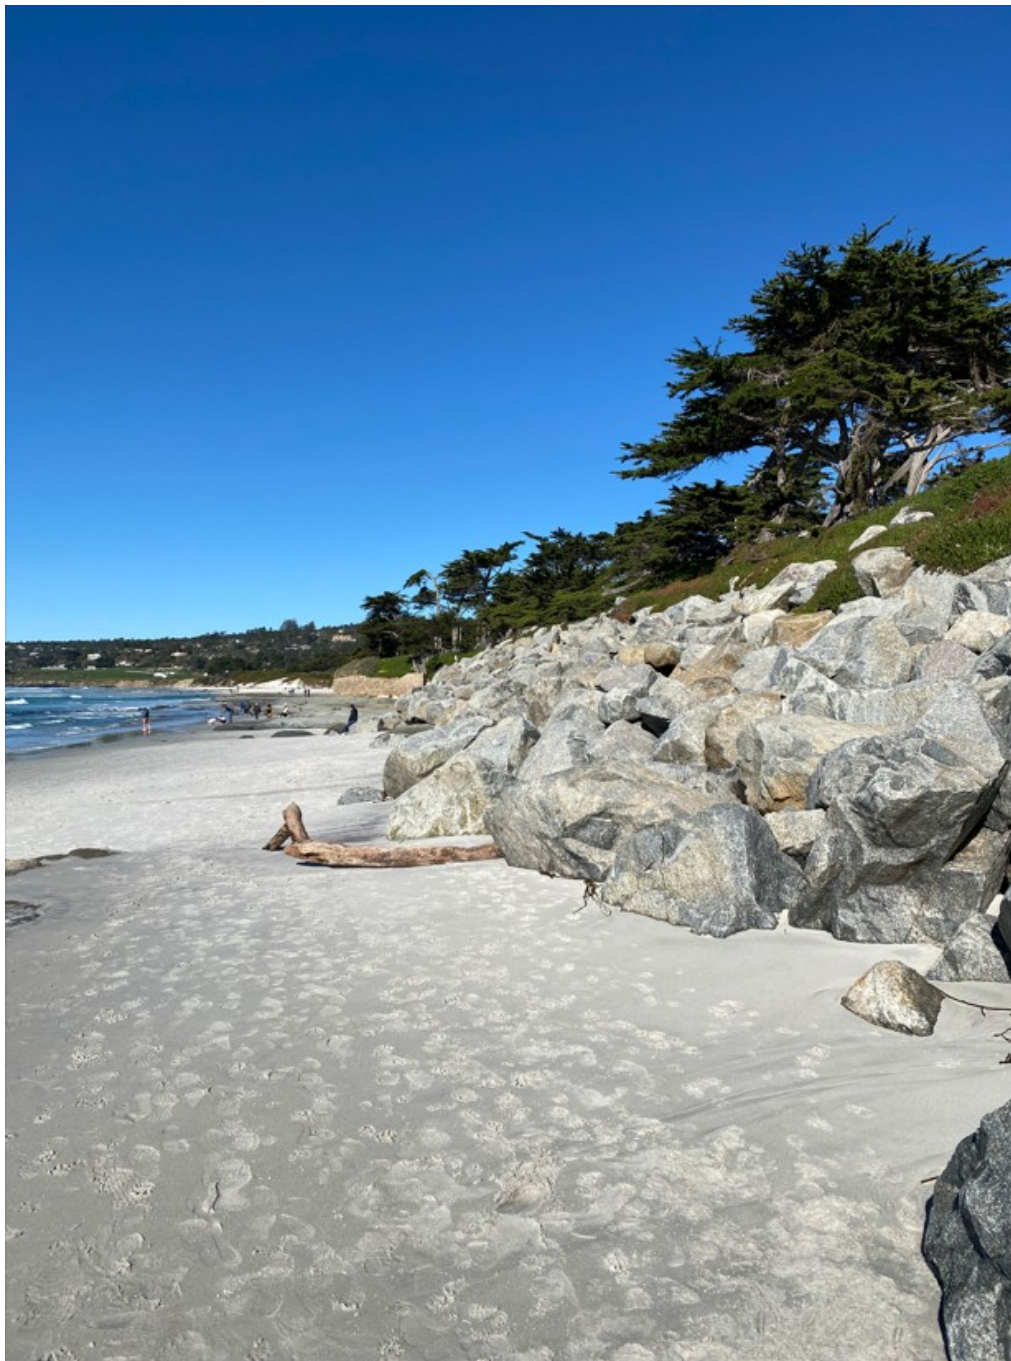
**Photograph 52: Showing Revetment R3 Looking North on January 30, 2023**

Photographs 51 and 52 show Revetment R3 looking north and south. The portion of R3 shown in Photograph 52 is in great condition.

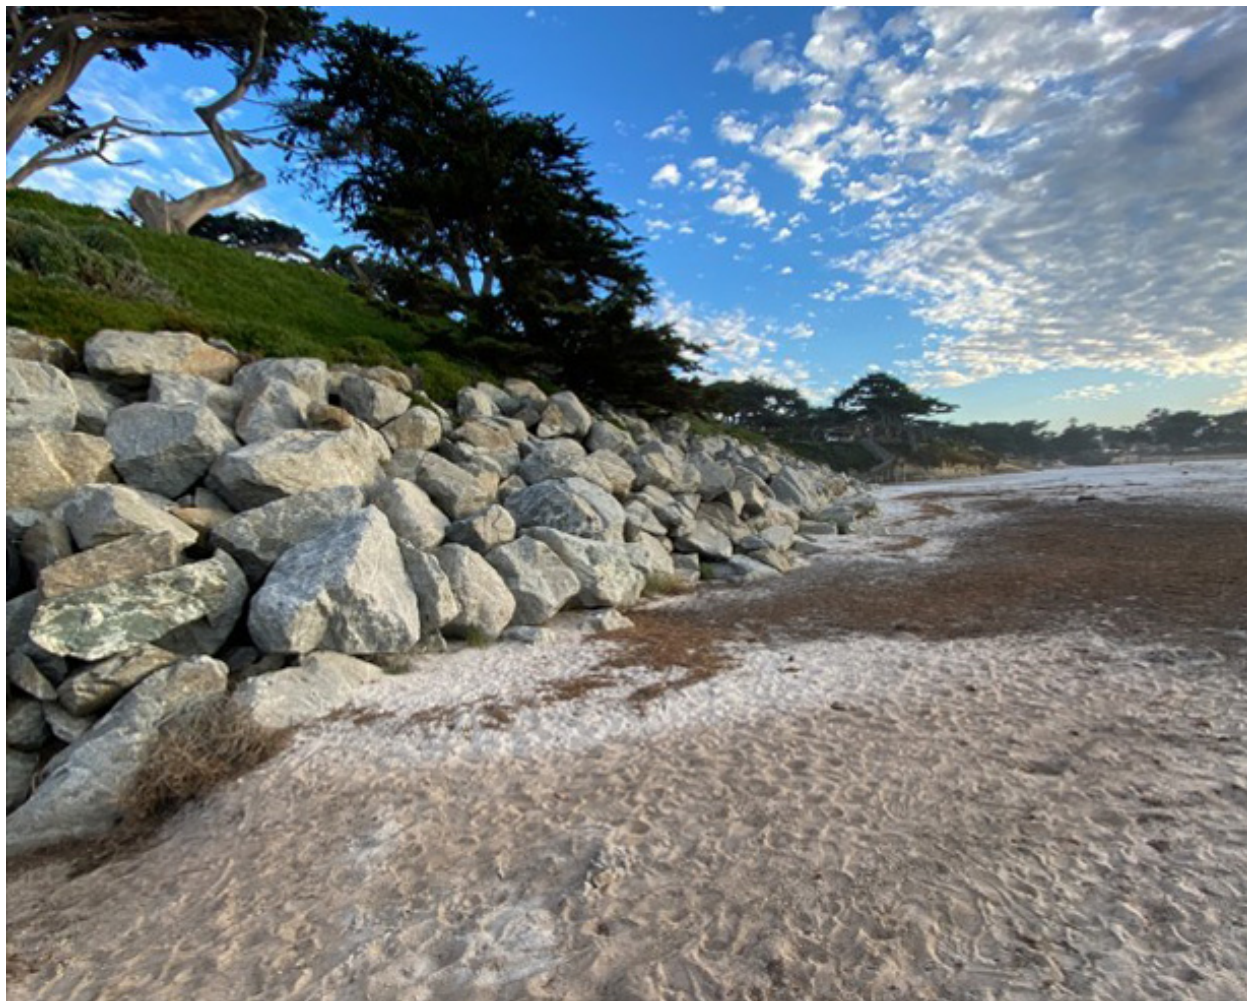
**Photograph 54: Over-steepened portion of Revetment R3 on December 22, 2022**

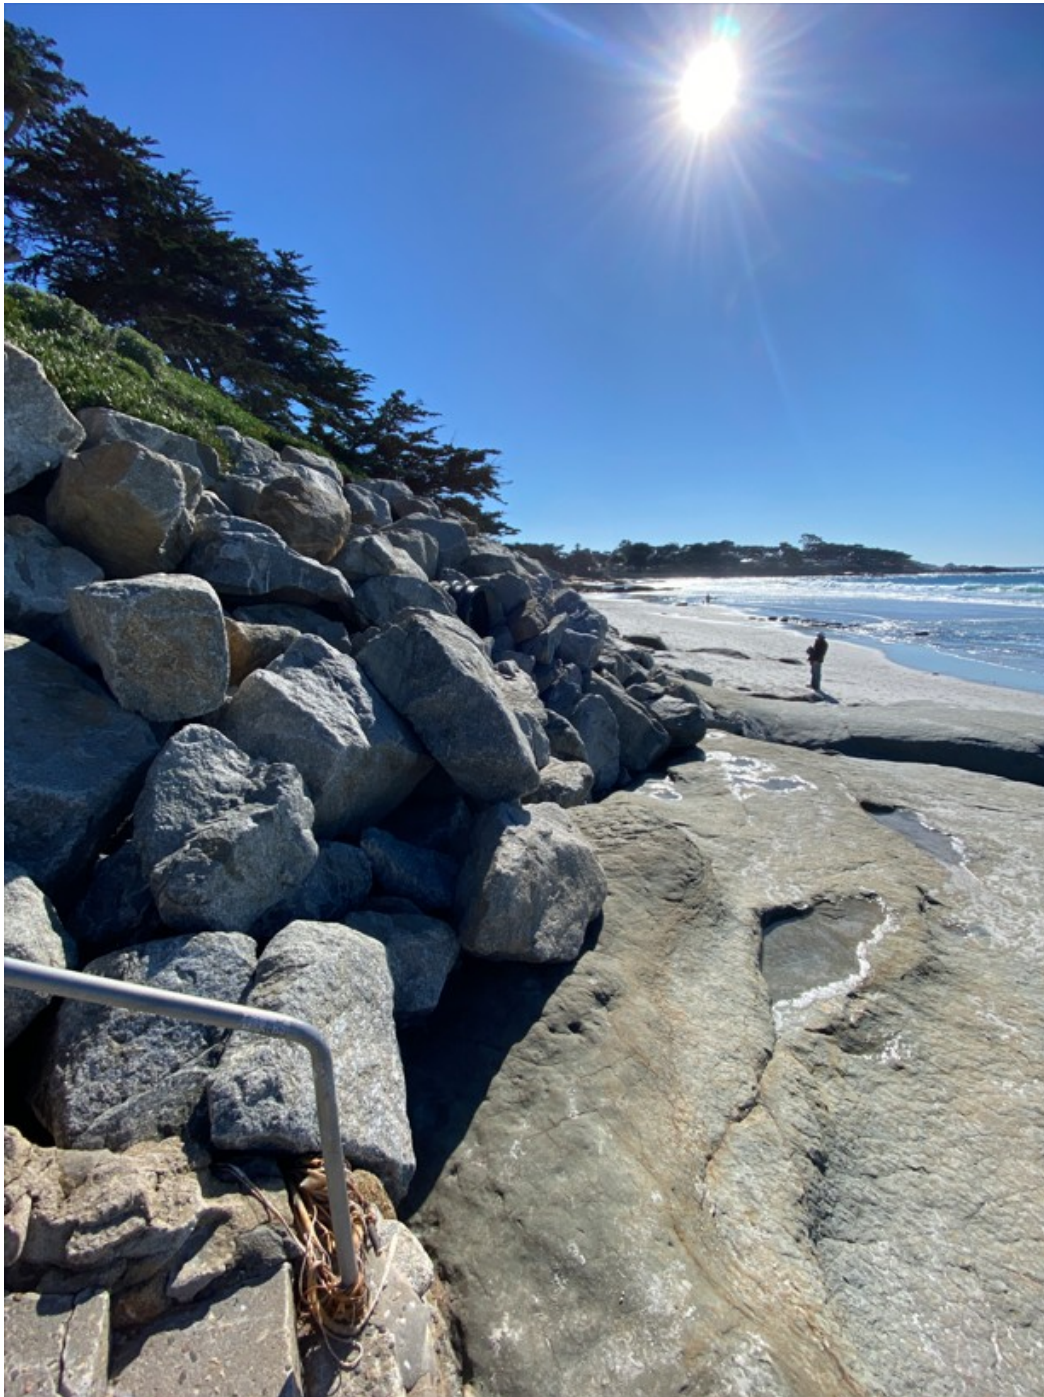
Photograph 55 shows that small portions near the north end of Revetment R3 are overly steep and could be re-stacked to be more stable and resistant to wave impact energy. During repair of the south 1/4 of R3, this area should be checked and the positions of a few boulders should be adjusted to improve boulder stability.

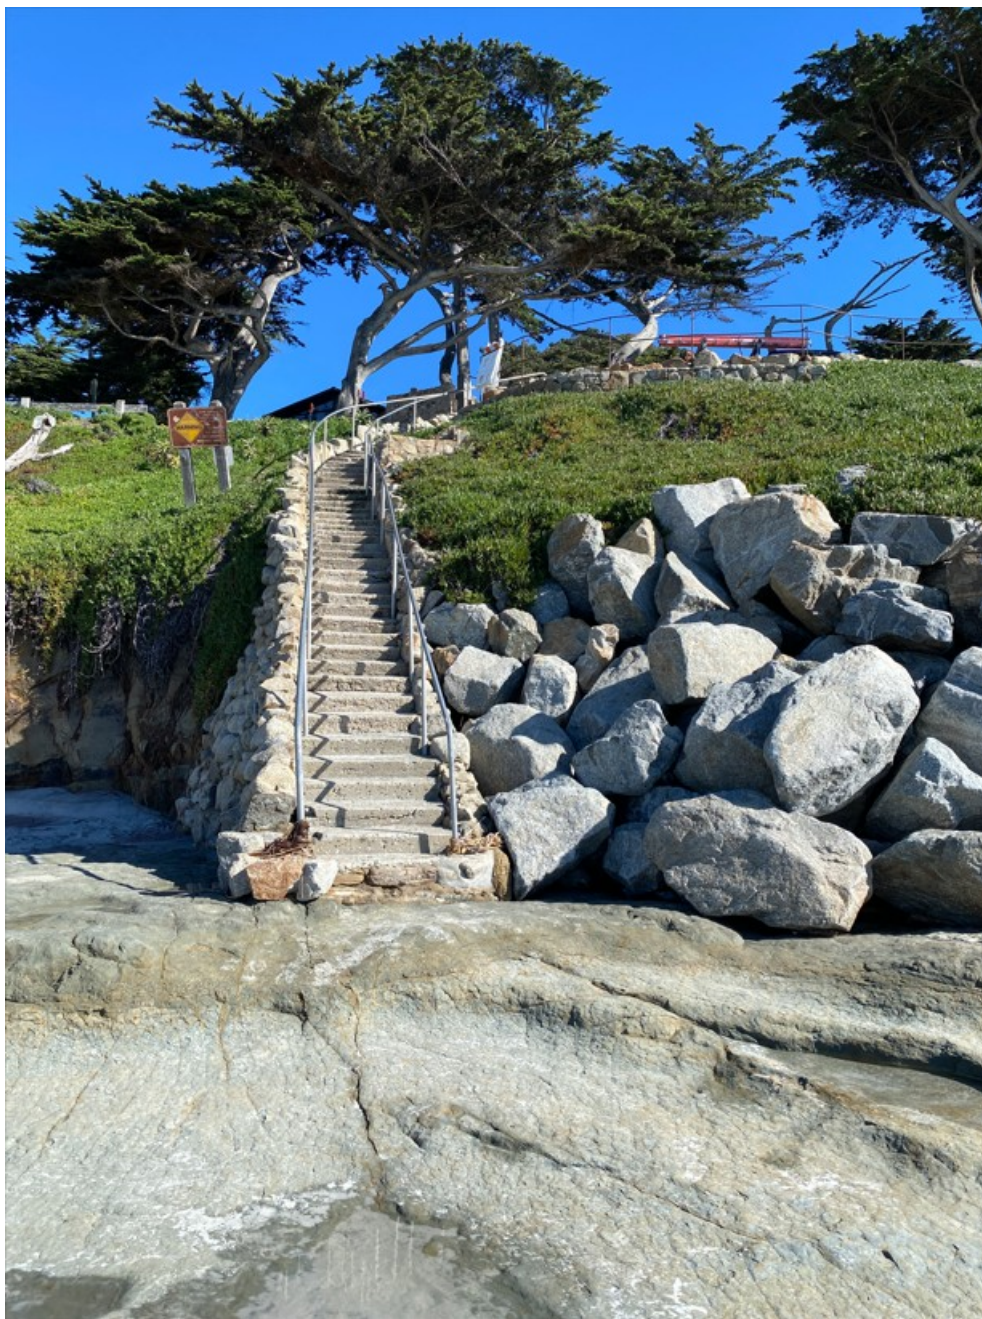
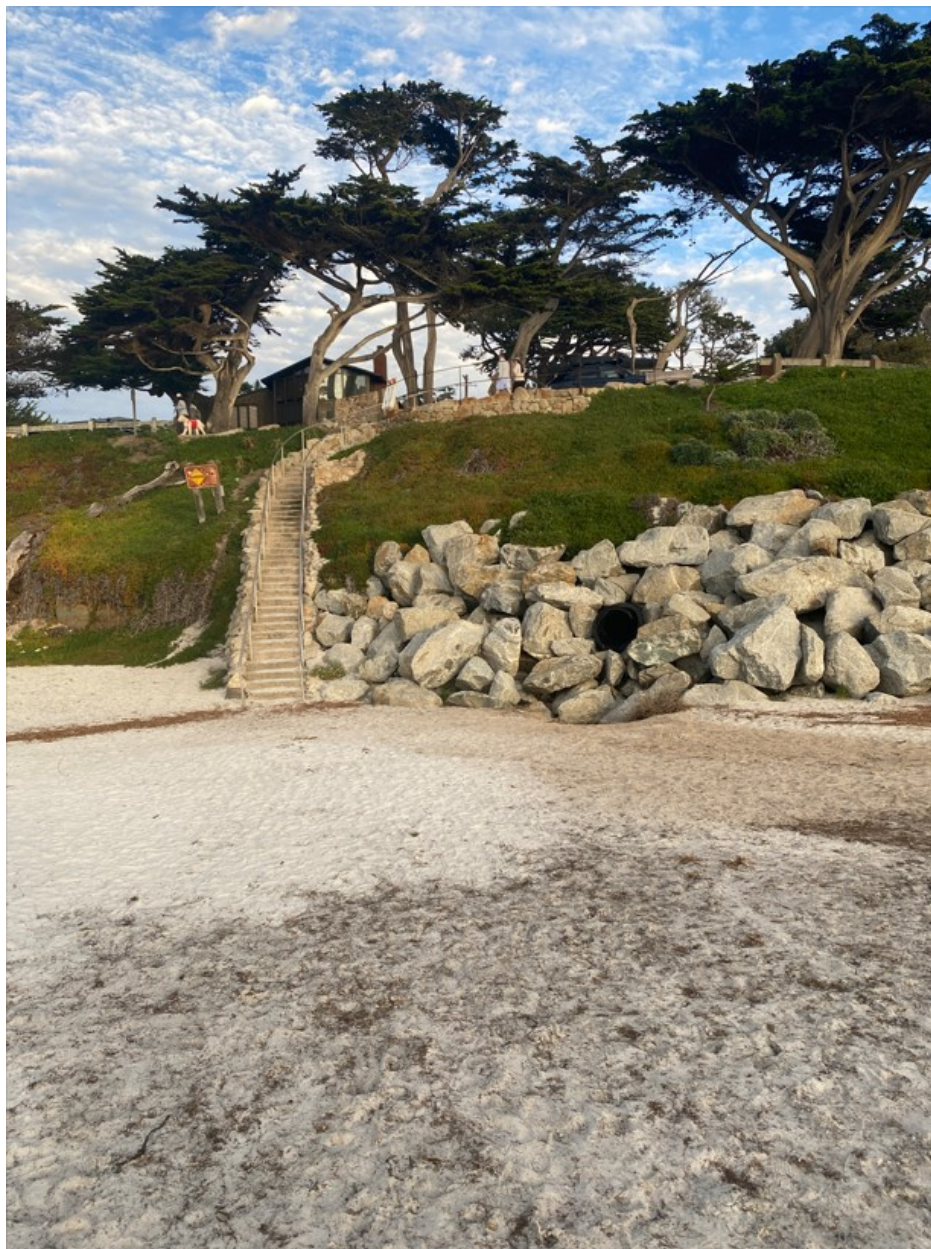
**Photograph 57: Showing Stairway ST5 on January 30, 2023**

Stairway ST5 repairs are needed due to corrosion of the concrete reinforcing, concrete spalling, and worn irregular concrete tread surfaces. We rank the concrete repair as a medium priority to abate slip and fall hazards. There is risk to users of the stairs because they do not extend to beach level during sand scour events. Extension of the stairs appears to be prudent. We rank extension of the stairs to beach level as a low priority if they are securely closed off at both the top and bottom during times when beach sand

**Photograph 58: Showing Stairway ST5 and North End of Revetment R6 on December 22, 2023**

Photographs 57 and 58 show Stairway ST5 before and after the severe January 2023 coastal storms and ocean wave events that resulted in beach scouring. Photograph 58 is a December 2022 photo of ST5 to show the influence of the scour event on beach conditions. This staircase is bearing upon sandstone bedrock platform and appears to be stable. The handrails are in decent shape. The ST5 stair treads are

worn and cracked and should be resurfaced.

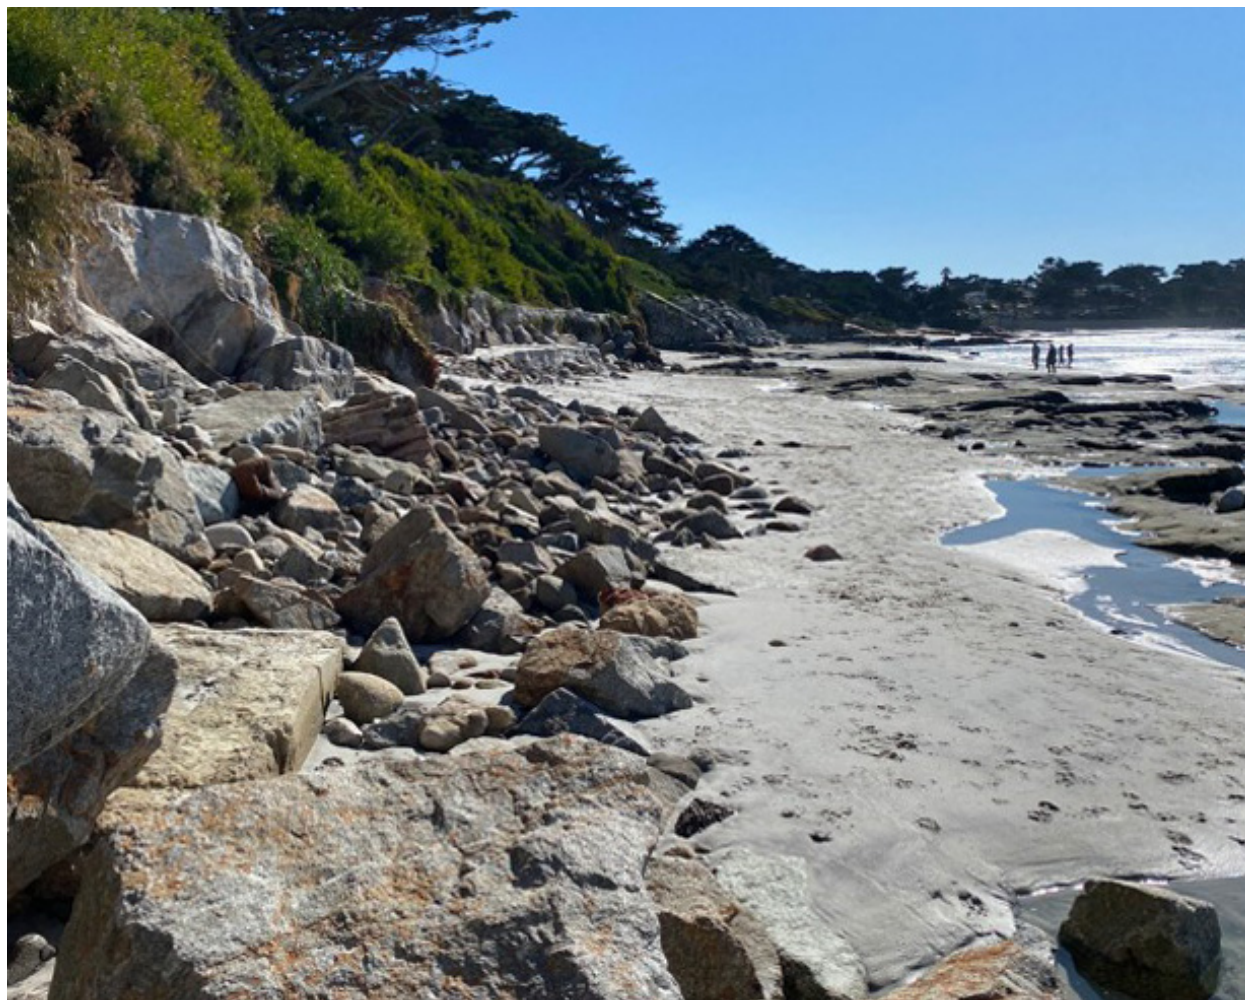
**Photograph 61: Northern 1/3 of Revetment R4 Showing Scattered Undersize Riprap Boulders  
on January 30, 2023**

Photograph 61 shows Revetment R4 in profile view showing over 50% of the visible structure is composed of very undersized scattered rock, that is subject to displacement and scattering onto the beach from wave action. The northern 1/3 of the Revetment R4 riprap is unstable, poses risks to beach users and we recommend it as a high priority for repair. Because this structure is composed of undersized, unstable rock, it increases the rate of bedrock erosion when the boulders are tumbled by wave action and abrade the bluff and bedrock platform. We recommend bringing in additional larger riprap quarrystone boulders to lower the revetment gradient. Alternately the revetment could be removed and replaced with a vertical seawall to match the appearance of the other nearby seawalls along Carmel Beach.

We recommend that Revetment R4, which is composed of very undersized scattered rock be completely reconstructed or replaced with a vertical concrete seawall faced with rock fascia.
