Date: 27 April 2023  
Client: City of Carmel  
Subject: Carmel Beach Coastal Protection Assessment  
Reference: Carmel Beach Adaptation Plan  
Project No.: 12176

## **CARMEL BEACH COASTAL PROTECTION ASSESSMENT REPORT**

Coastal Protection Evaluation 22 December 2022 thru 30 January 2023

Carmel Adaptation Plan - Carmel Beach All Areas

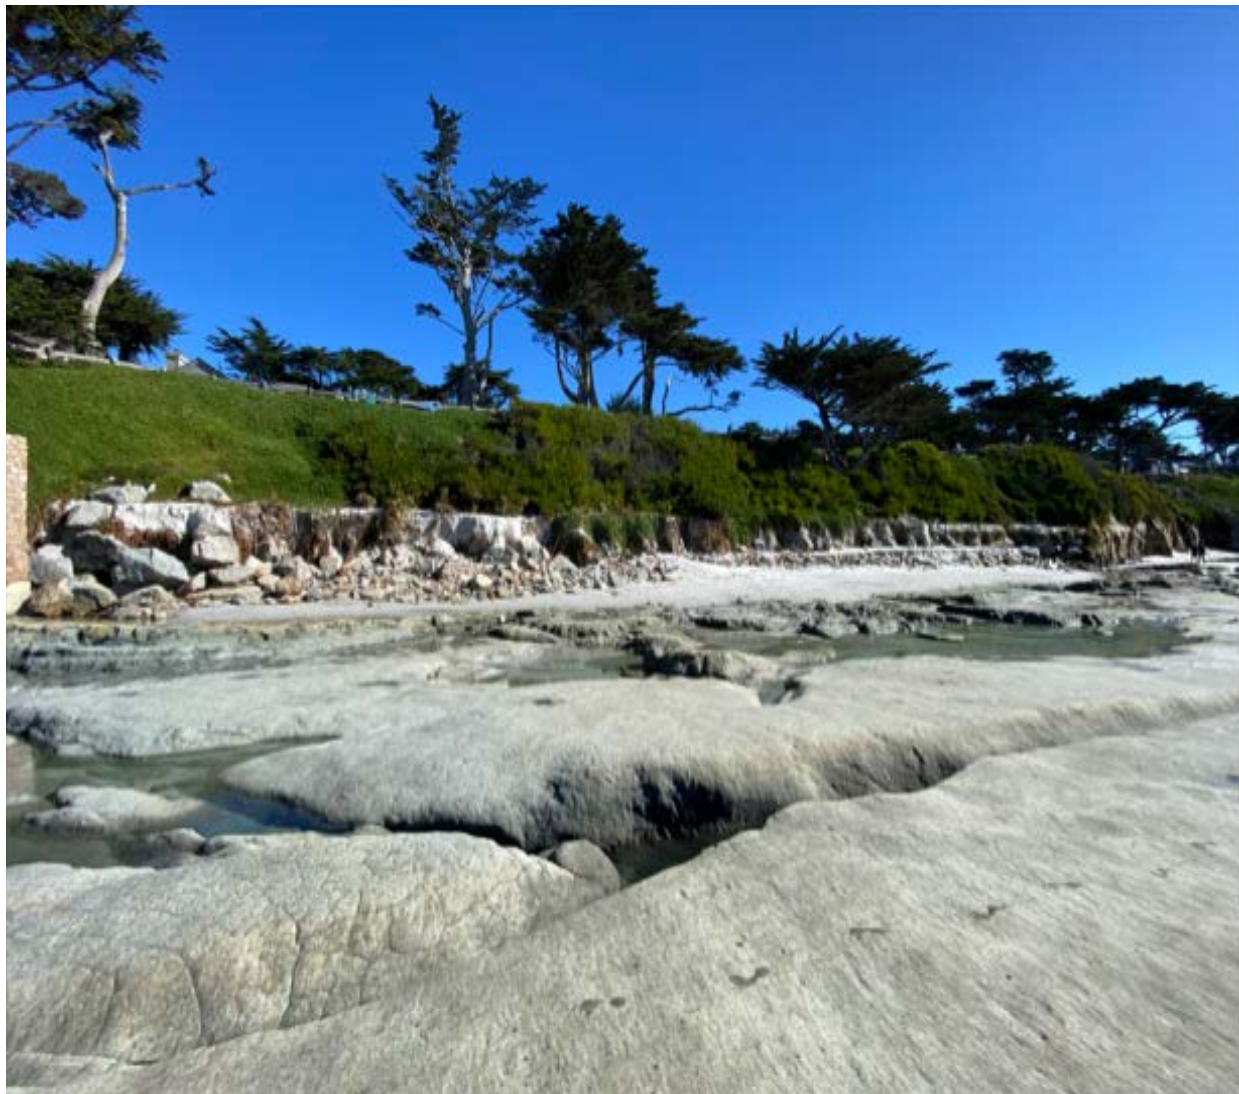
**Photograph 62: Northern 1/3 of Revetment R4 Showing Very Undersized Scattered Rock  
on January 30, 2023**

Photographs 61, 62 and 63 show Revetment R4, which is comprised of mostly undersized rock and broken concrete debris. The exposed portion of R4 where we observed substantially undersized scattered rock is approximately 225 feet in length and 8 to 10 feet tall. This structure has been undermined and has collapsed. Undersized riprap has been tumbling around in the wave action and is abrading the bedrock platform seaward of the riprap revetment structure toe. Future wave action could cause the steep slope below the path to slump, undermining the large cypress trees and public pathway along Scenic Road. A vertical concrete seawall at the toe of the bluff would be a preferred alternative here, as opposed to the riprap revetment structure, which requires more maintenance, and takes up a larger footprint.

We recommend that Revetment R4, which is composed of very undersized scattered rock be completely reconstructed or replaced with a vertical concrete seawall faced with rock fascia.

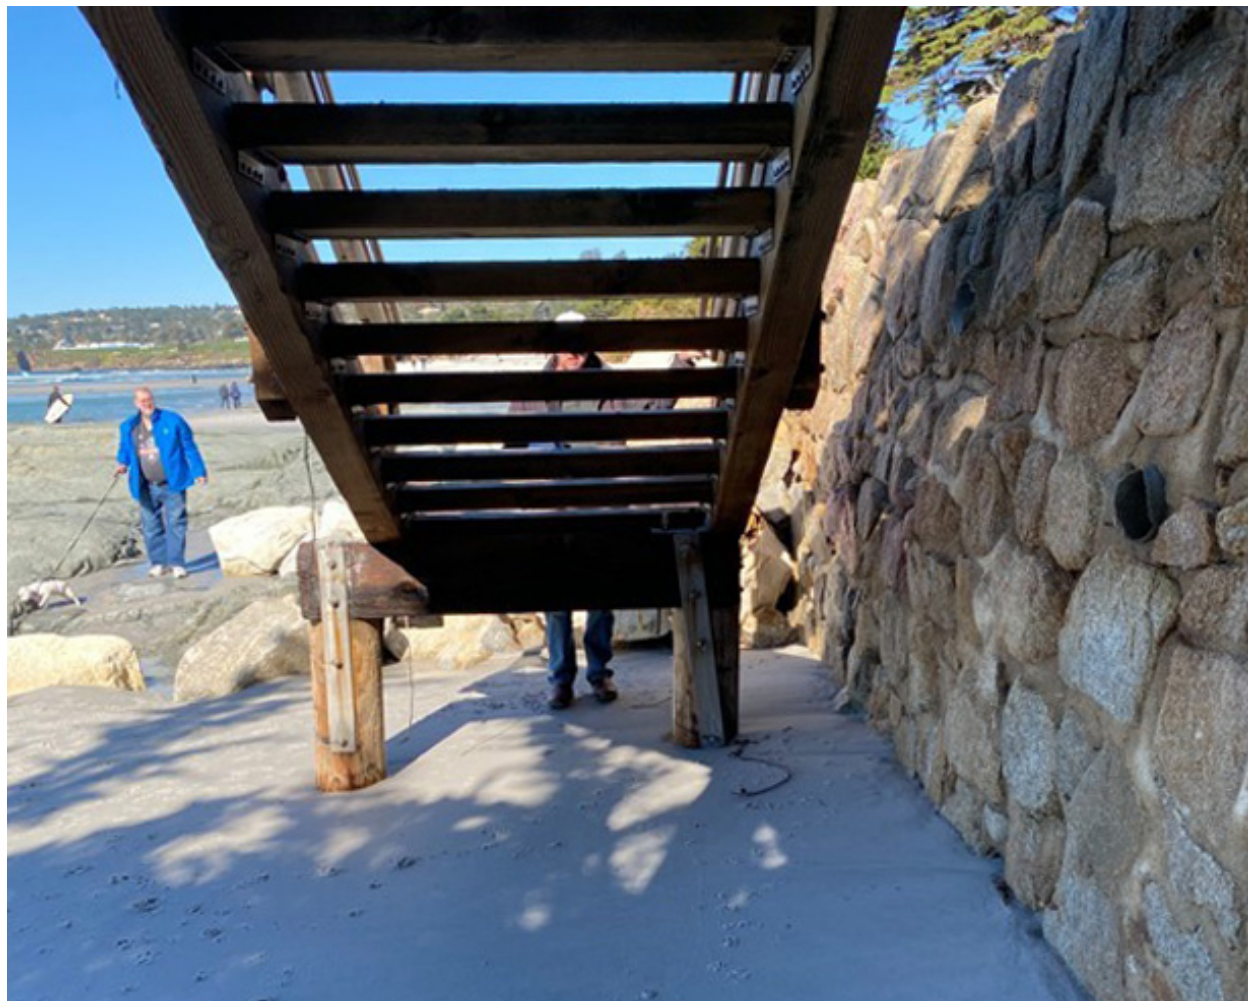
**Photograph 74: Stairway ST7 on January 30, 2023 Showing Undermining**

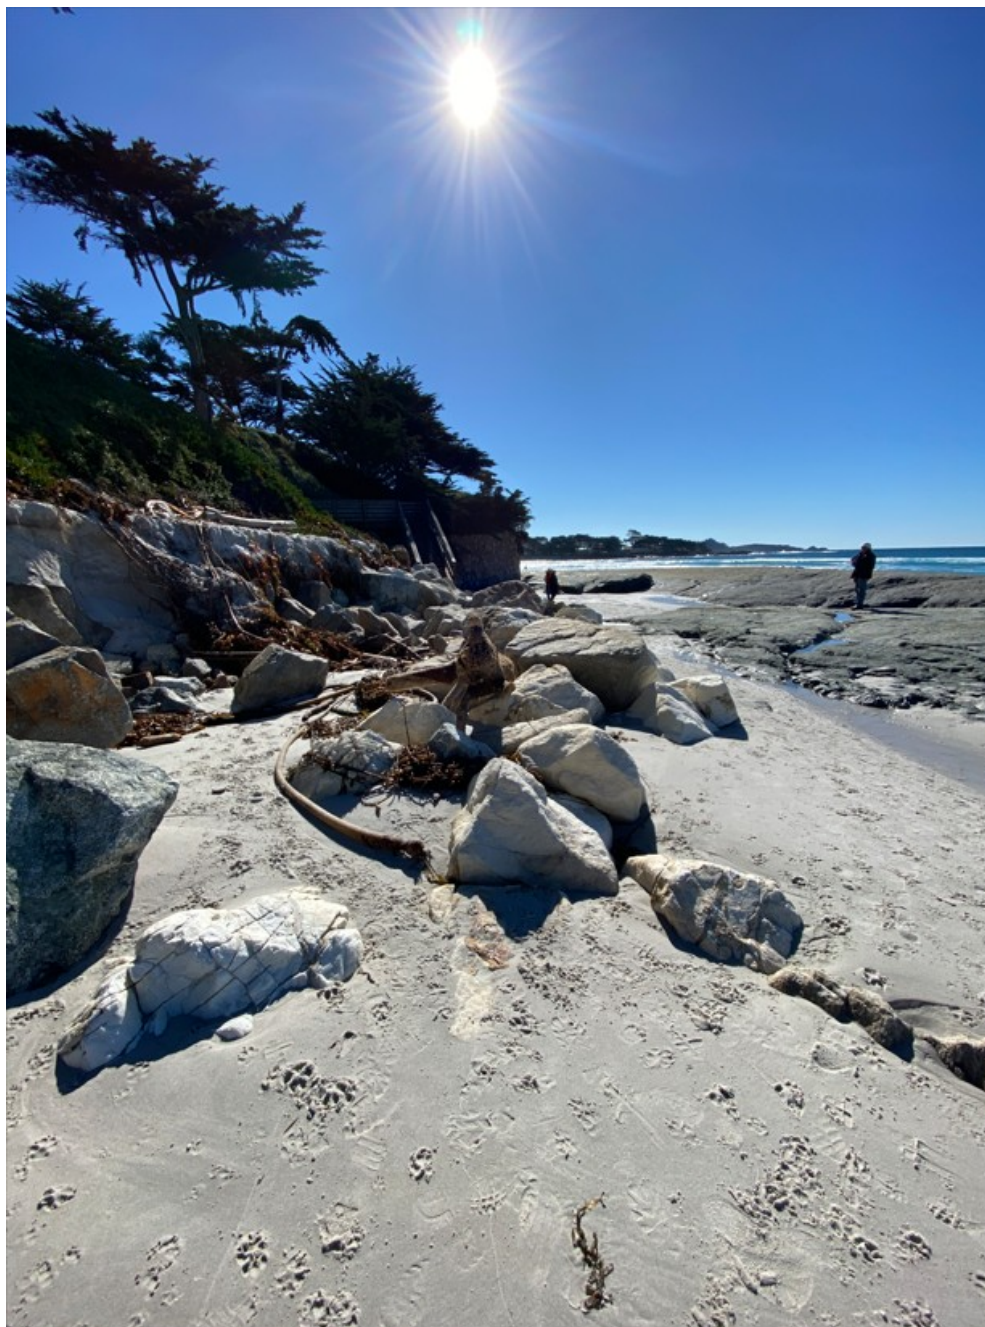
**Photograph 76: Showing Collapsed Southern End of Revetment R5 on January 30, 2023**

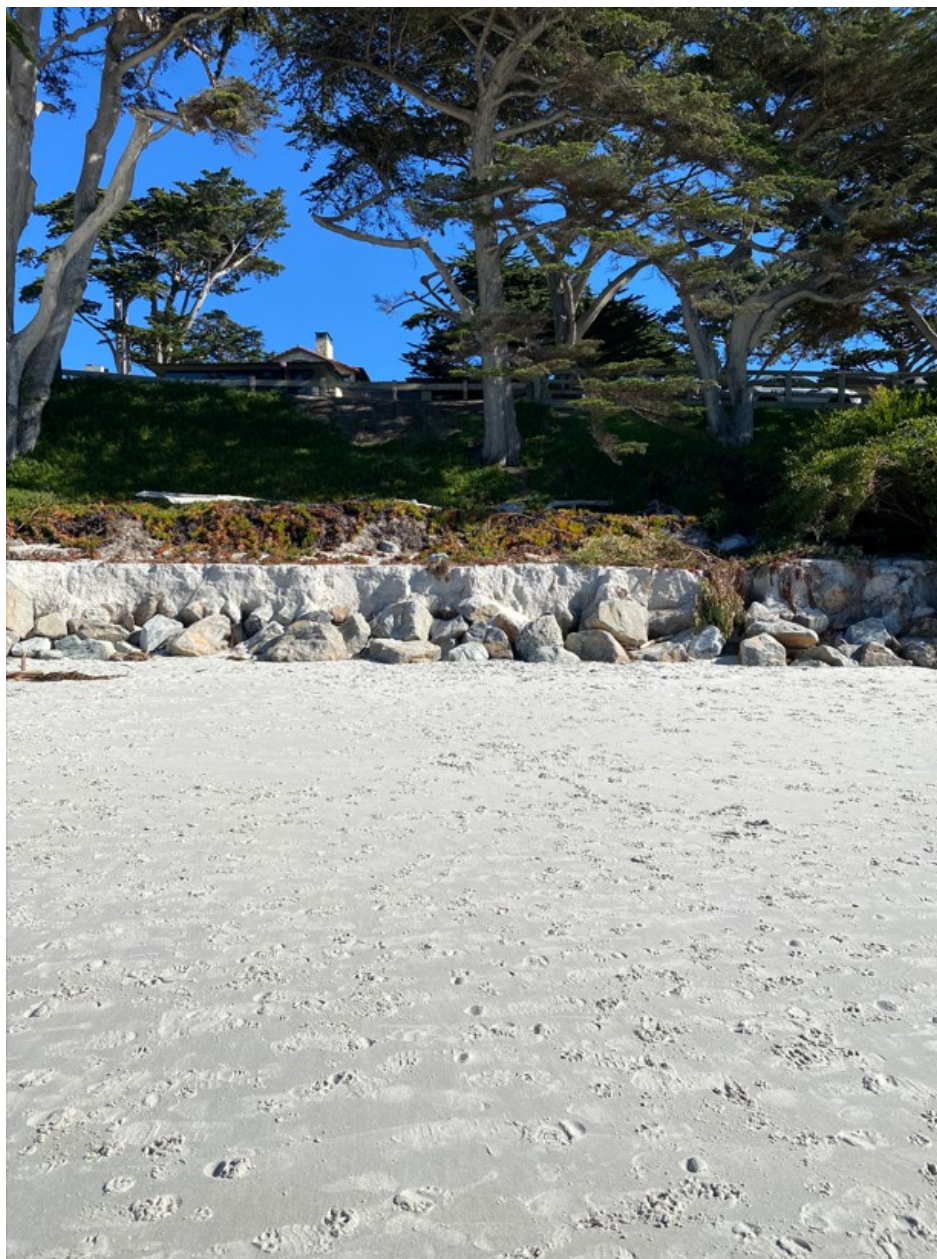
**Photograph 77: Southern Portion of Revetment R5 on January 30, 2023 Showing Steep Slope**

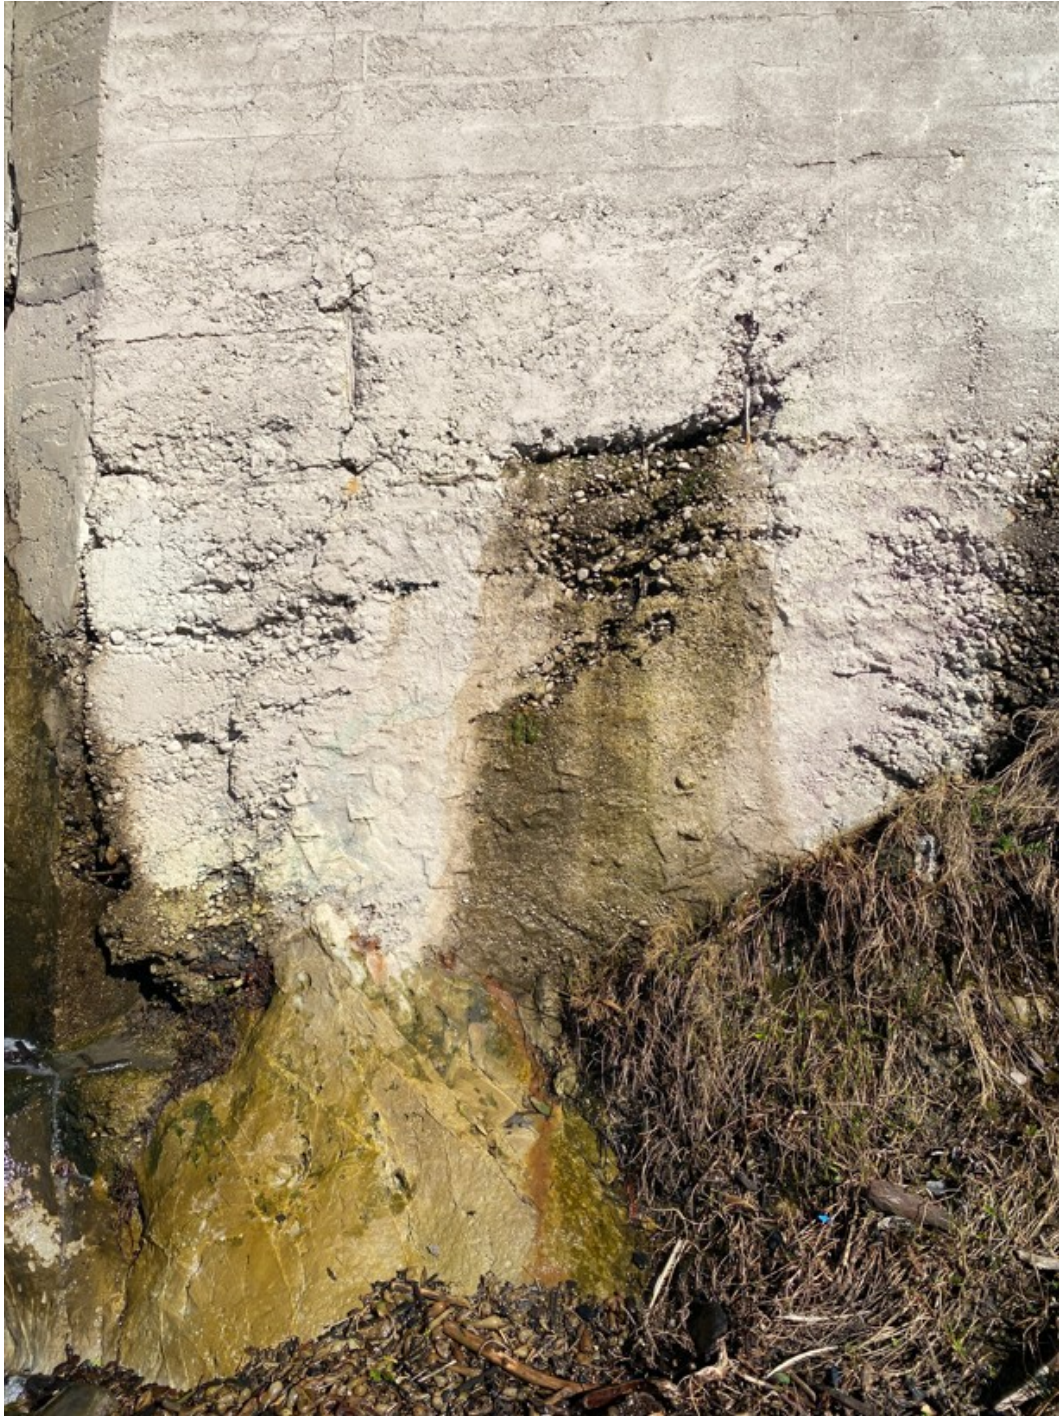
**Photograph 93: Central Part of Foundation of Seawall S10 on January 30, 2023**

Photograph 93 is a photograph that shows concrete spalling, exposing steel reinforcement.
