MEMORANDUM

Subject: Carmel Climate Change Vulnerability Assessment, Shoreline and Beach Erosion Exposure Modeling and Coastal Hazard and Sea Level Rise Vulnerability

Project No.: C3016

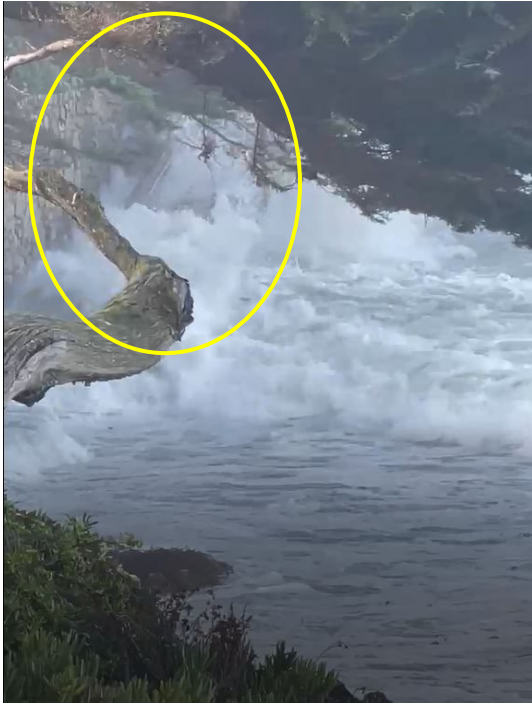
Figure 2. Martin Way Stairs (highlighted in yellow) during the El Niño winter of 2023–24.
Source: City of Carmel, January 2024

Waves that reach the seawalls will reflect off the seawalls and travel seaward. At the seawall, the water particles under the reflected wave will move quickly, mobilize sand, and cause scour at the toe of the structure. The amount of scour is proportional to the height of the wave; the higher the wave, the greater the scour. In Figure 2, waves are crashing into the seawall near Martin Way.

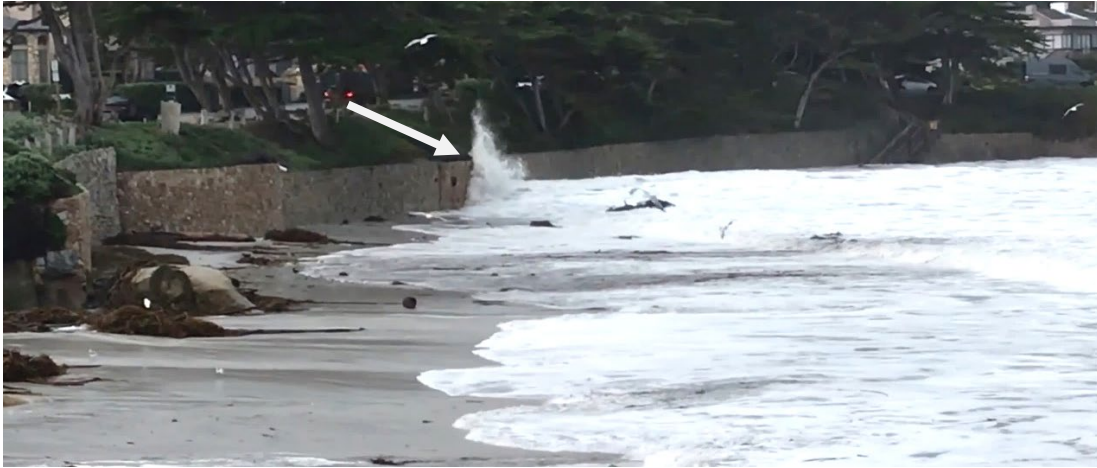
Figure 3. Wave overtopping on a Carmel seawall (see arrow). Note the directional wave and splash along the wall. Source: City of Carmel January 5, 2023

When wave run-up reaches coastal armoring structures, especially vertical seawalls, it can elevate water levels and create wave splash over the seawalls (Figure 3). This wave splash water, especially when driven by onshore winds, can saturate the bluff terraces behind the wall, contributing to bluff failure and erosion behind the seawalls. As sea levels rise, wave run up elevations reach a point where the water that is overtopping is not just a vertical splash but rather a wave (or “green water”), that has horizontal momentum and can further accelerate the erosion of the bluff above the coastal armoring structures.

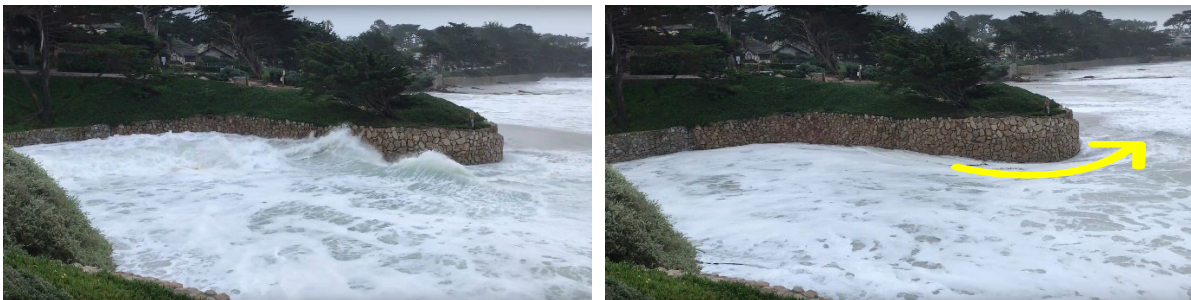
Figure 4. Rip currents moving away from the shore in the cove at 13th Avenue. Left, the cove fills with water from broken waves. Right, an alongshore current develops, channeling water out of the cove and along the seawall to the south. Source: City of Carmel, January 2023

The study by Rogers E. Johnson and Associates (Johnson 1983) detailed a swift inshore current that moves horizontally along the beach, typically heading southward where elevations are lower. Inshore and backshore currents have been observed in recent events, illustrated in Figure 4. In the initial panel, waves collide with the seawall, reflecting away from it. The water, attempting to escape, is directed around the seawall. These currents with high particle velocities can more effectively mobilize sand away from the beach.

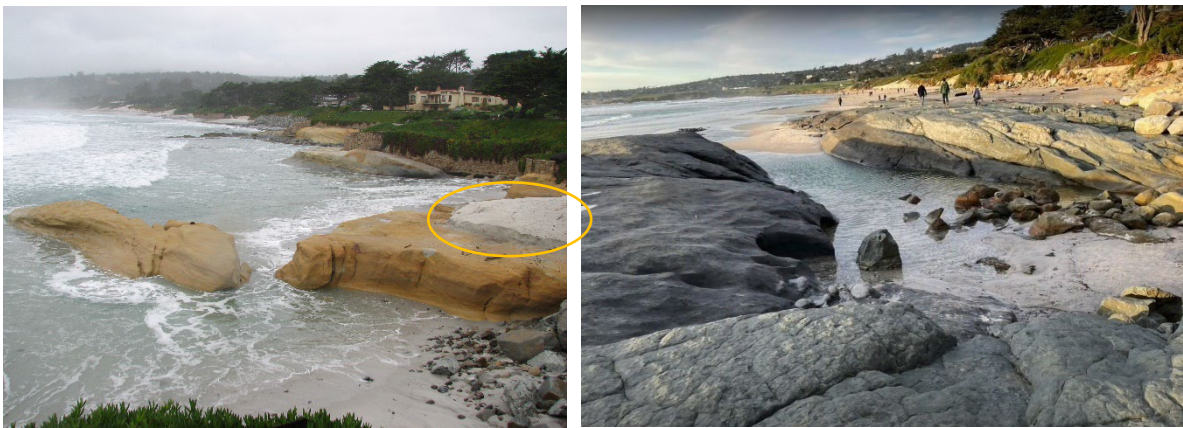
Figure 5. Left: Sandstone outcrop between Santa Lucia Ave and 13th Avenue, winter of 2010. Note the perched beach sand atop the sandstone outcrop to the right (orange circle), an indication of the previous summer’s sand levels. Right: A scoured beach in January 2023 near 10th Avenue reveals a channel between sandstone bedrock with a gap oriented at an angle to the backshore. Source: City of Carmel.

Outcrops and variability of the backshore will affect how currents develop and where wave focusing occurs. A unique contributing factor for Carmel is the orientation of exposed outcrops of sandstone in the beach area (Figure 5). These outcrops are usually buried by beach sand and are only exposed following significant winter scouring events. The Johnson (1983) study notes that deep channels exist between these outcrops that lie perpendicular to the bluffs. These formations may act to direct and focus water flow toward specific locations on the backshore, producing more severe erosion (Figure 6).

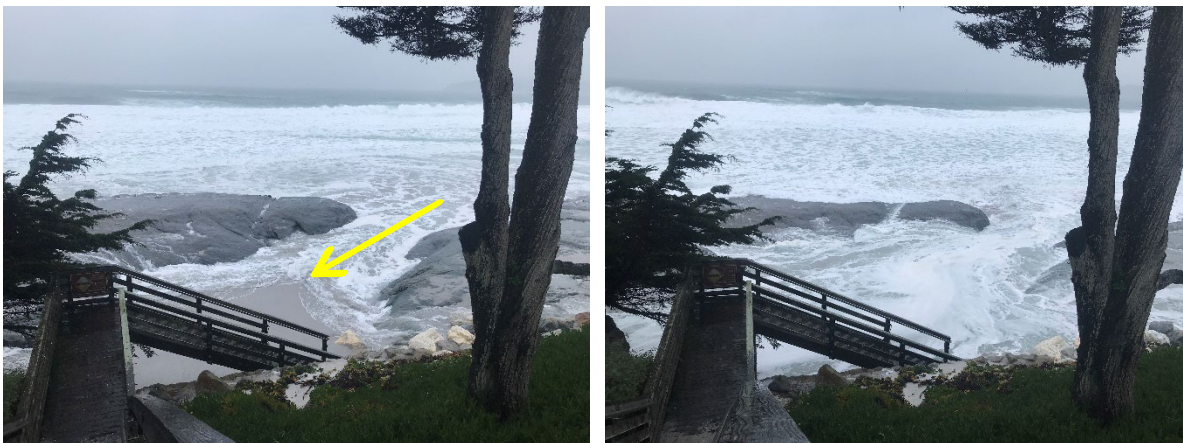
Figure 6. Focusing of water flow between the gap in the sandstone formation. This leads to a piling up of water in the gap and subsequently higher erosion. Location: Stairs at northern end of 10th Avenue. Source: City of Carmel, January 2023

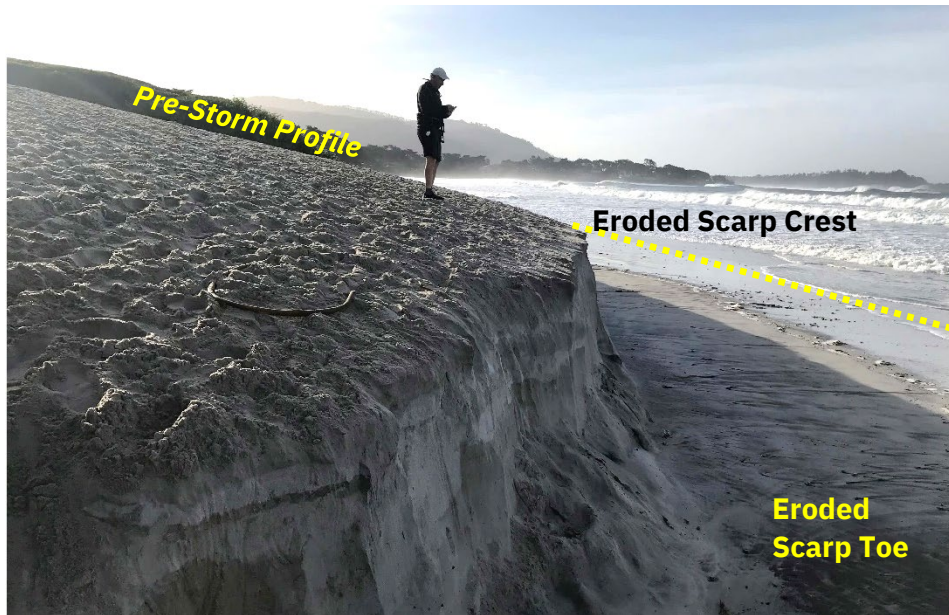
Figure 8. Dune scarp at Del Mar Sand Ramp. The yellow hatched line represents the previous summer’s beach profile. Dune scarping can have a significant impact on beach access. Source: City of Carmel, January 2023

Following significant erosion, the recovery of Carmel’s dunes occurs gradually, facilitated by smaller waves and wind bringing sand back over an extended period. However, because of the longer recovery time of dune systems, they are especially susceptible to increased storm frequencies and sea level rise. Elevated water levels with sea level rise will allow wave erosion processes to act farther up on the beach profile causing an evolution of the dune profile farther inland.

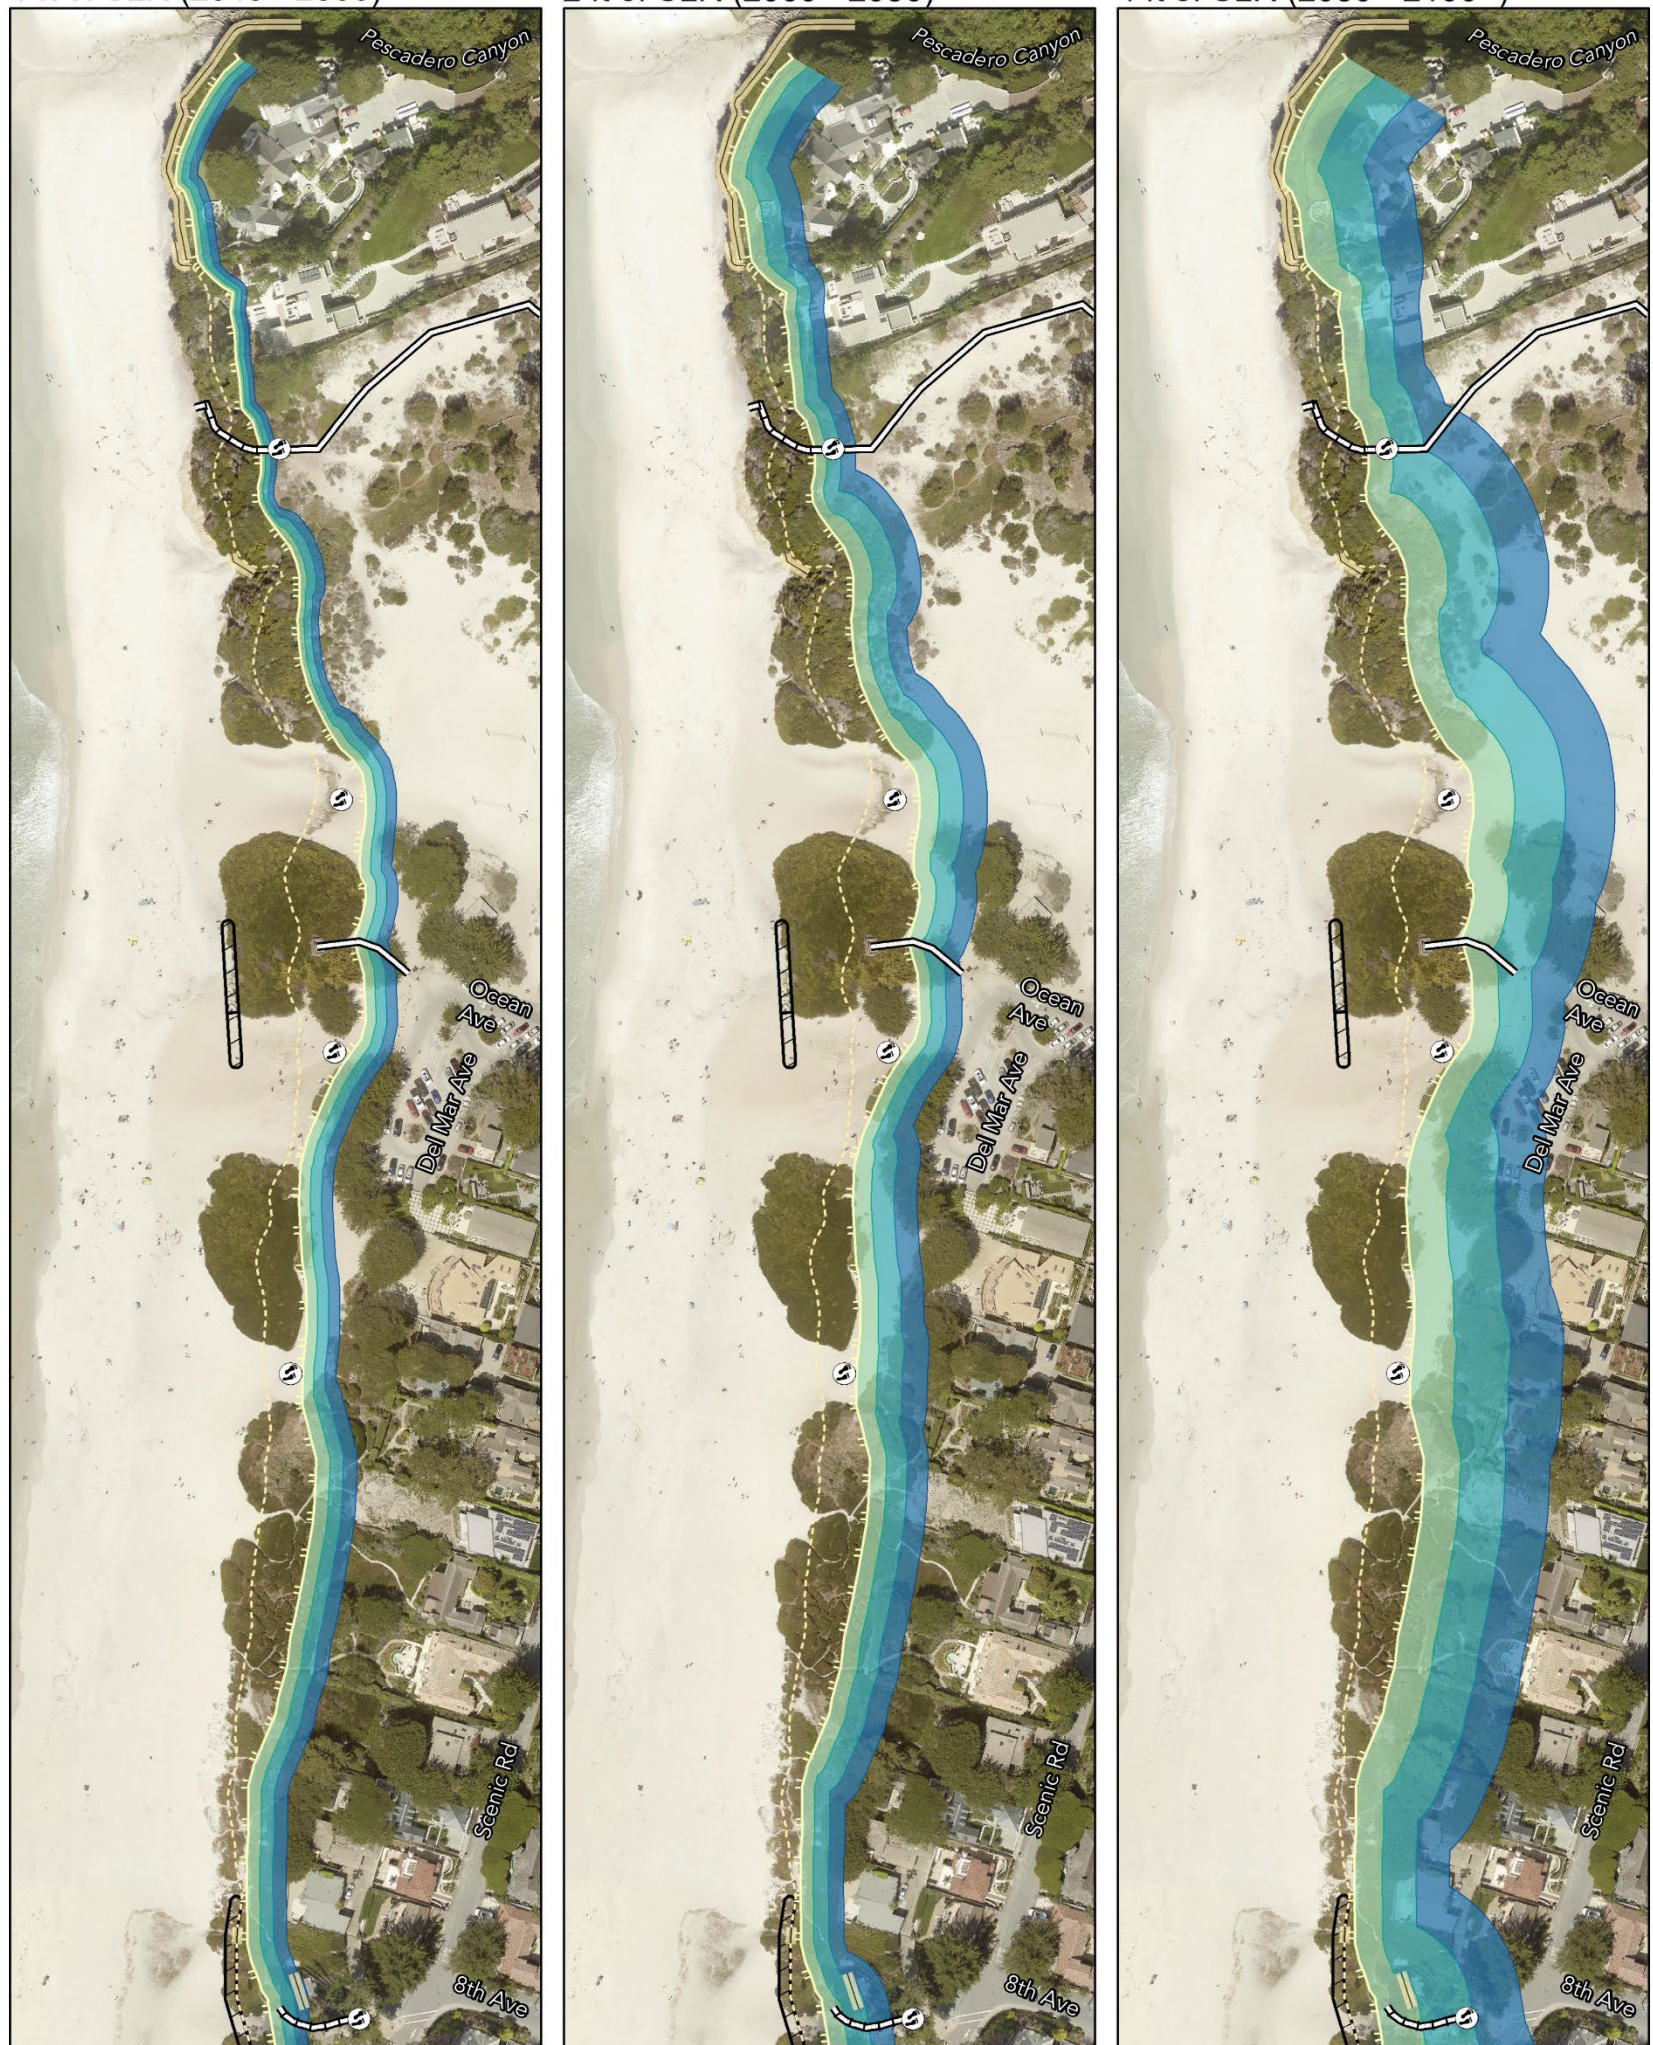
Projected Bluff Crest Position Across Sea Level Rise Elevations

Figure 10. Map of dune and cliff erosion for the northern beach. Displays erosion hazards without armoring. Hazard zones represent three bands of certainty, most likely, based on the assumption of a low average erosion rate (0.2 ft/yr), best, based on the assumption of an average erosion rate (0.4 ft/yr), and worst case, based on the assumption of a high average erosion rate (0.7 ft/yr).

This section provides maps of the erosion hazard zones (Figures 12 through 16). The maps are organized by the with and without armoring scenarios and split into the north (including the North Dunes, North Beach, and Central Beach), central (including the Central Beach and South Beach), and south (including South Beach) areas. For the with armoring scenario, a range of future erosion probabilities are presented. For the armored erosion projection, only a best estimate scenario relying on a range of erosion baselines and future conditions is presented. For the armored scenario, erosion rates are dampened significantly in the near term due to limited wave splash above the crest of the armoring structures; however, with increasing sea level rise, the effectiveness of the armoring is reduced, leading to more green water horizontal wave run up velocities and an acceleration in bluff-top erosion above the coastal armoring in future.

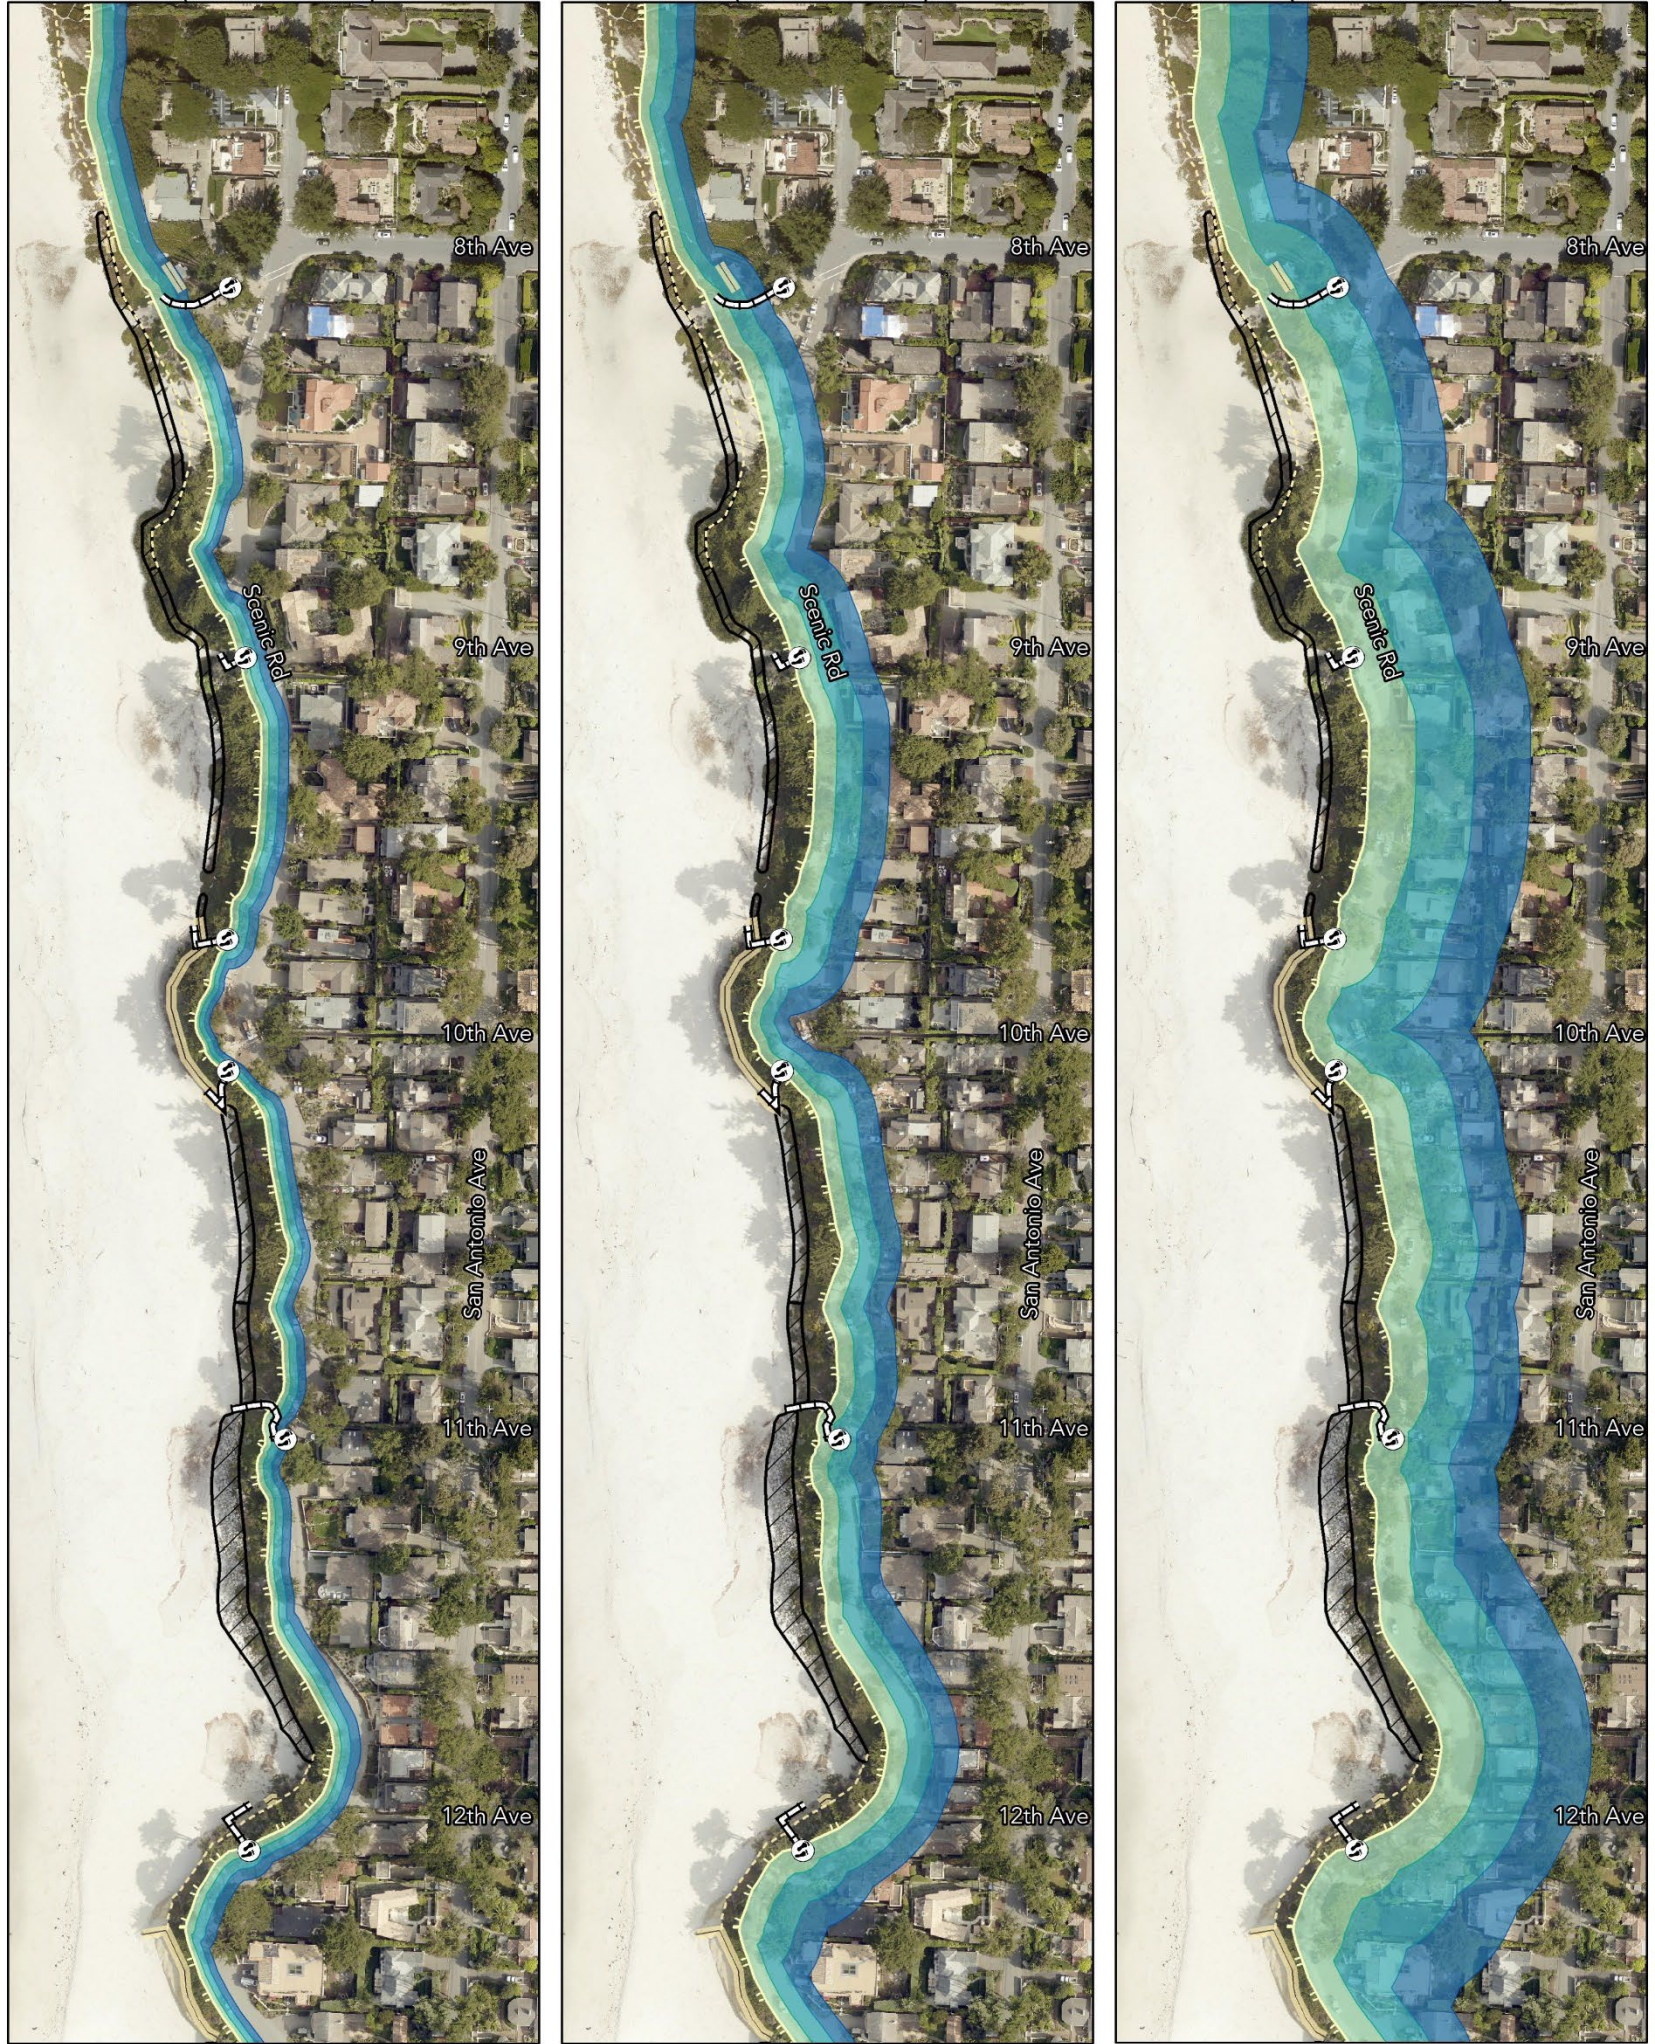
Figure 11. Map of dune and cliff erosion for the central beach. Displays erosion hazards without armoring. Hazard zones represent three bands of certainty, most likely, based on the assumption of a low average erosion rate (0.2 ft/yr), best, based on the assumption of an average erosion rate (0.4 ft/yr), and worst case, based on the assumption of a high average erosion rate (0.7 ft/yr).

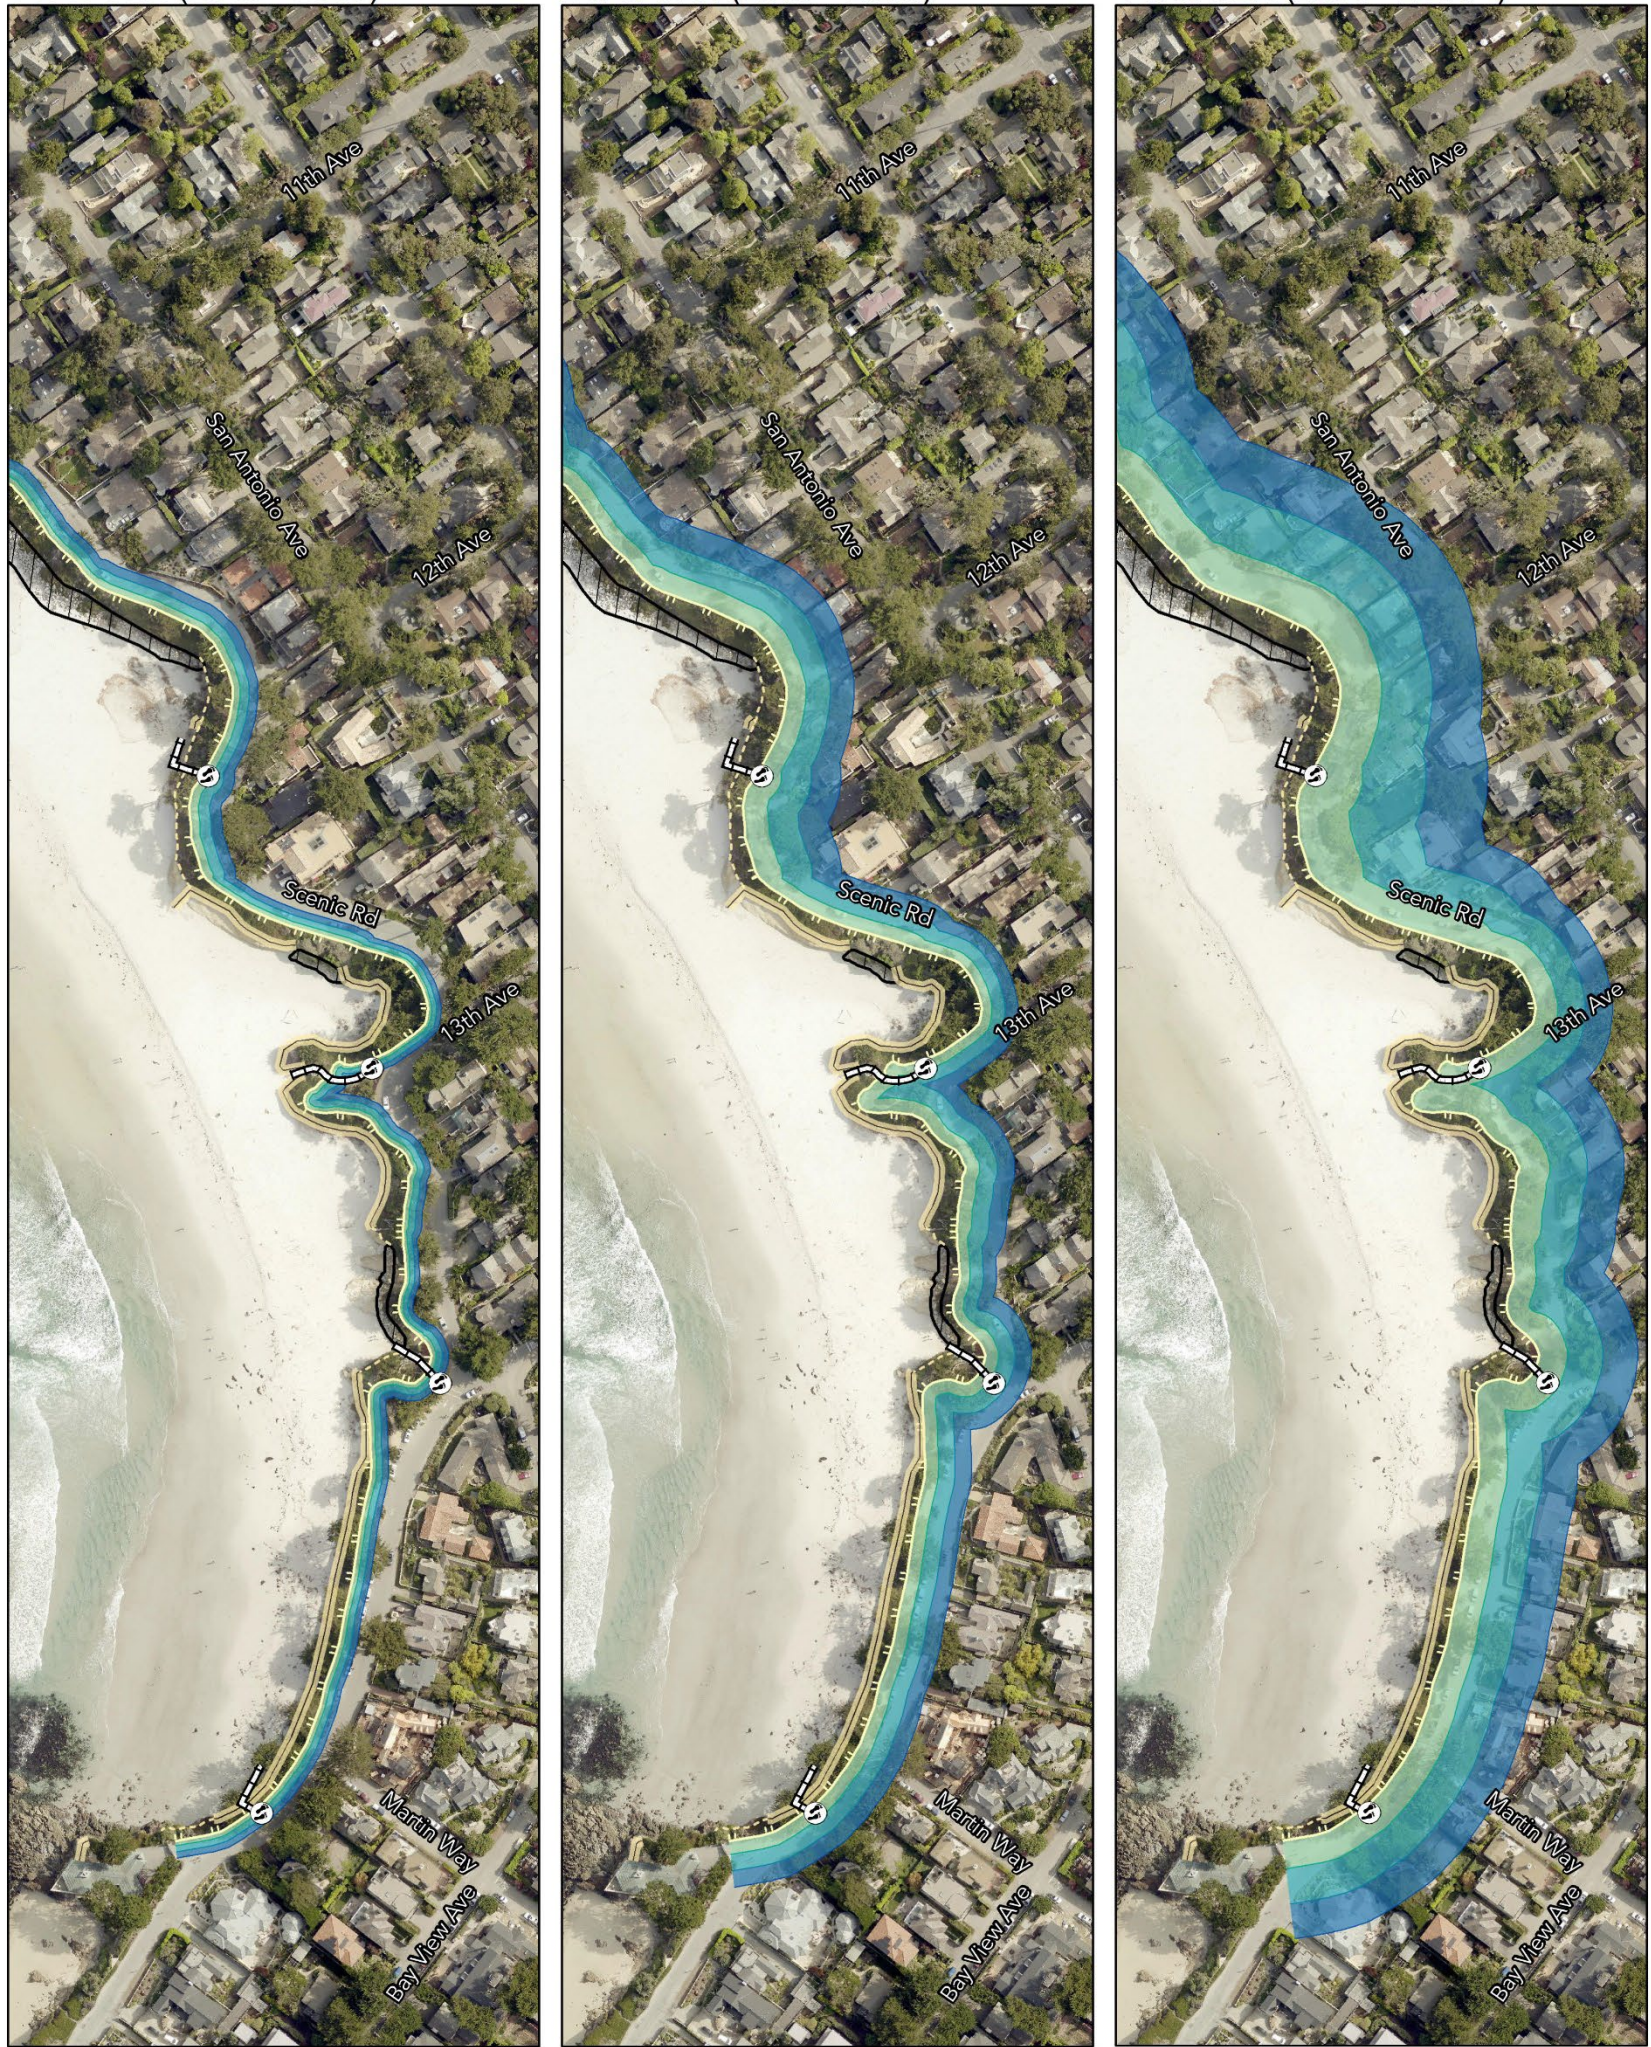
Figure 12. Map of dune and cliff erosion for the southern beach. Displays erosion hazards without armoring. Hazard zones represent three bands of certainty, most likely, based on the assumption of a low average erosion rate (0.2 ft/yr), best, based on the assumption of an average erosion rate (0.4 ft/yr), and worst case, based on the assumption of a high average erosion rate (0.7 ft/yr).

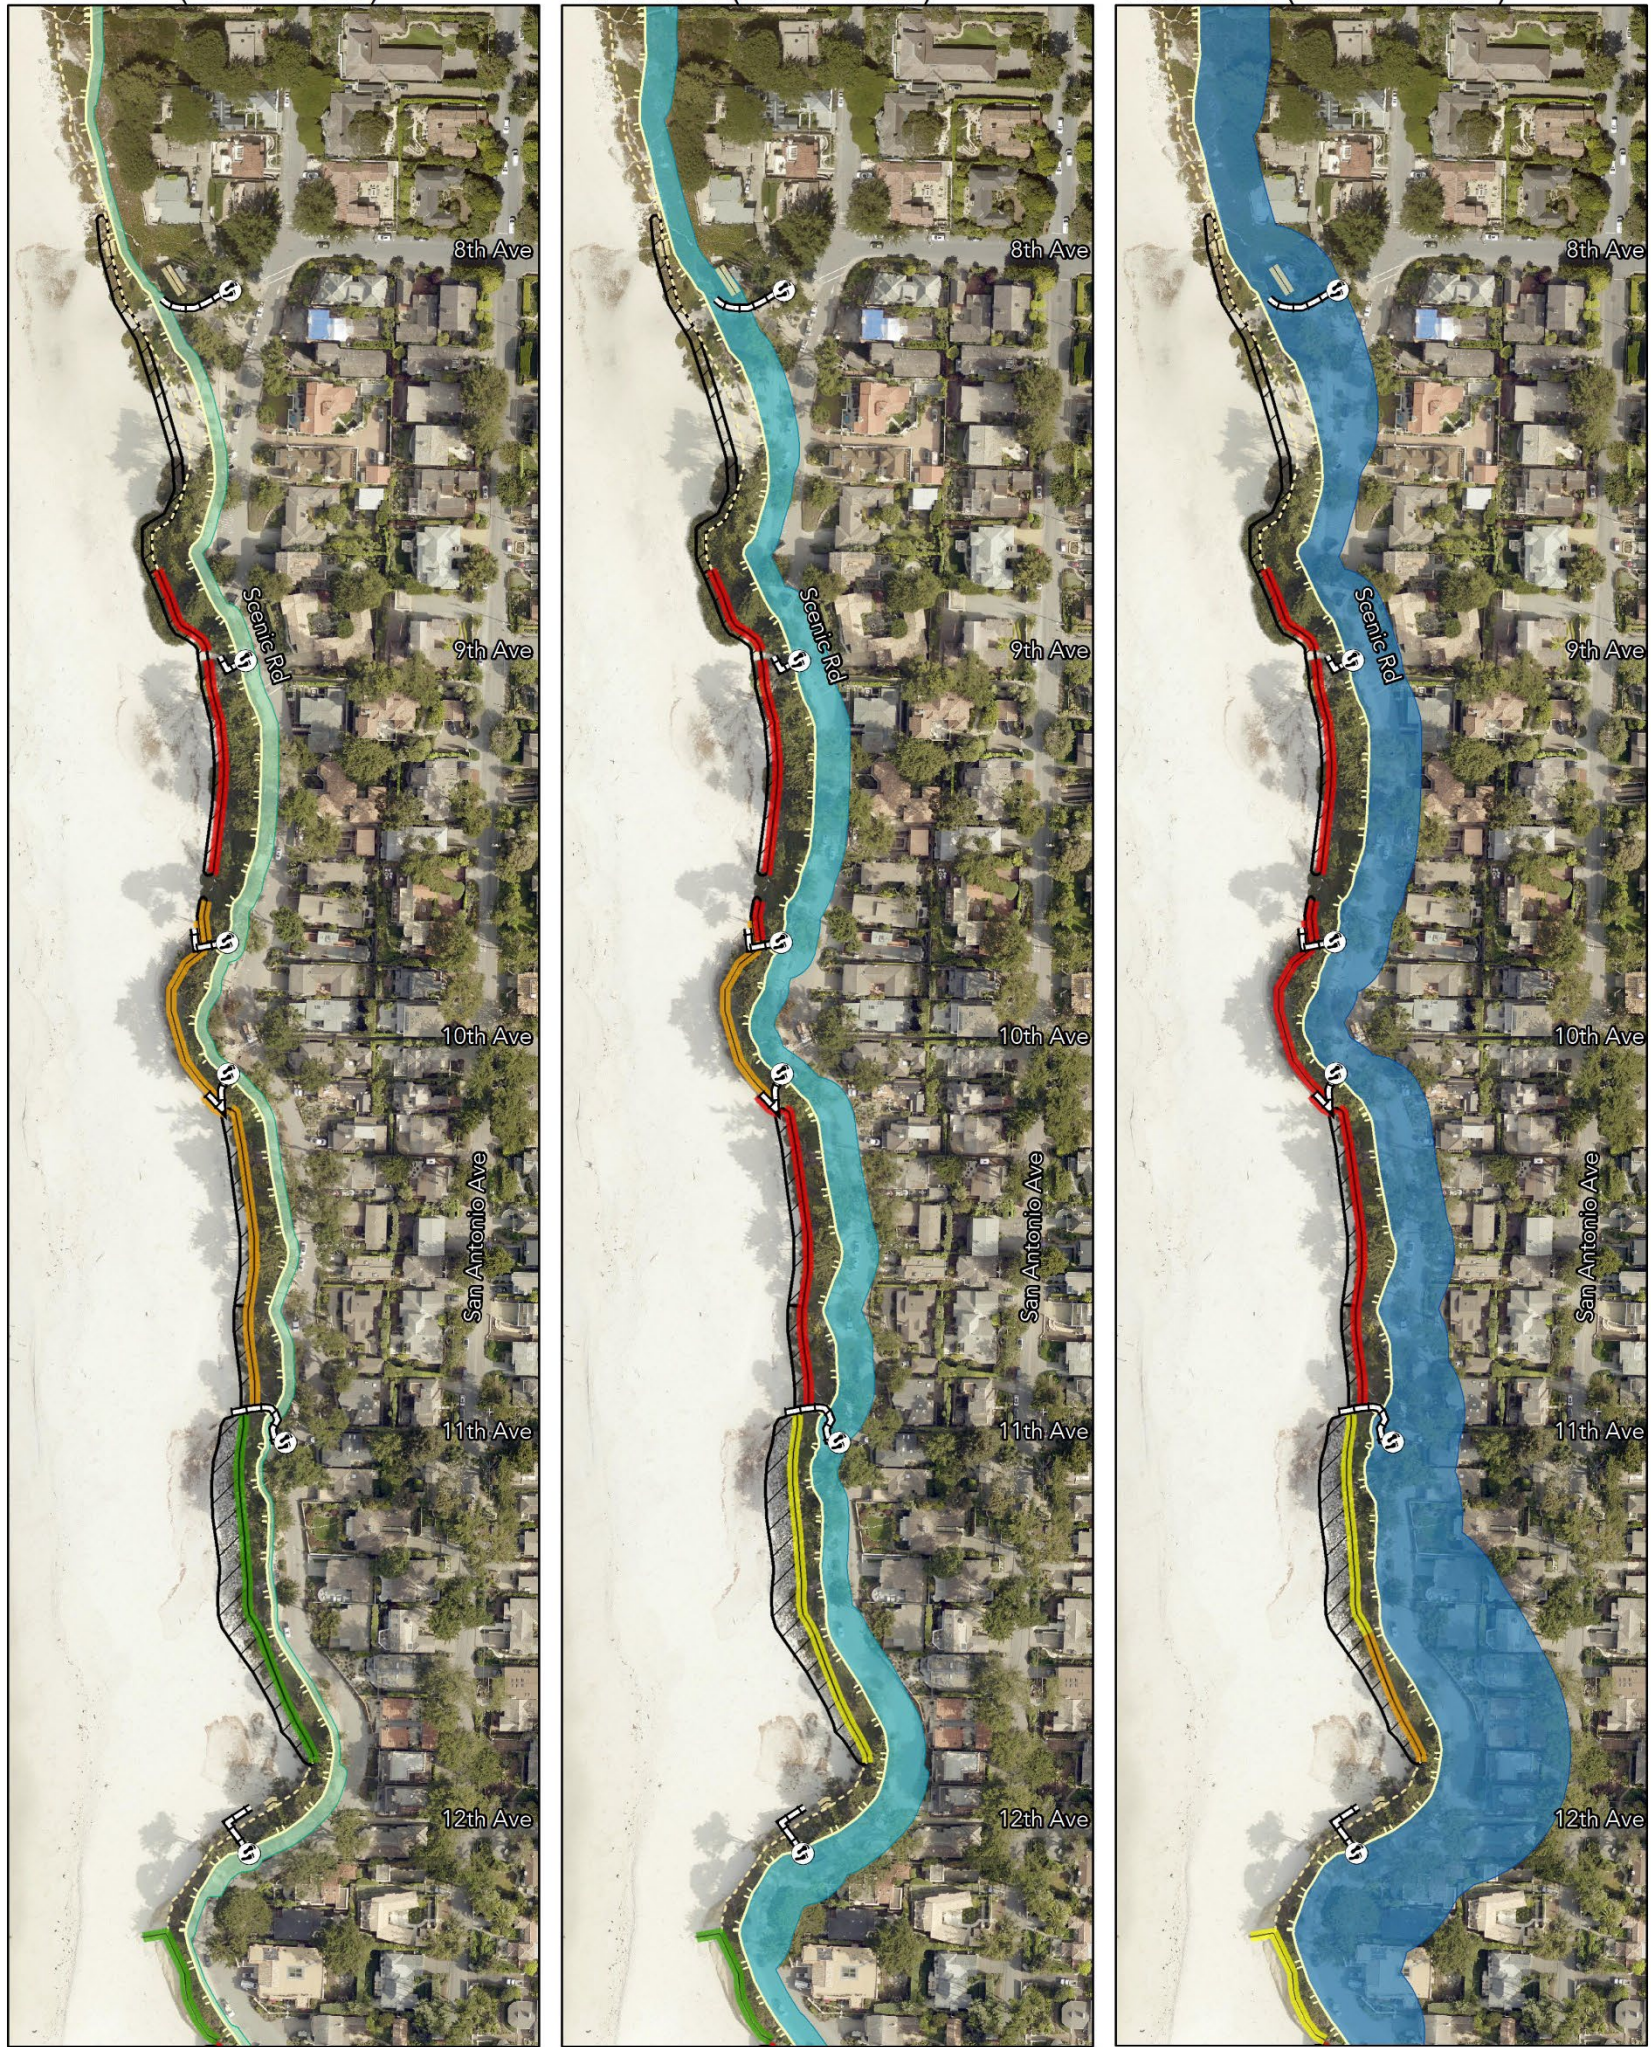
Figure 14. Map of dune and cliff erosion for the central beach. Displays erosion hazards with armoring. Hazard zones in areas where armoring is not present rely on the 'without armoring' scenario using the assumption of an average erosion rate (0.4 ft/yr).

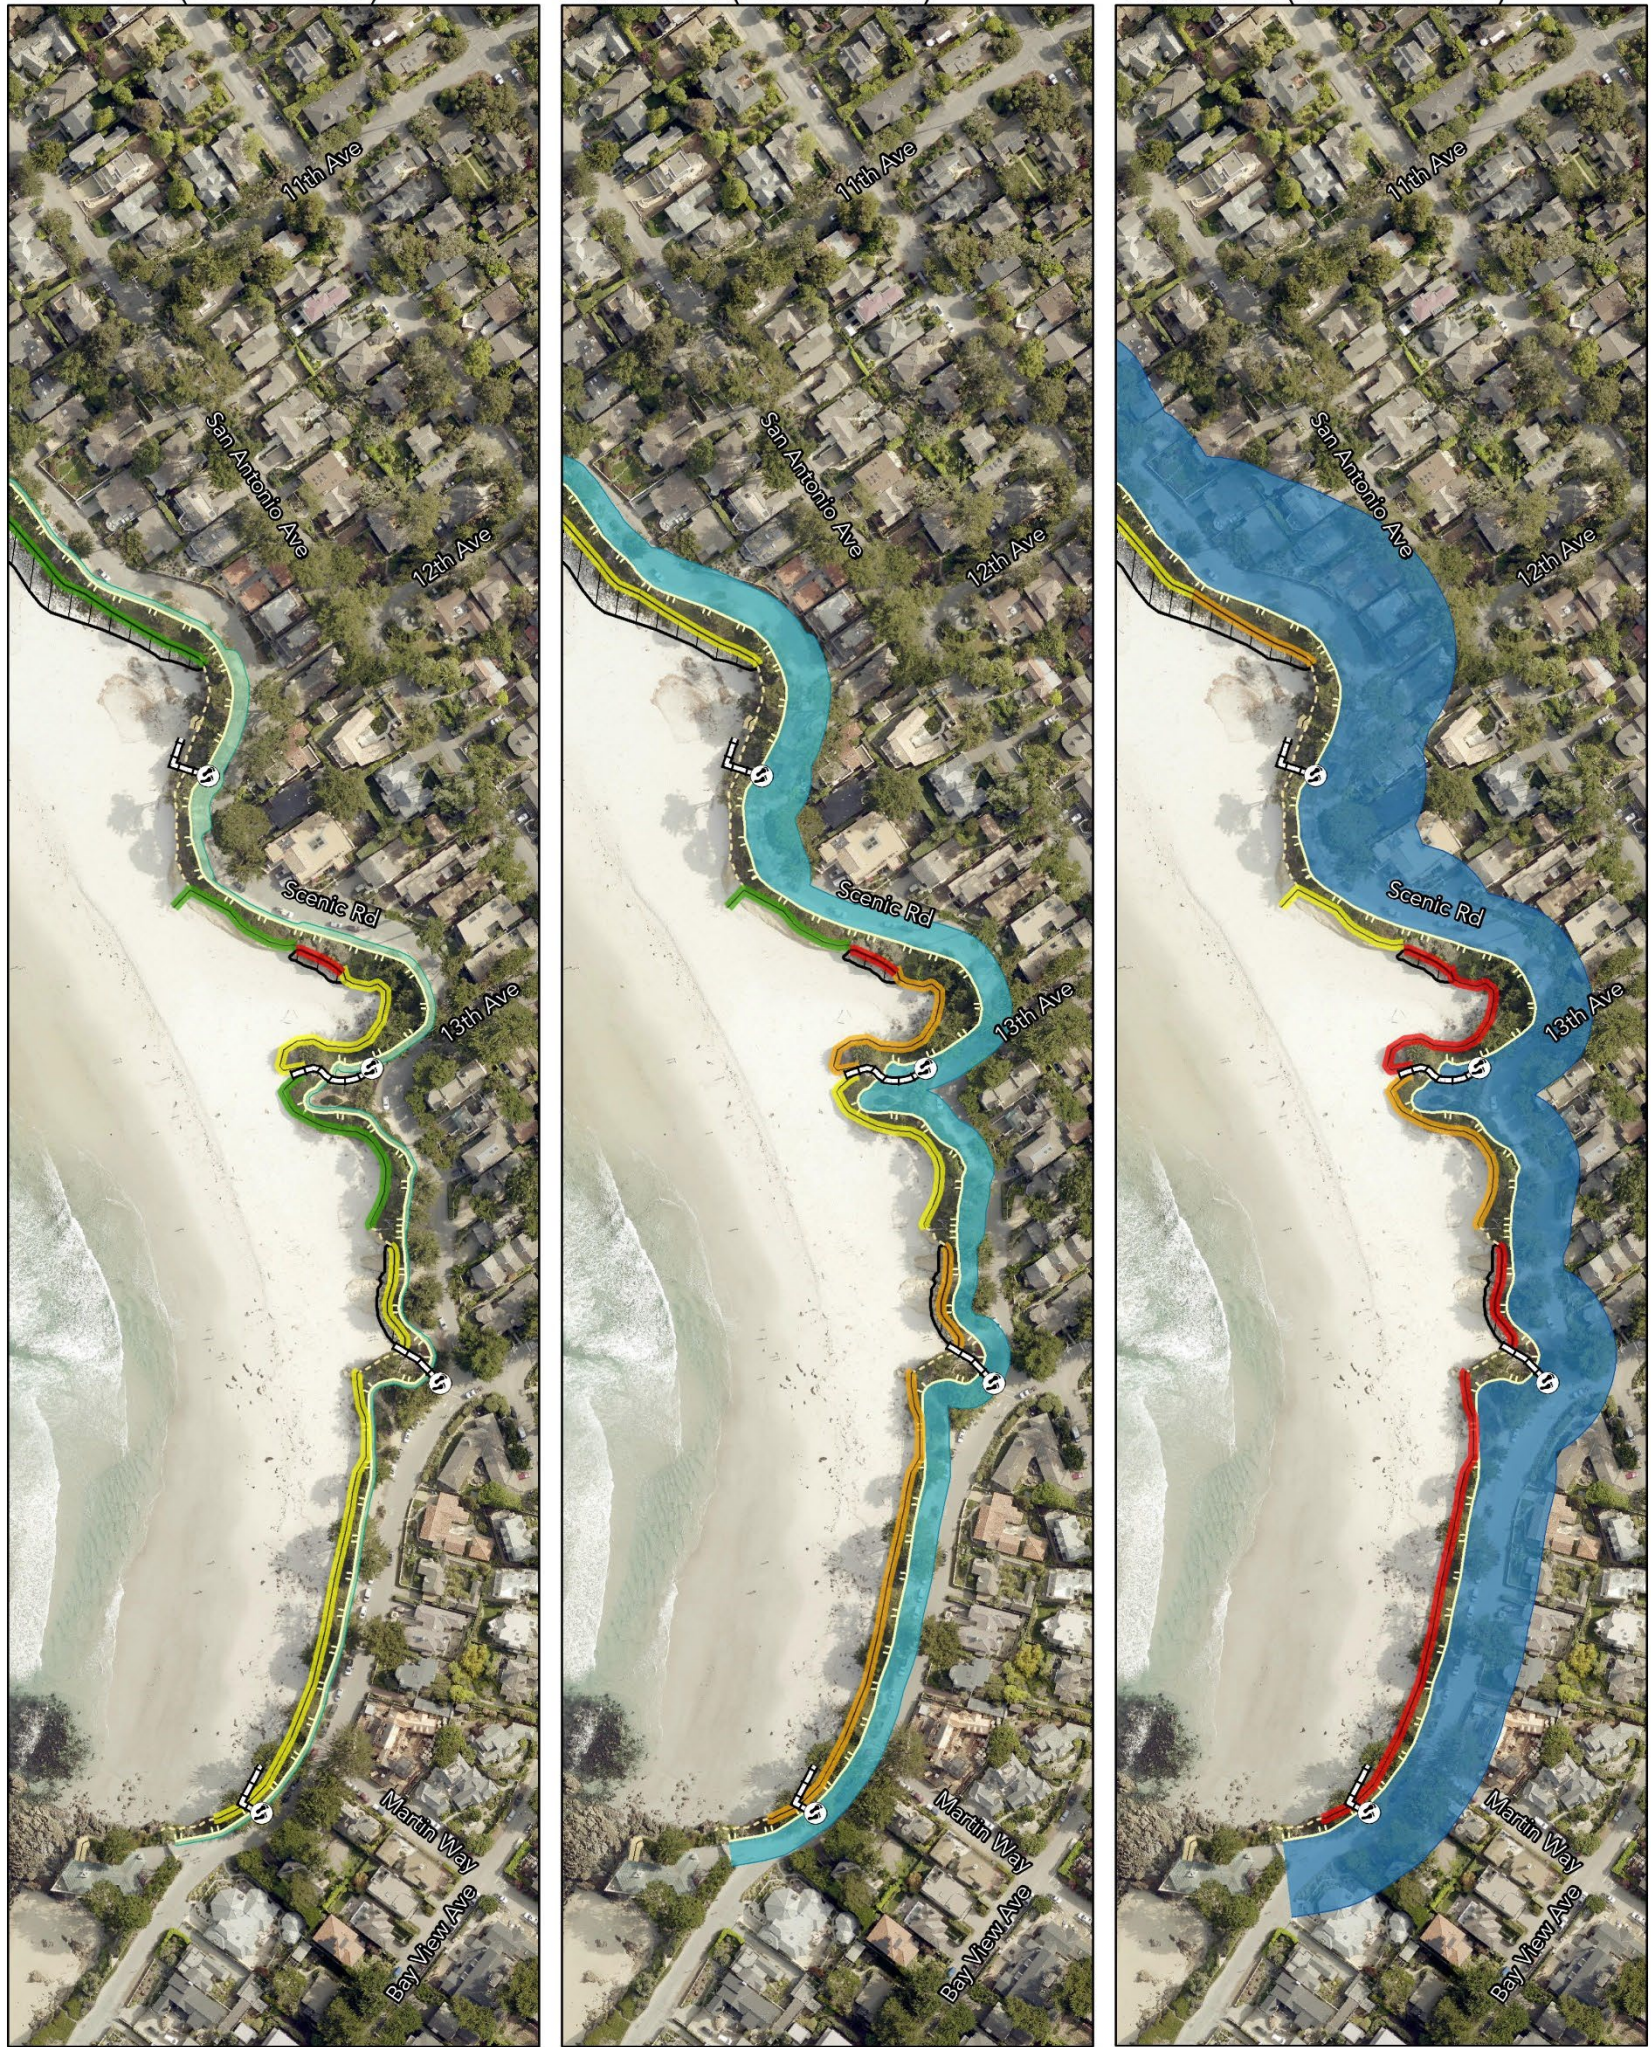
Notes: Erosion distances represent projected long-term time-averaged trends in erosion with coastal armoring. Future erosion distances and bluff crest position may vary from these projections.

Figure 15. Map of dune and cliff erosion for the southern beach. Displays erosion hazards with armoring. Hazard zones in areas where armoring is not present rely on the 'without armoring' scenario using the assumption of an average erosion rate (0.4 ft/yr).
