MEMORANDUM

Subject: Carmel Climate Change Vulnerability Assessment, Shoreline and Beach Erosion Exposure Modeling and Coastal Hazard and Sea Level Rise Vulnerability

Project No.: C3016

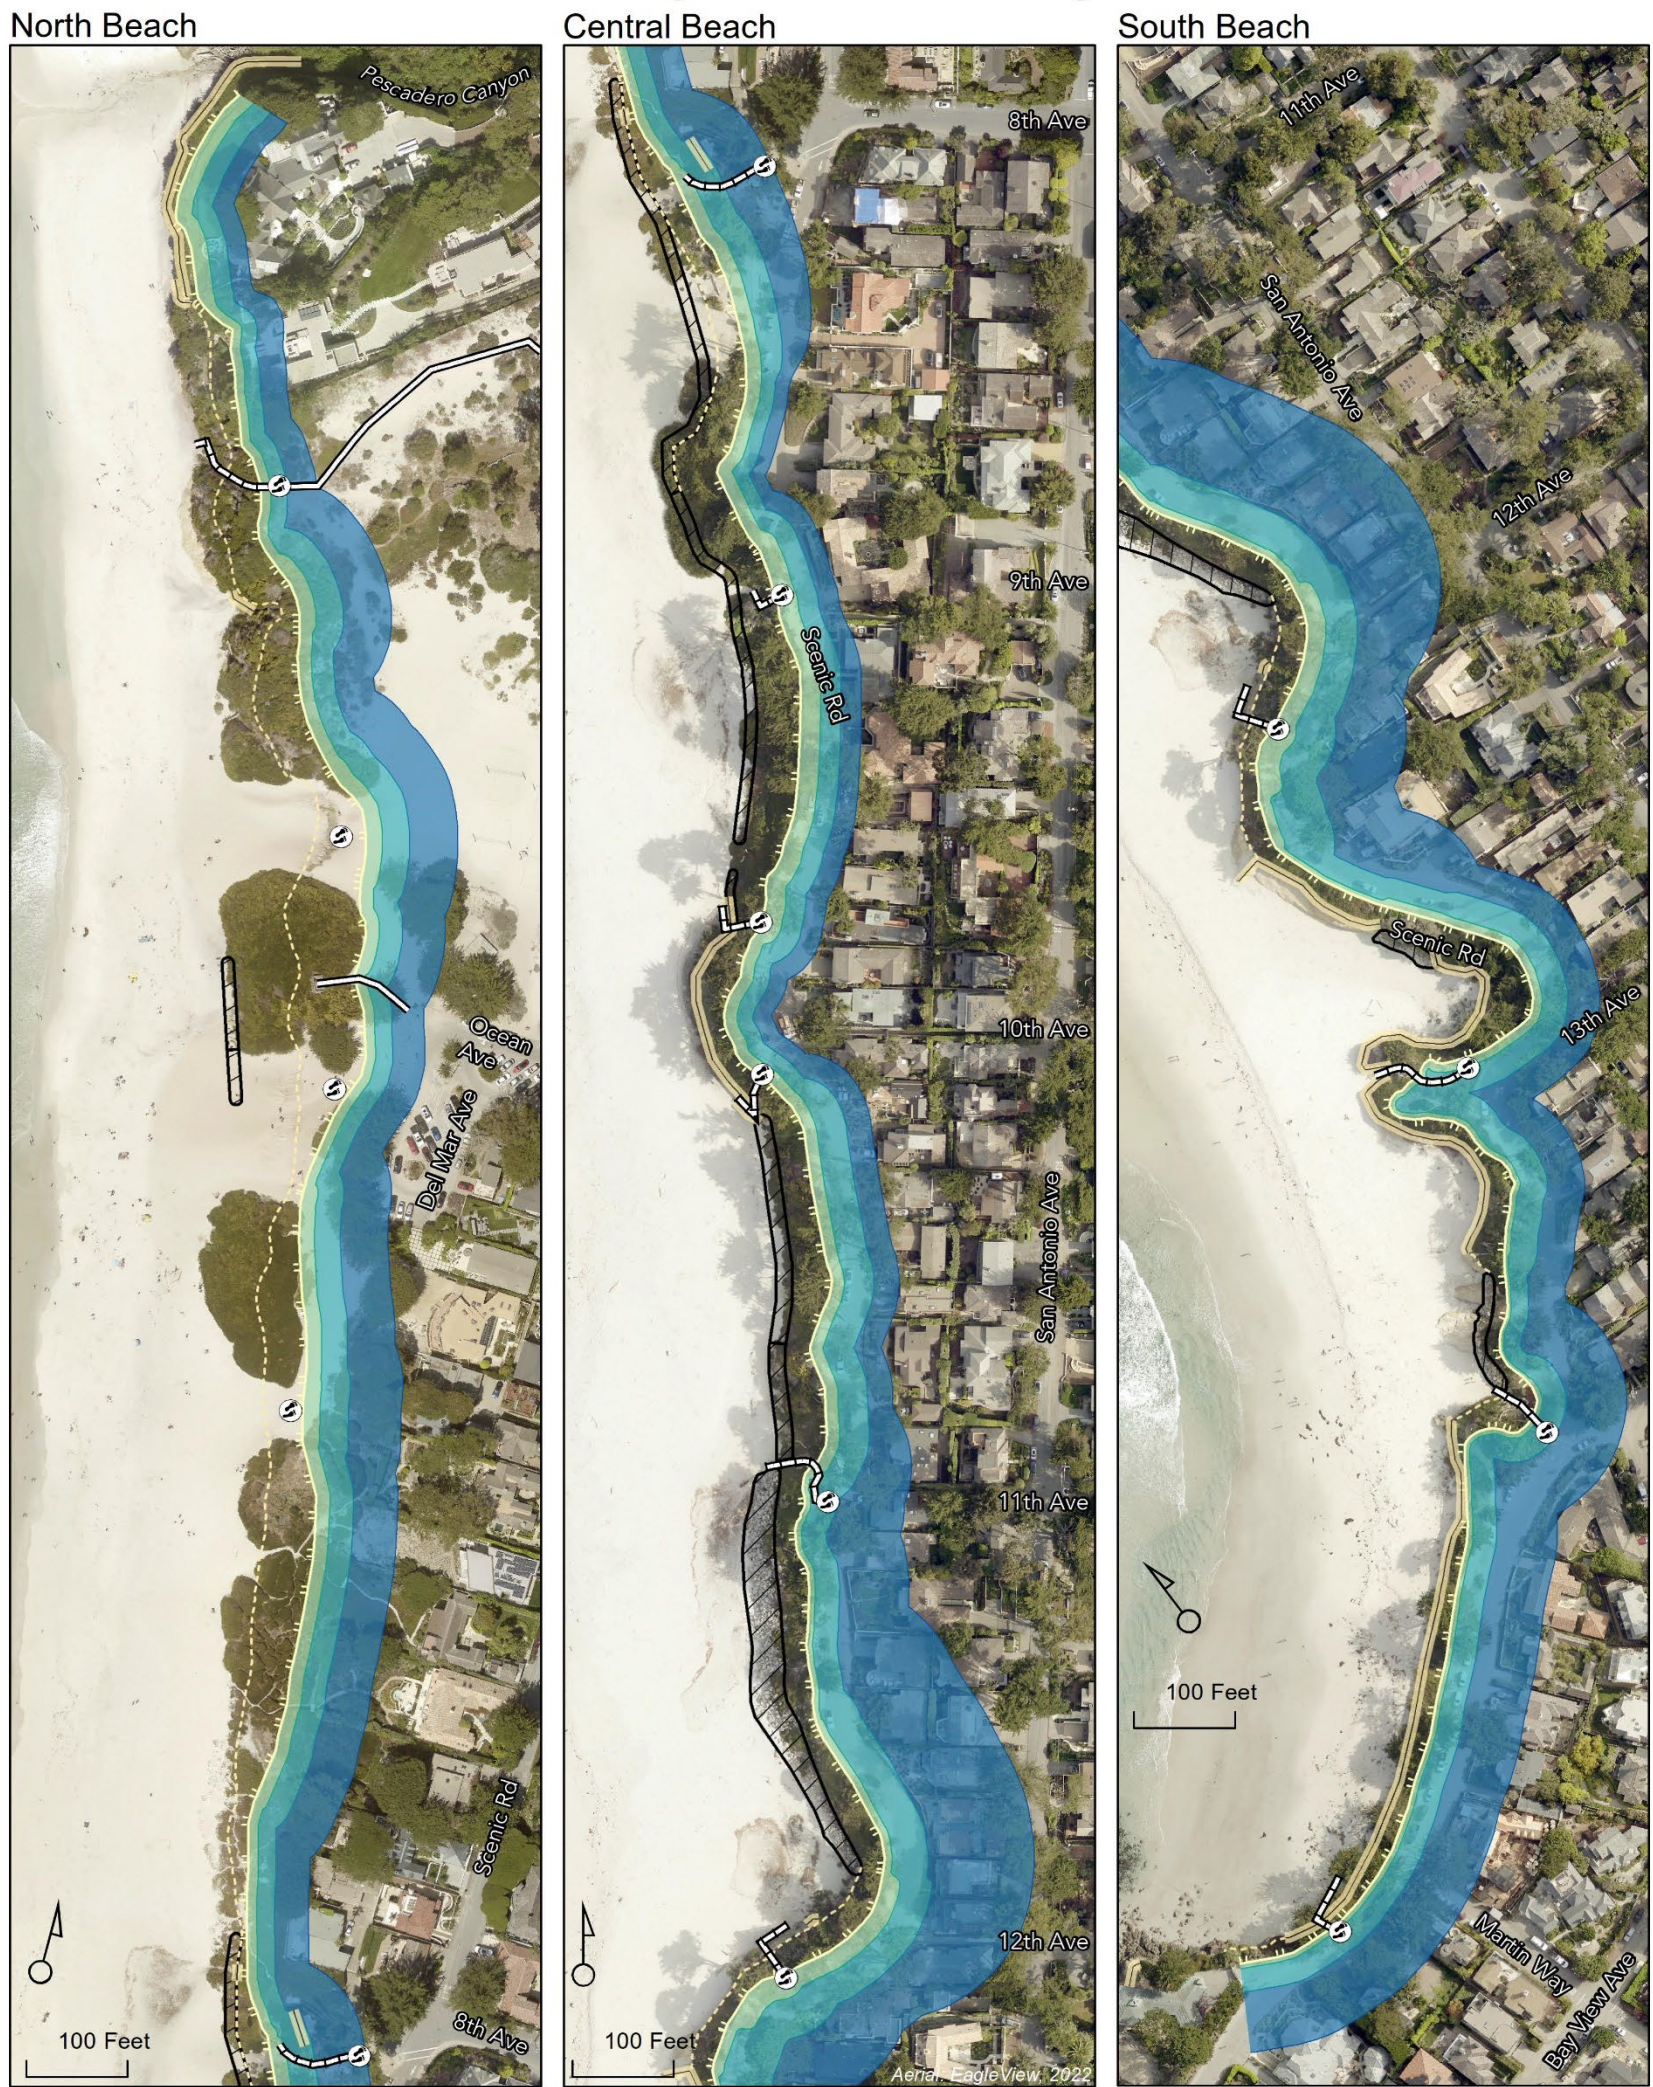
<p>Projected Bluff Crest Position Across Sea Level Rise Elevations</p>	<p>Shoreline Features</p>	<p><i>Notes: Erosion distances represent projected long-term time-averaged trends in erosion with coastal armoring. Future erosion distances and bluff crest position may vary from these projections.</i></p>	
<ul style="list-style-type: none"> 1 ft (2045 - 2060) 2 ft (2060 - 2080) 4 ft (2080 - 2100+) 	<ul style="list-style-type: none"> Boardwalk Beach Access Stairway S Coastal Access Location Riprap Footprint Seawalls Approx. Cliff to Terrace Contact Location Bluff-Top Edge 	<p><i>Sea level rise elevations and time periods are based on 2018 OPC guidance and refer to a high emissions scenario with 2020 as a baseline.</i></p>

Figure 16. Map of dune and cliff erosion for the entire beach. Displays erosion hazards with armoring. Hazard zones in areas where armoring is not present rely on the 'without armoring' scenario using the assumption of an average erosion rate (0.4 ft/yr).

This section provides maps of the erosion hazard zones (Figures 12 through 16). The maps are organized by the with and without armoring scenarios and split into the north (including the North Dunes, North Beach, and Central Beach), central (including the Central Beach and South Beach), and south (including South Beach) areas. For the with armoring scenario, a range of future erosion probabilities are presented. For the armored erosion projection, only a best estimate scenario relying on a range of erosion baselines and future conditions is presented. For the armored scenario, erosion rates are dampened significantly in the near term due to limited wave splash above the crest of the armoring structures; however, with increasing sea level rise, the effectiveness of the armoring is reduced, leading to more green water horizontal wave run up velocities and an acceleration in bluff-top erosion above the coastal armoring in future.

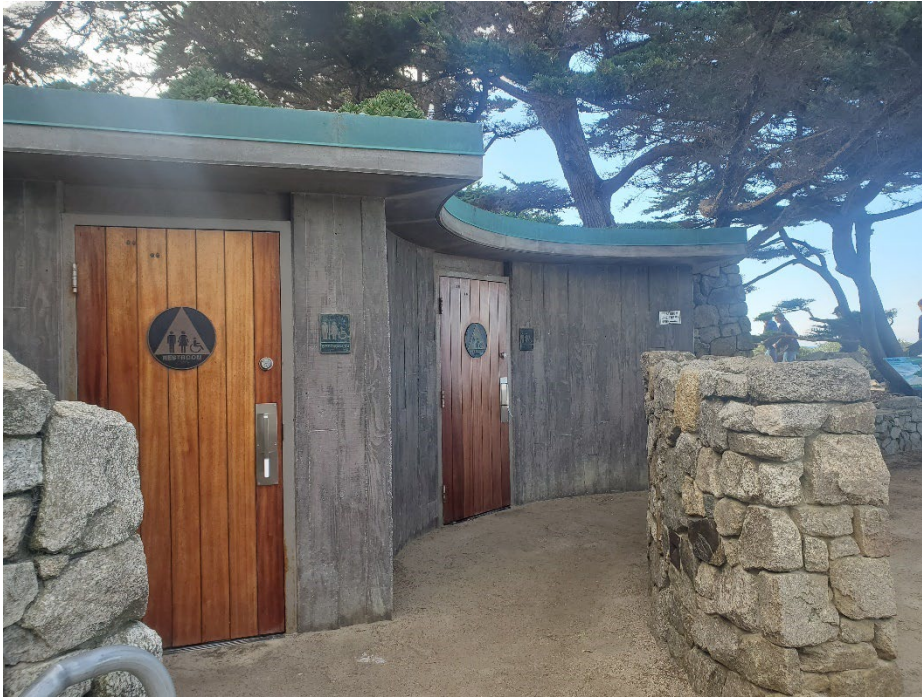
Figure 19. Restroom at Santa Lucia Avenue.

There is a restroom near Santa Lucia Avenue located along the bluffs (Figure 19). The base of the restroom is located at ~24 ft NAVD 88, which is at the same elevation of the FEMA base flood elevation for this area. This restroom will face an increased exposure to coastal wave flooding with sea level rise. The Johnson (1983) study notes that the rock stairway adjacent to this bathroom was almost destroyed in the 1982-83 El Niño storms.

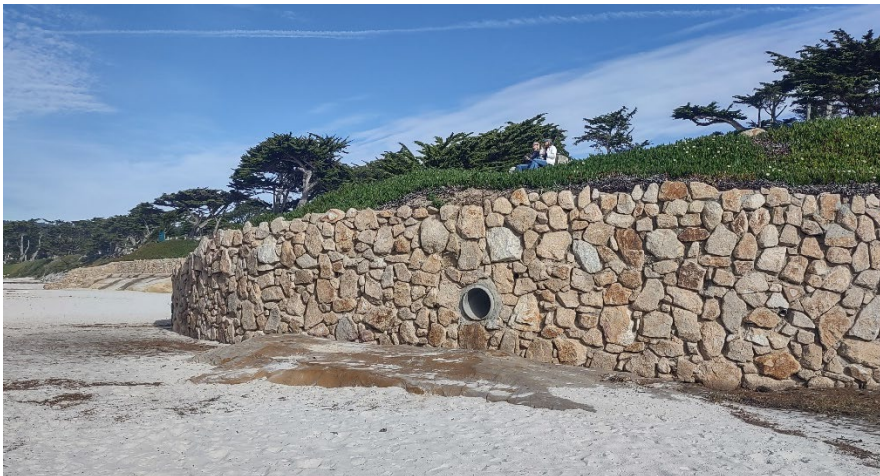
Figure 20. Stormwater drainage near 13th Avenue.

The stormwater drainage network, which is often buried beneath the bluff terrace and the cliff to drain stormwater to the beach, is likely to be exposed to storm wave flooding and erosion (Figure 20). Failure of a storm drain can also exacerbate erosion from terrestrial scouring during rain events.

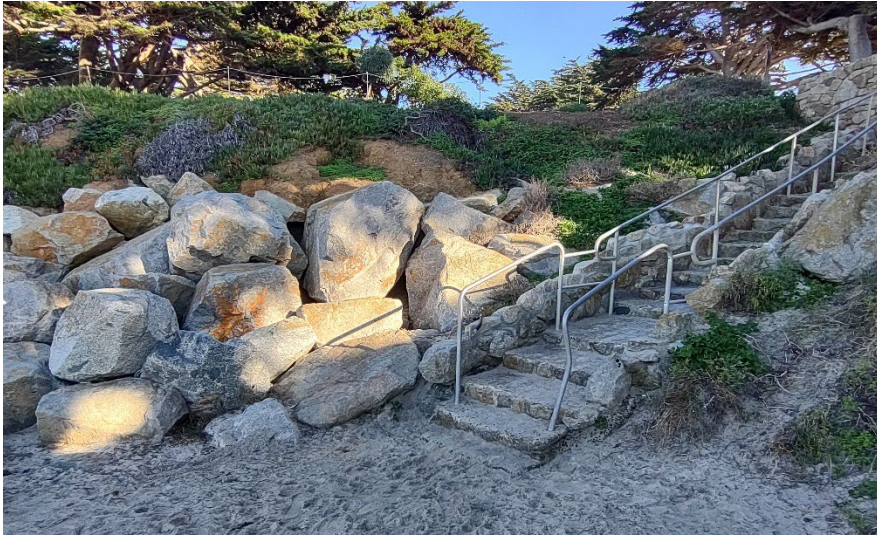
Figure 21. Stairway at Santa Lucia Avenue. Note damage to the railing from past storms.

There are ten beach access stairways that lead to the beach, and all of these stairways are vulnerable to wave attack, scouring and undercutting of their foundations, and coastal erosion. In addition, the failure of a stairway can exacerbate erosion of surrounding bluffs. Breakaway stair designs such as those just north of 10th Avenue can greatly reduce the potential for stairway failures to contribute to erosion.

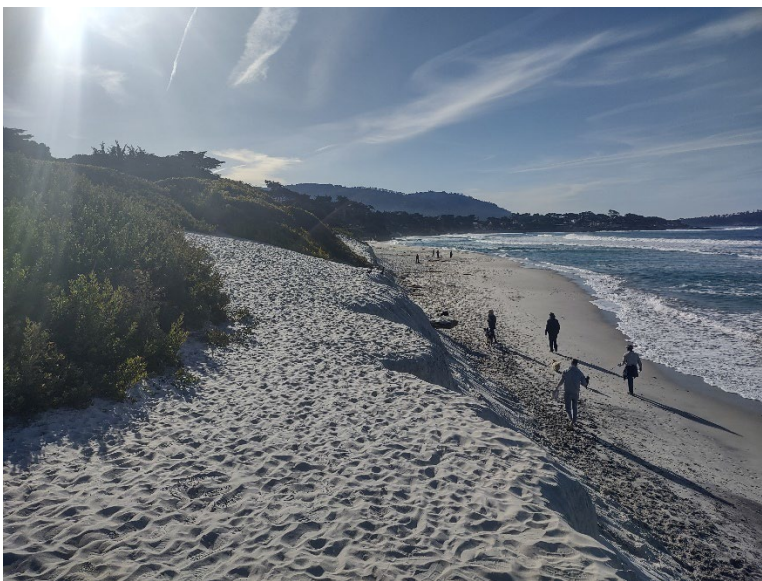
Figure 22. A view looking south over the Del Mar Dunes. A dune scarp is evident along the sand ramp and the dunes. January 2023.

Dune erosion was observed in this area during the winter storms of 2022-23 (Figure 22). The Johnson (1983) study notes that the dunes near 8th Avenue eroded 30 ft and formed a 14 ft-high scarp during the 1982-83 El Niño winter. Dune erosion hazards between 0 and 1 ft of sea level rise are projected to cause erosion of 30 to 40 ft in this area, corresponding with the severe winter storm erosion observed in the Johnson study.

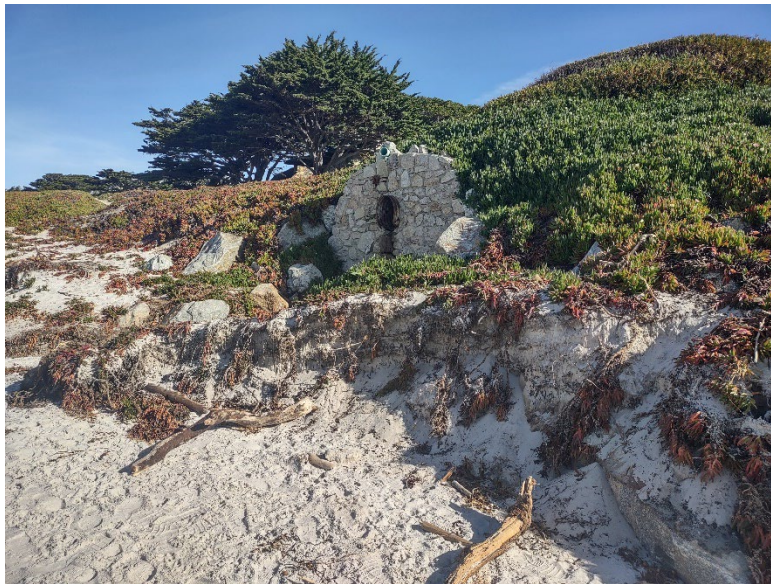
Figure 23. Stormwater drain near 8th Avenue fronted by an eroded scarp following winter storms in 2023. Note the riprap boulder on the bottom right.

This shoreline section has less immediate bluff-top development than other areas of the City and faces fewer immediate vulnerabilities for the oceanfront homes due to wider setback distances. However, dune erosion and wave flooding could threaten the private coastal accessways, as well as the two coastal access sand ramps south of the Del Mar parking lot and the stairway at 8th Avenue. In addition, the City's stormwater drainage system is vulnerable to dune erosion, and this section also contains private stormwater drain pipes that are exposed to erosion (Figure 23).

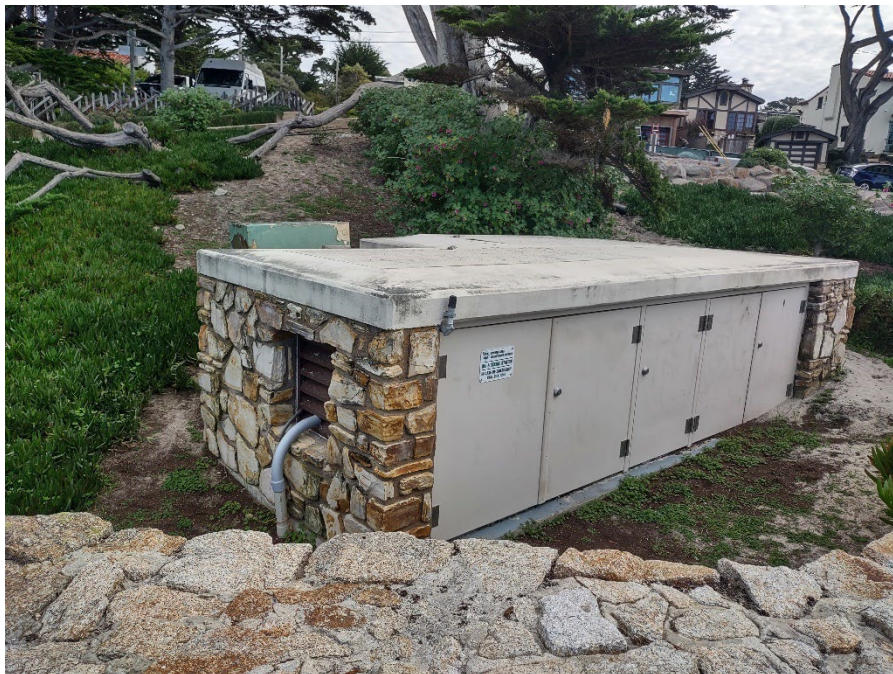
Figure 24. Wastewater lift station near 8th Avenue.

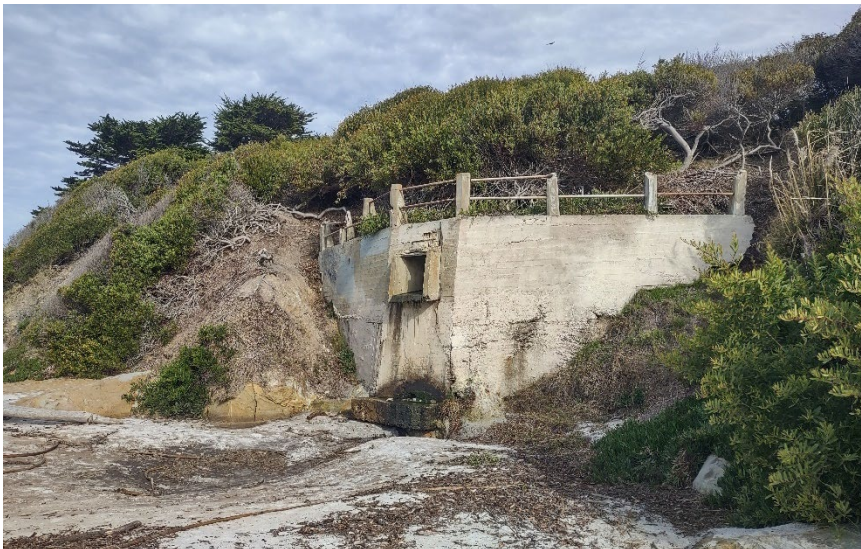
Figure 25. Seawall and outfall just south of the 4th Avenue Stairway.

The bluff-top viewing platform at Ocean Avenue is vulnerable to dune erosion, as is the coastal access stairway at 4th Avenue. A stormwater outfall and seawall just south of 4th Ave is likely exposed to erosion. The Task 1 Coastal Protection Assessment identified this seawall as being a high priority for repair.

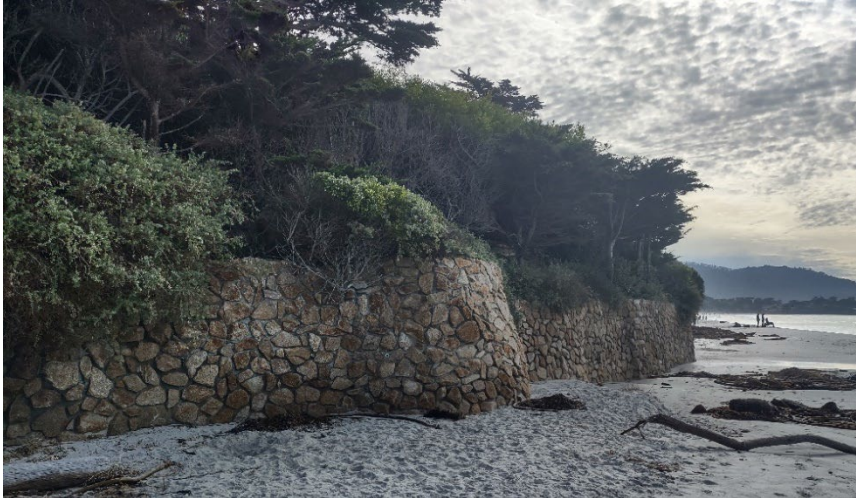
Figure 26. Privately owned seawall near Pescadero Canyon.

A private seawall (Figure 26) is vulnerable to wave attack and overtopping.
