Date: 27 April 2023  
Client: City of Carmel  
Subject: Carmel Beach Coastal Protection Assessment  
Reference: Carmel Beach Adaptation Plan  
Project No.: 12176

## **CARMEL BEACH COASTAL PROTECTION ASSESSMENT REPORT**

Coastal Protection Evaluation 22 December 2022 thru 30 January 2023

Carmel Adaptation Plan - Carmel Beach All Areas

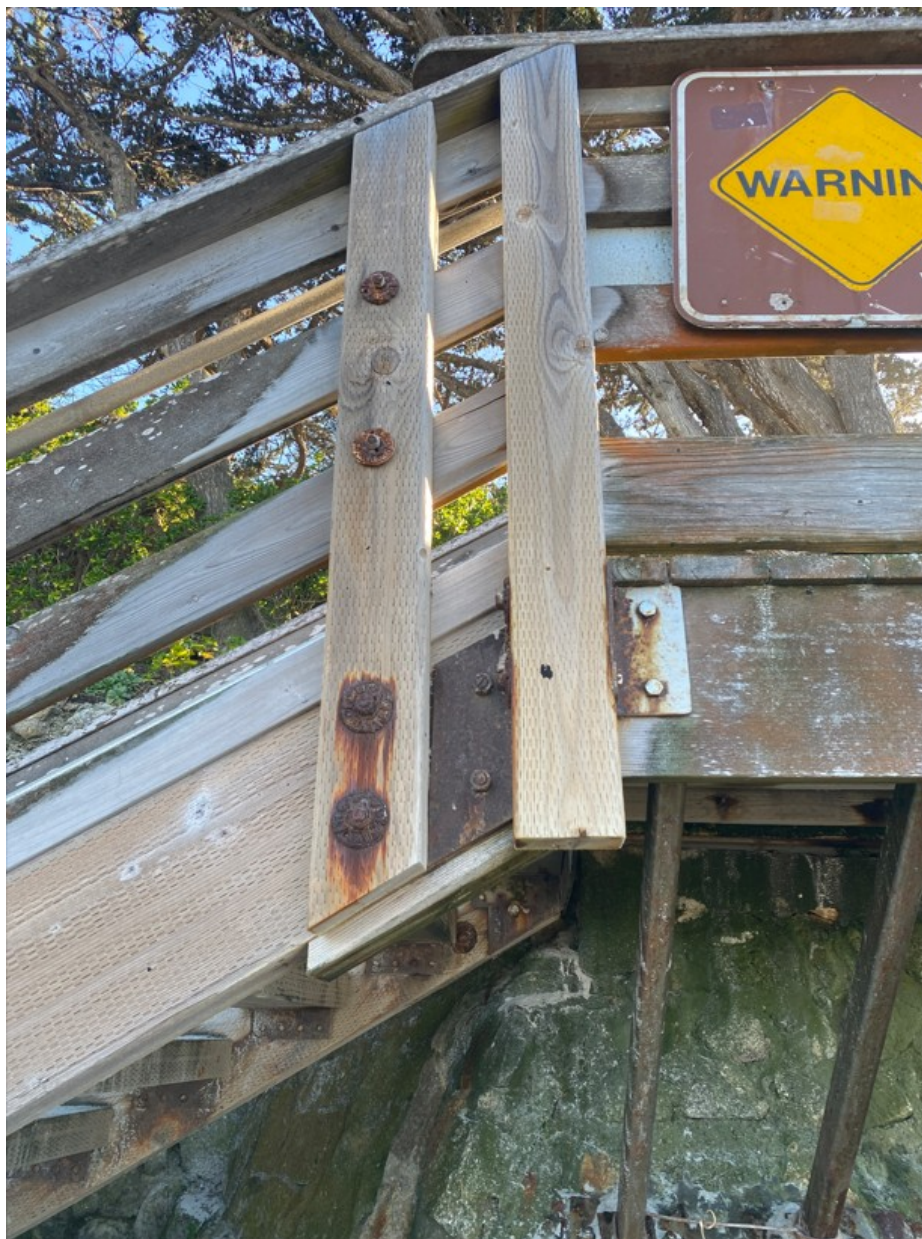
**Photograph 5: Public Access Stairway ST1 on December 22, 2022**

Photograph 5 shows Public Access Stairway ST1 on December 22, 2022. Corrodible fasteners and brackets were used on this stairway and those are deteriorating. At some point it will need maintenance and/or repair. Visually it appears satisfactory to us at this time. Further evaluation of the structure by an independent licensed structural engineer (and if need be a licensed corrosion engineer) should be scheduled to verify the structure is safe for public use, and recommend any needed repairs.

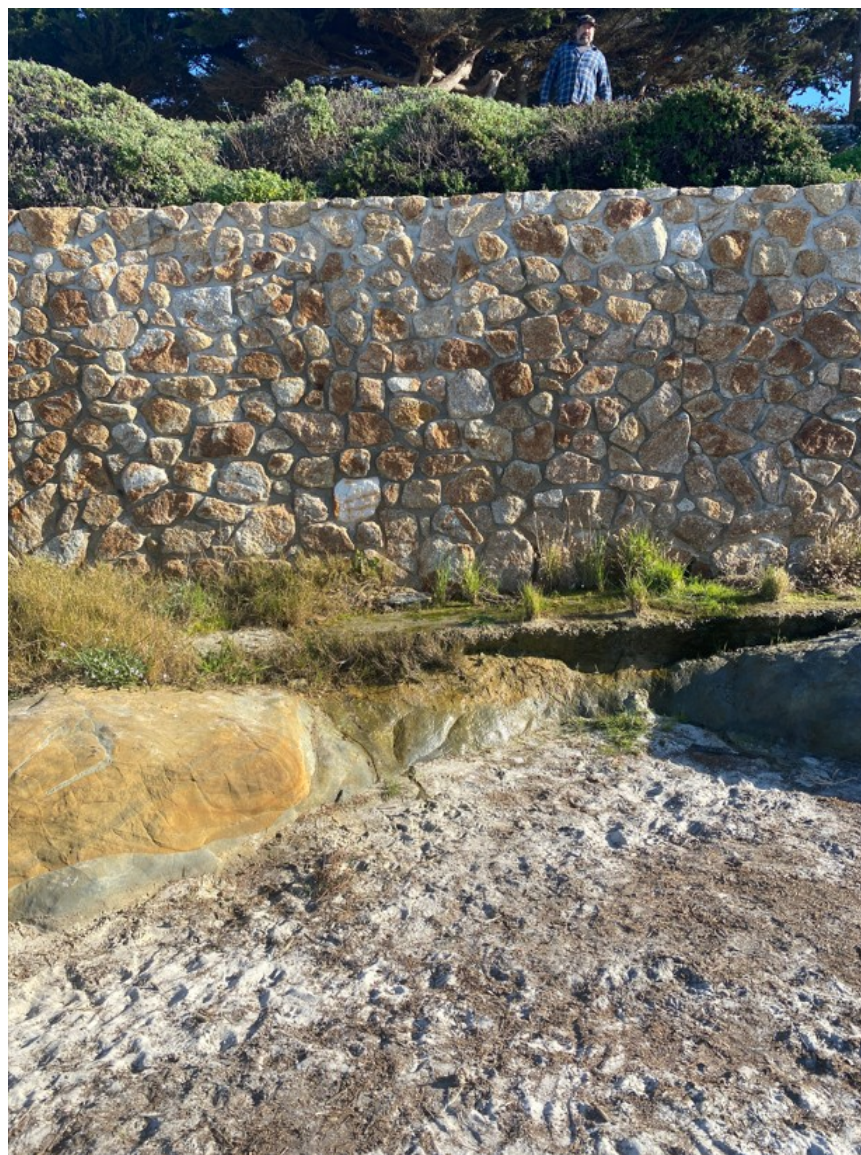
**Photograph 11: North End of Seawall S2 on December 22, 2022**

Photograph 11 shows an area at the northern end of Seawall S2 on December 22, 2022, where the edge of the seawall footing is exposed and it has been slightly undermined. Easton Geology inspected this location as well. Photograph 12 (below) is an Easton Geology photograph of the north end of Seawall S2 showing it was undermined in 2016. Comparison of that photo with the 2022 photo (above) shows there has been very little change in the conditions; there has been no continued undermining during that 7 year period. It is likely that this area was buried in beach sand during most of those 7 years; when the bedrock supporting the footing is buried, wave action does not contact the bedrock and no erosion or bedrock retreat occurs under the footing.

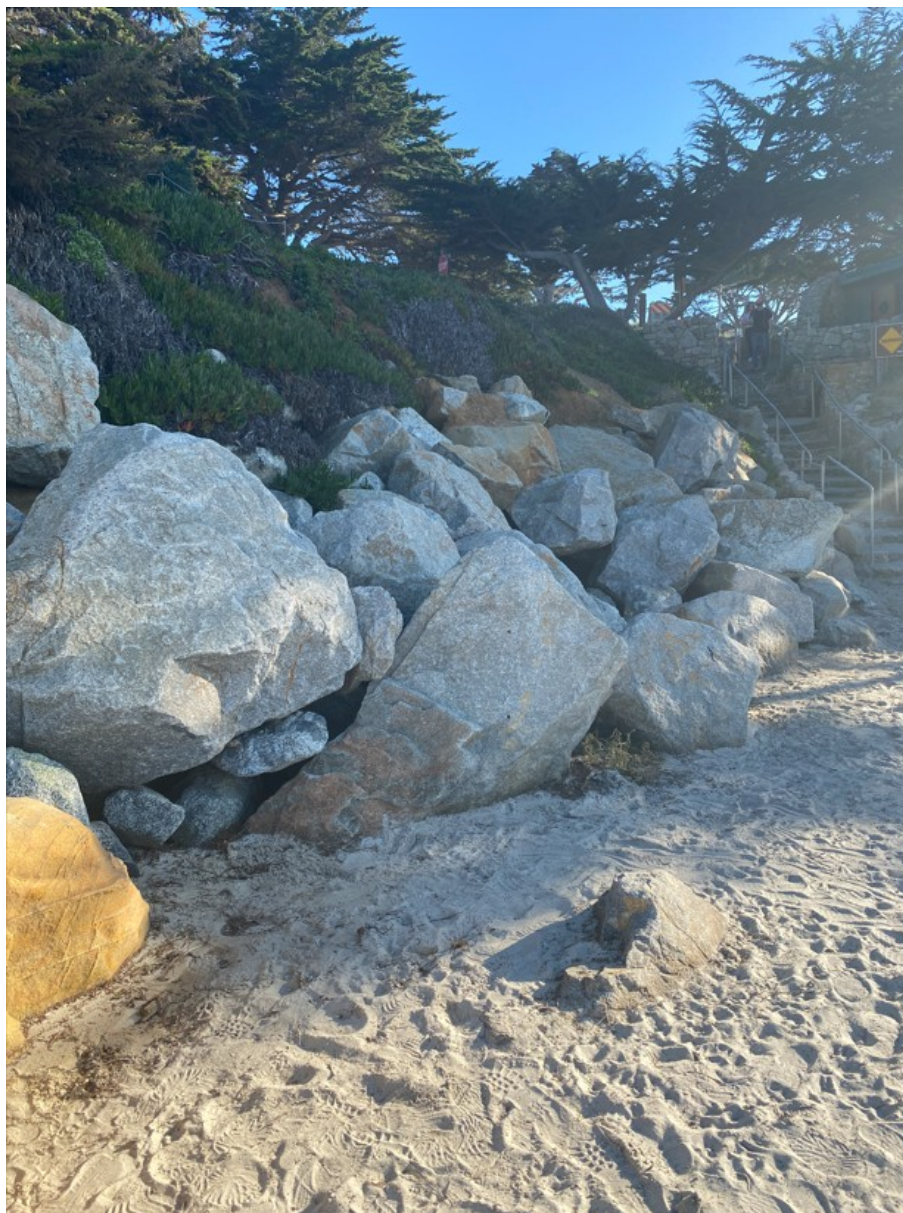
**Photograph 17: Revetment R1 on December 22, 2022**

Photograph 17 shows the southern end of Revetment R1 on December 22, 2022, which consists of oversteep riprap, making it relatively unstable. One displaced boulder (a "fugitive" rock) can be seen poking out of the beach sand seaward of the revetment. Historic instability and the use of undersized boulders to construct this revetment have caused cavities to develop in the revetment and have diminished the erosion protection it provides. We recommend the holes in the revetment structure be filled and the 1 to 4 ton rocks be restacked. It is presently unsafe.

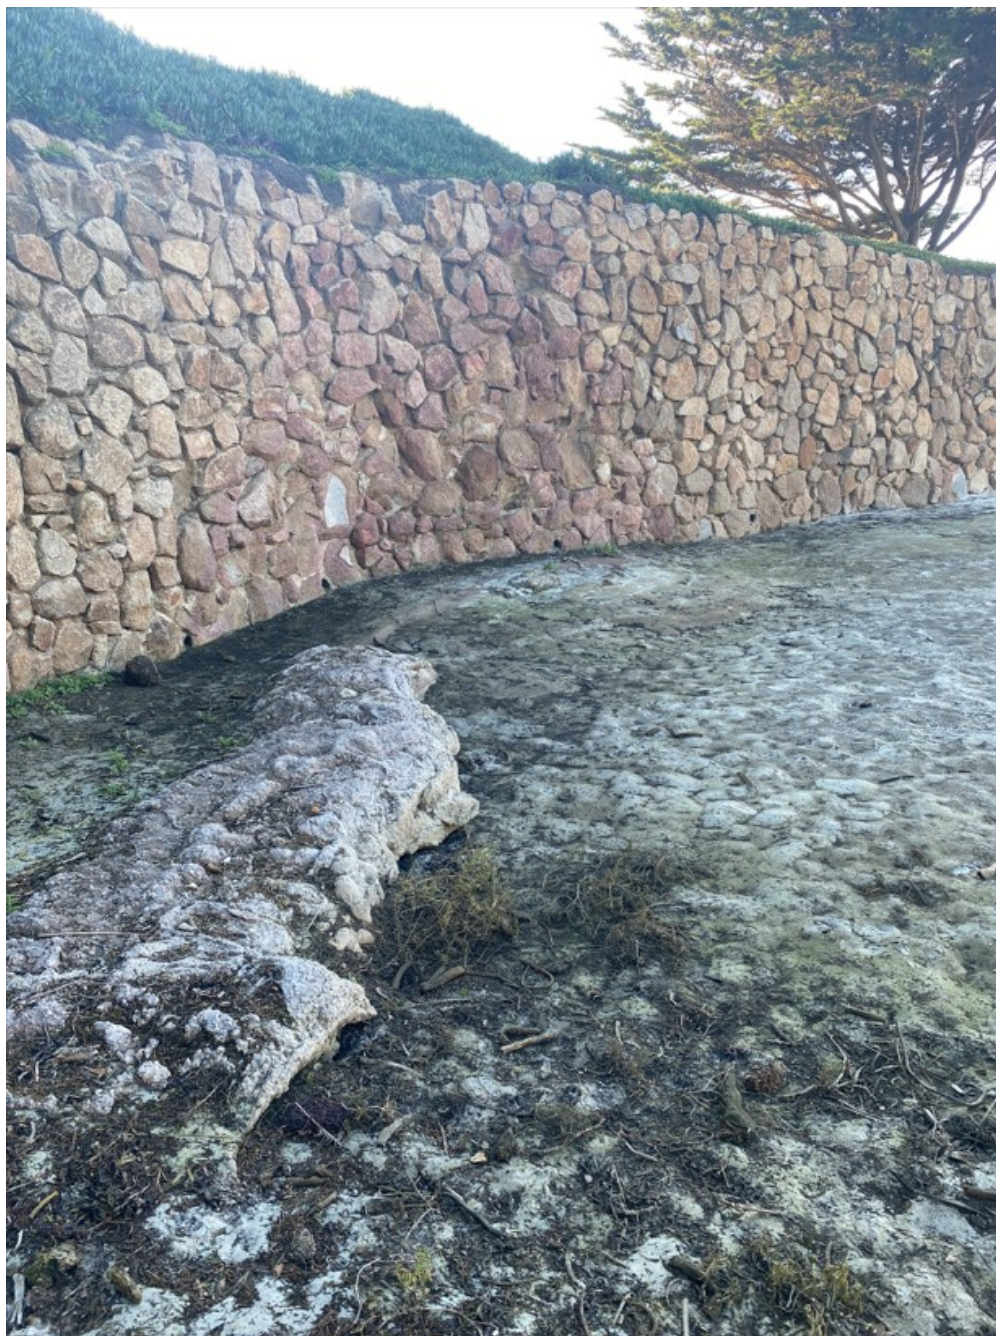
**Photograph 23: Concrete Debris on Beach at Base of Seawall S3 on December 22, 2022**

Photograph 23 shows Seawall S3 on December 22, 2022 which has pumped concrete debris located on the beach at base of the seawall. Easton Geology inspected Seawall S3 in February 2016 and again in June 2016 for the City. Photograph 24 from Easton Geology shows that the beach was more scoured then than during our 2022 and 2023 inspections.

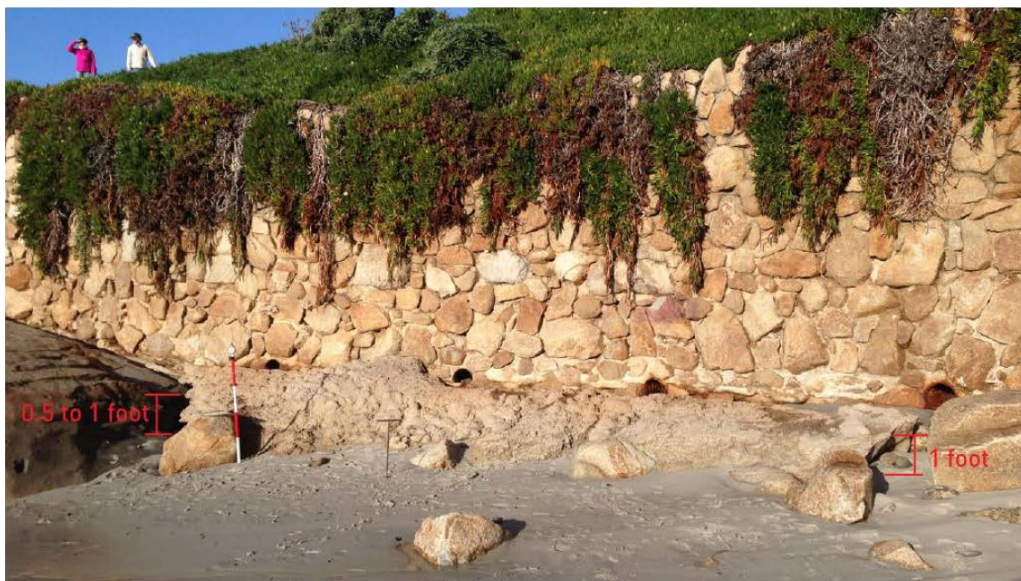
**Photograph 24: Southern End of Seawall S3 in February 2016 Photographed by Easton Geology Showing Pumped Concrete Repair of Undermining of Seawall S3**

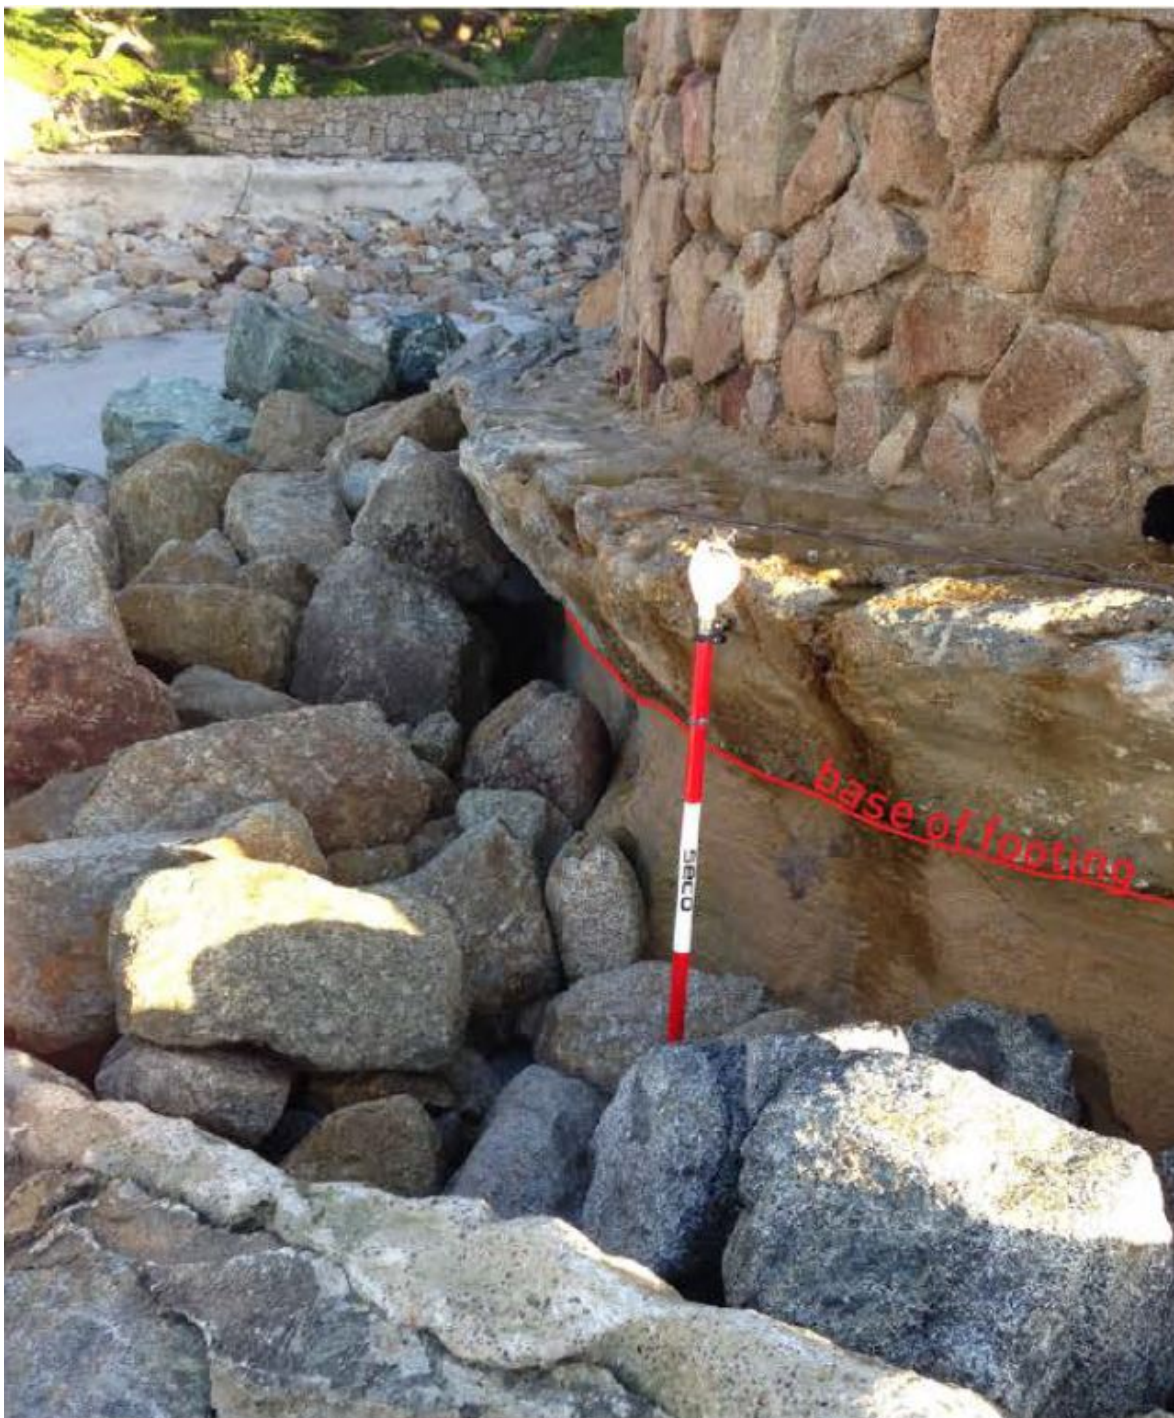
**Photograph 30: Seawall S3 Just North from ST4 in February 2016 (Easton Geology)**

Photograph 30 shows that the footing of Seawall was bearing on bedrock and slightly undermined in 2016.

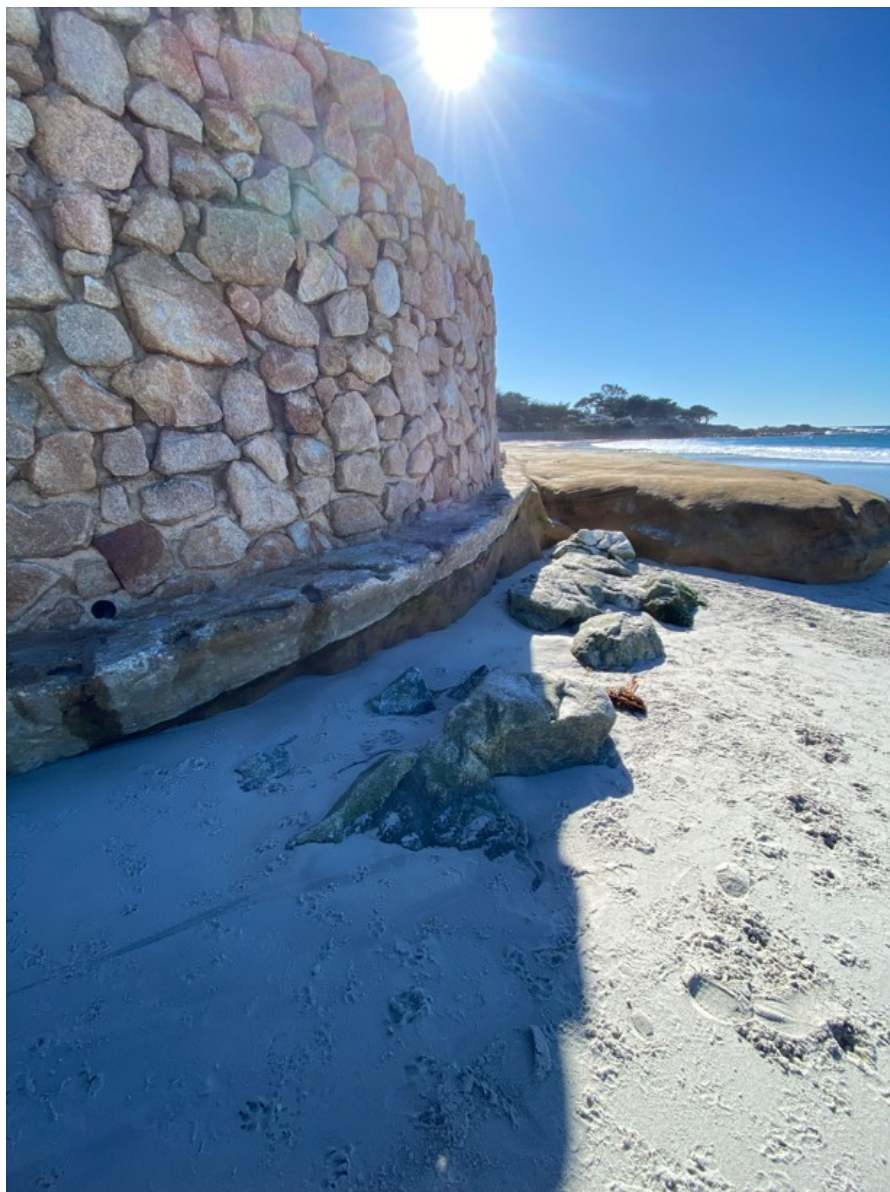
**Photograph 31: Looking South at Seawall S3 Adjacent to ST3 on January 30, 2023**

Photograph 31 shows Seawall S3 at the south end of Cooks Cove, adjacent to ST3, showing its foundation is still bearing on a sandstone bedrock platform, and the footing remains slightly undermined. It is still performing well, and we have no recommended maintenance at this time. We note that when beach sand levels are naturally higher, the footing is buried and naturally protected from wave impact, resulting in no undermining occurring during those time periods, which are typically present in most years all year long. We recommend the undermining shown in Photographs 30 and 31 be photographically monitored whenever it is exposed, to verify the that undermining is occurring at over time.

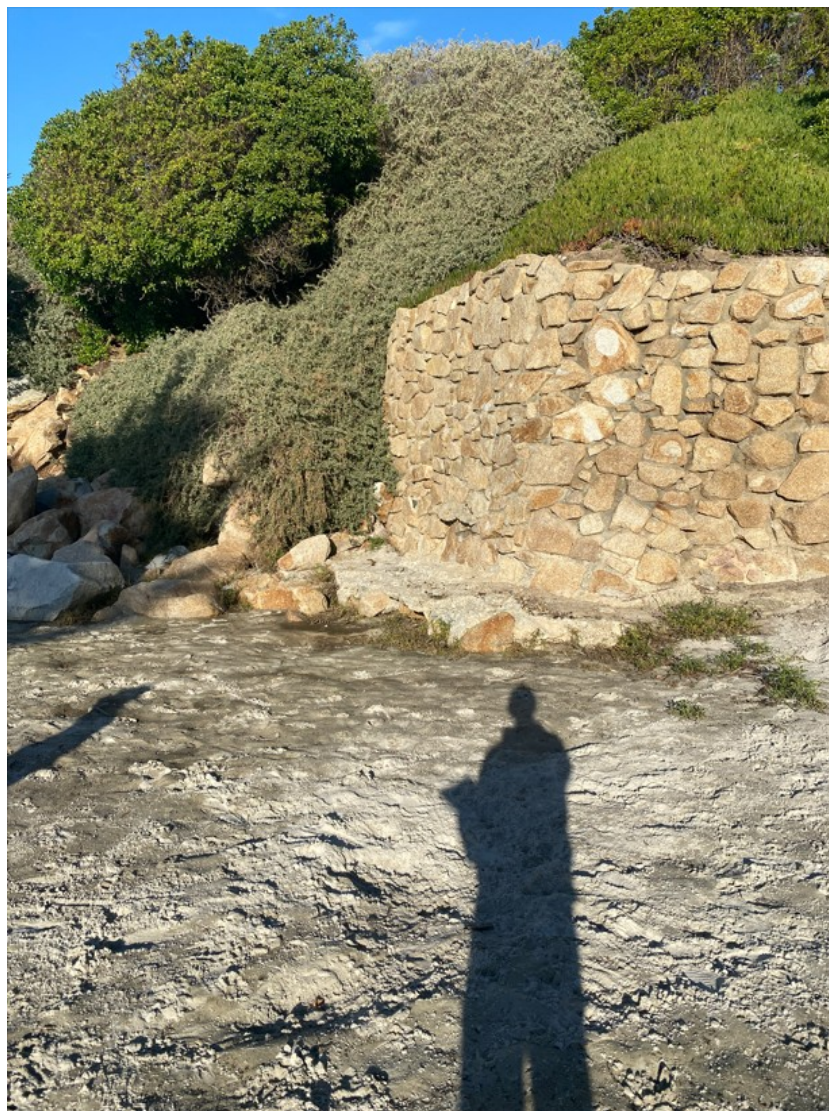
**Photograph 32: North End of Seawall S3 on December 22, 2022**

Photograph 32 shows the north end of Seawall S3 where it adjoins Revetment R2 on December 22, 2022. The north end of Seawall S3 was historically slightly undermined, and the resultant cavities have been repaired with concrete patchwork, and or grouted riprap. The north end of Seawall S3 appears to be stable.

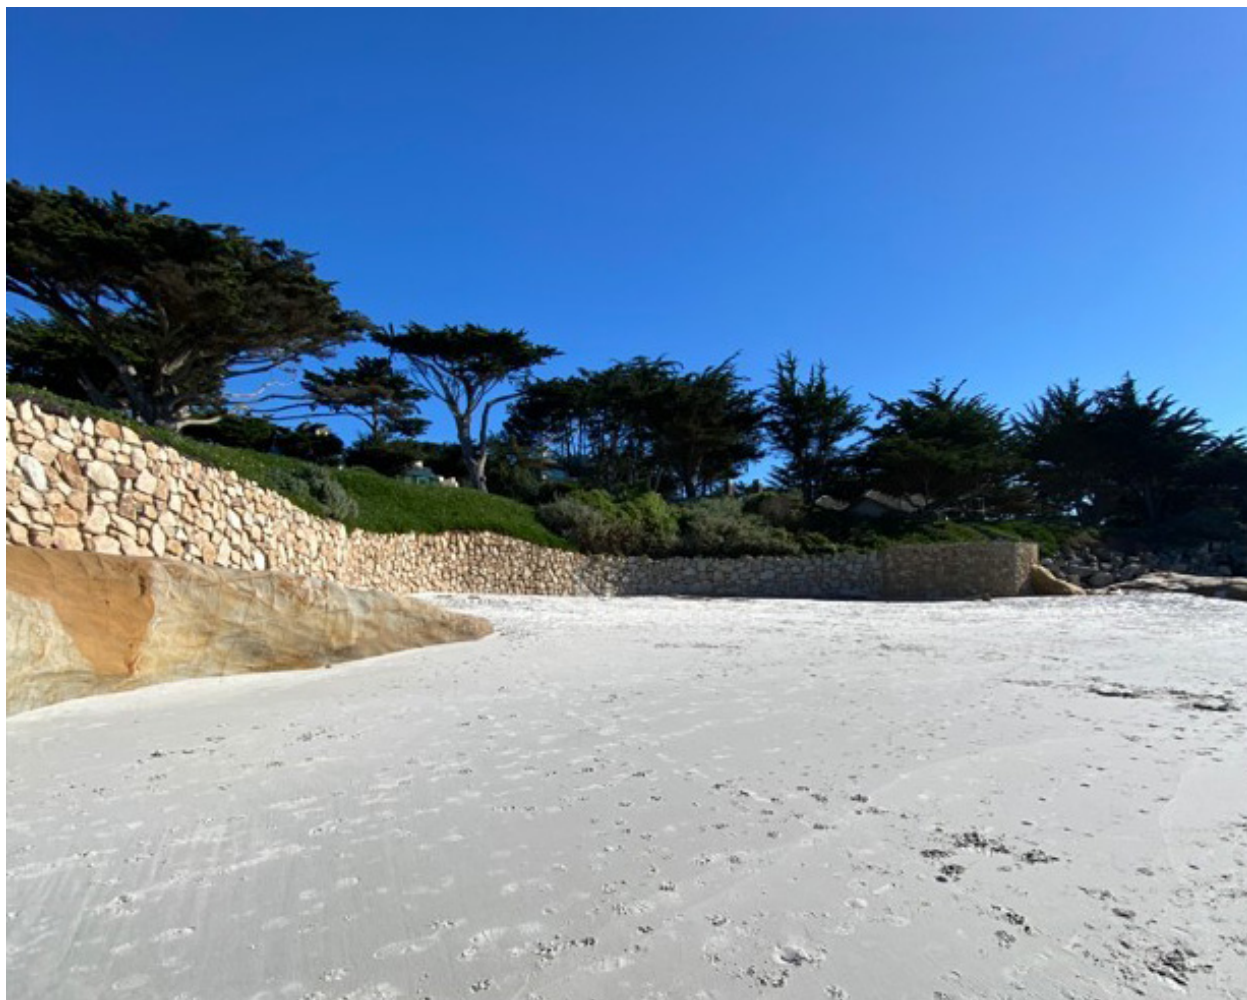
**Photograph 35: Showing Seawall S4 on January 30, 2023**

Photograph 35 shows the southern portion of Seawall S4 on January 30, 2023 which is in similar conditions to when our December inspection was done. This seawall is in good to excellent condition and is founded on the bedrock platform. No repairs appear to be needed.

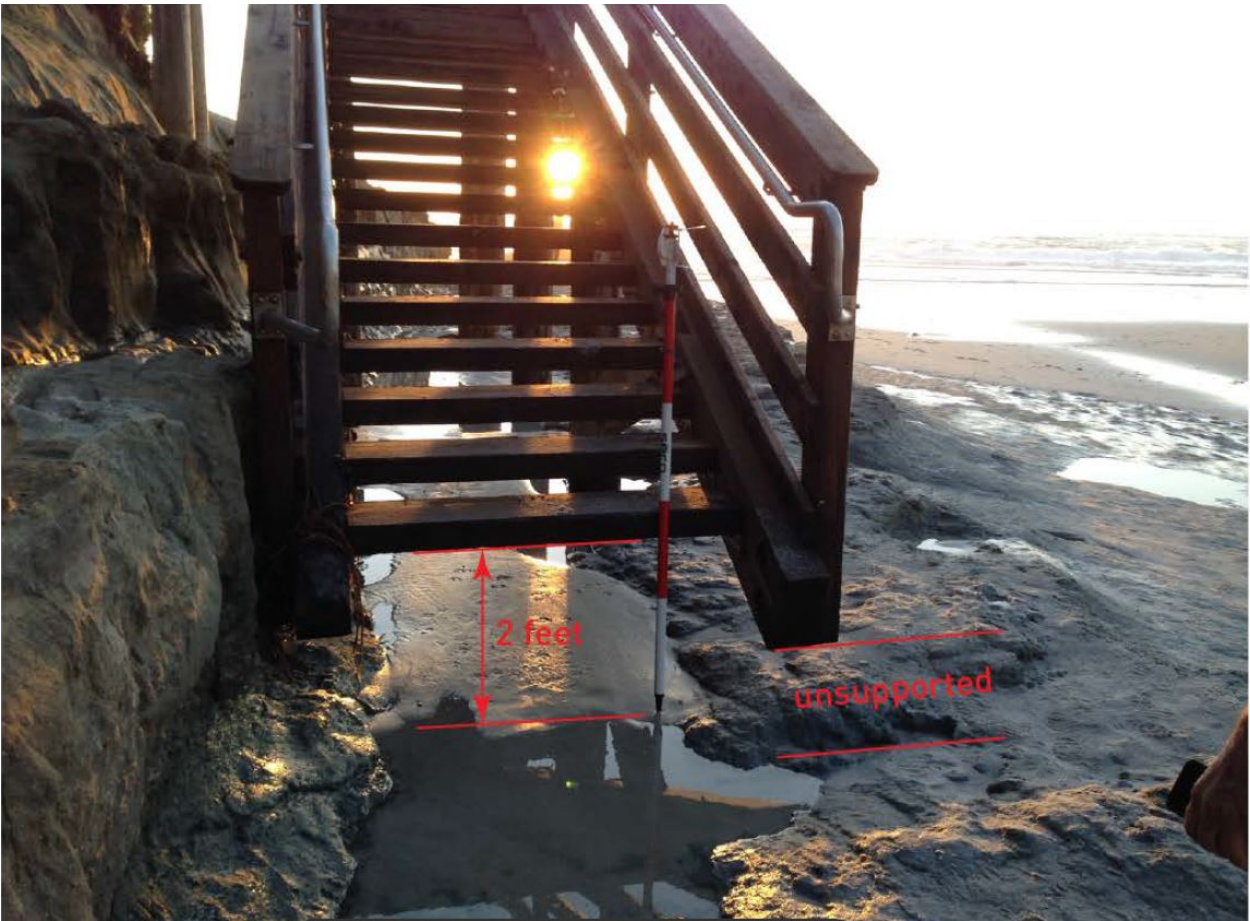
**Photograph 39: Undermined Stairway ST4 in February 2016 (Easton Geology)**

The undermined portion of Stairway ST4 that was visible in 2016 was not visible during our December 2022 inspection but was subsequently exposed by beach scour and visible in our January 2023 inspection. The metallic hardware for the railing is severely corroded and is expanding and splitting the timber framework of these stairs, which are located at 12th Avenue.

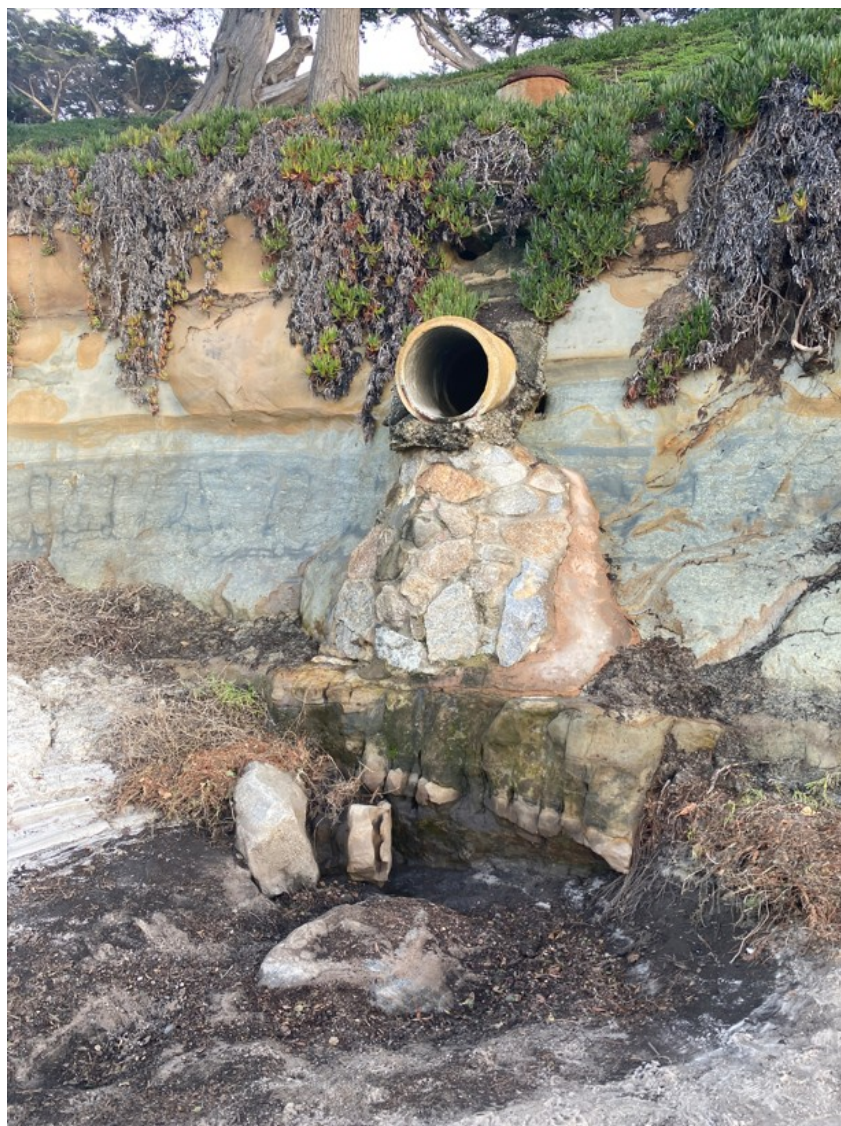
Photograph 43 (below) shows a storm drain outfall just northeast of Stairway ST4 with a rock and mortar seawall that armors the bluff face below the outfall that is Seawall S5. A small amount of riprap below the outfall and Seawall S5 was barely visible during our December 2022 inspection.

**Photograph 43: Storm Drain Outfall and Seawall S5 Northeast from Stairway ST4 on December 22, 2022**

Seawall S5 is immediately below the storm drain outfall near 12th Avenue.

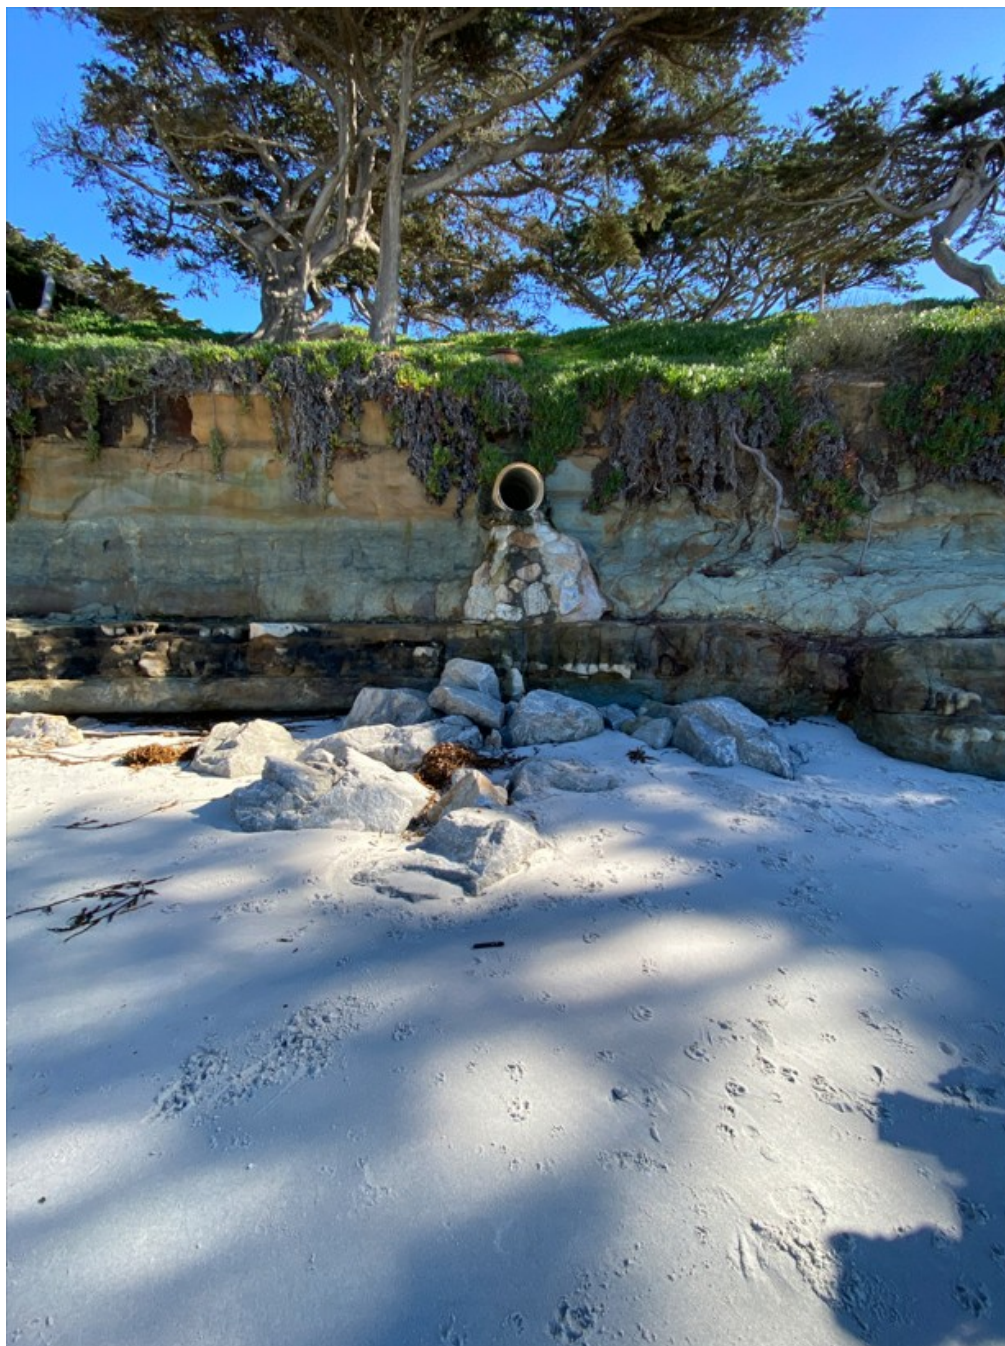
**Photograph 44: Storm Drain Outfall with Minor Armoring Between ST4 and R3 on January 30, 2023**

As Photograph 44 shows, a greater amount of riprap below the outfall and Seawall S5 was visible during our January 2022 inspection. The rip-rap dissipates the energy from the runoff flowing onto the beach and serves to reduce bedrock erosion during times of low beach elevation.

Photograph 43 shows a storm drain outfall with minor armoring (Seawall S5) south of Revetment R5 and Stairway ST4 on December 22, 2022. Photograph 44 shows the same outfall and Seawall S5 after during January 2023 when considerable additional sand scour had occurred, exposing the grouted riprap energy dissipater placed on the bedrock platform below the outfall. About 75% of the coastal bluff height consists of erosion resistant bedrock, and appears to be in good shape. A seawall may be needed to slow bluff retreat in the future. Photograph 45 by Easton Geology (above) shows the conditions in February 2016, and includes their recommendations regarding extending the culvert and restacking the rip-rap they made at that time. Seawall S5 has no maintenance recommended by HKA at this time. It appears to have at least 30 years remaining life.

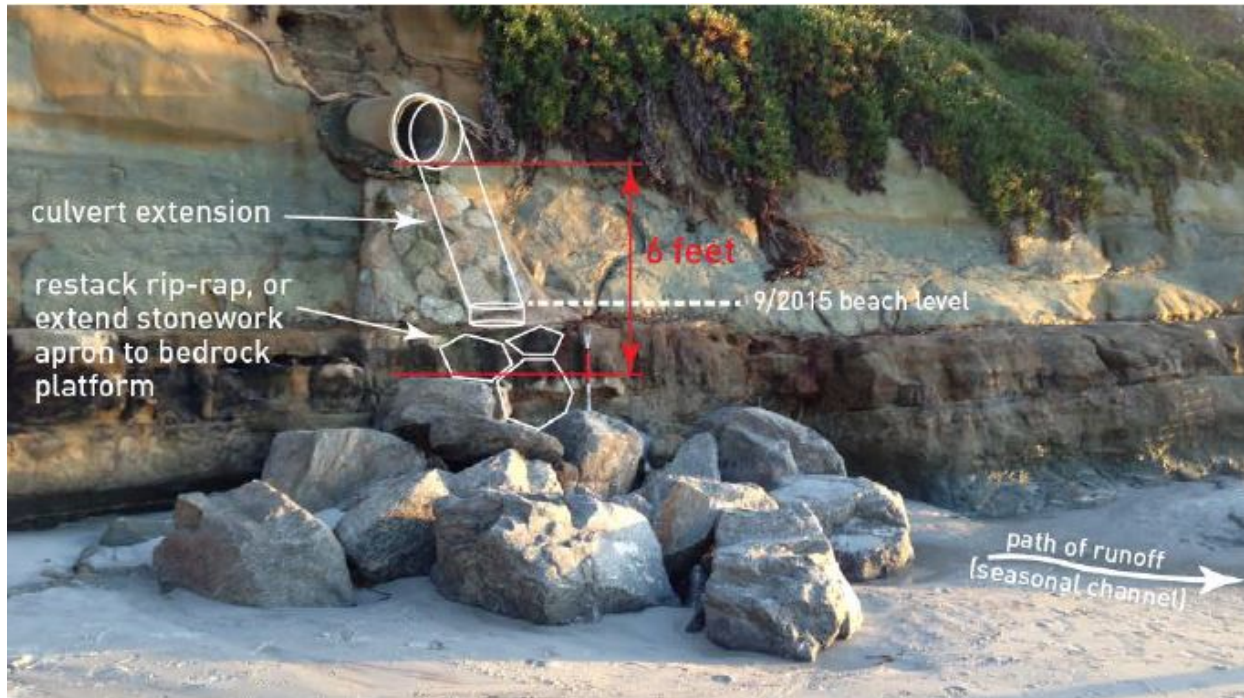
**Photograph 45: Seawall S5 Just North from ST4 in February 2016 (Easton Geology)  
Easton Geology's Recommendations Are Shown on the Photo**

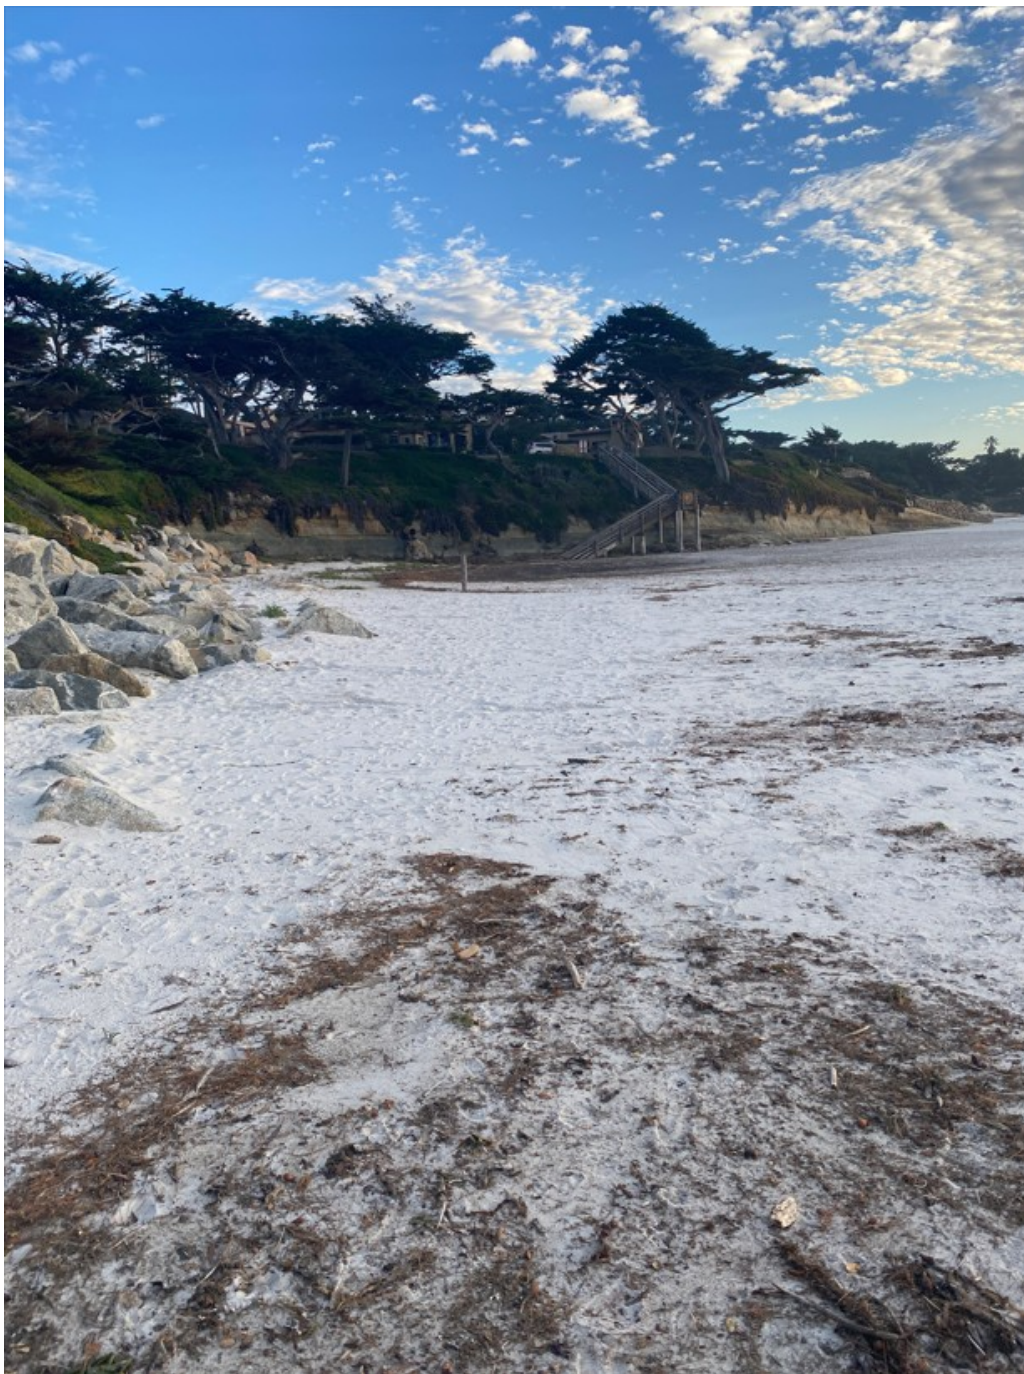
**Photograph 46: Looking South along Revetment R3 towards ST4 on December 22, 2022**

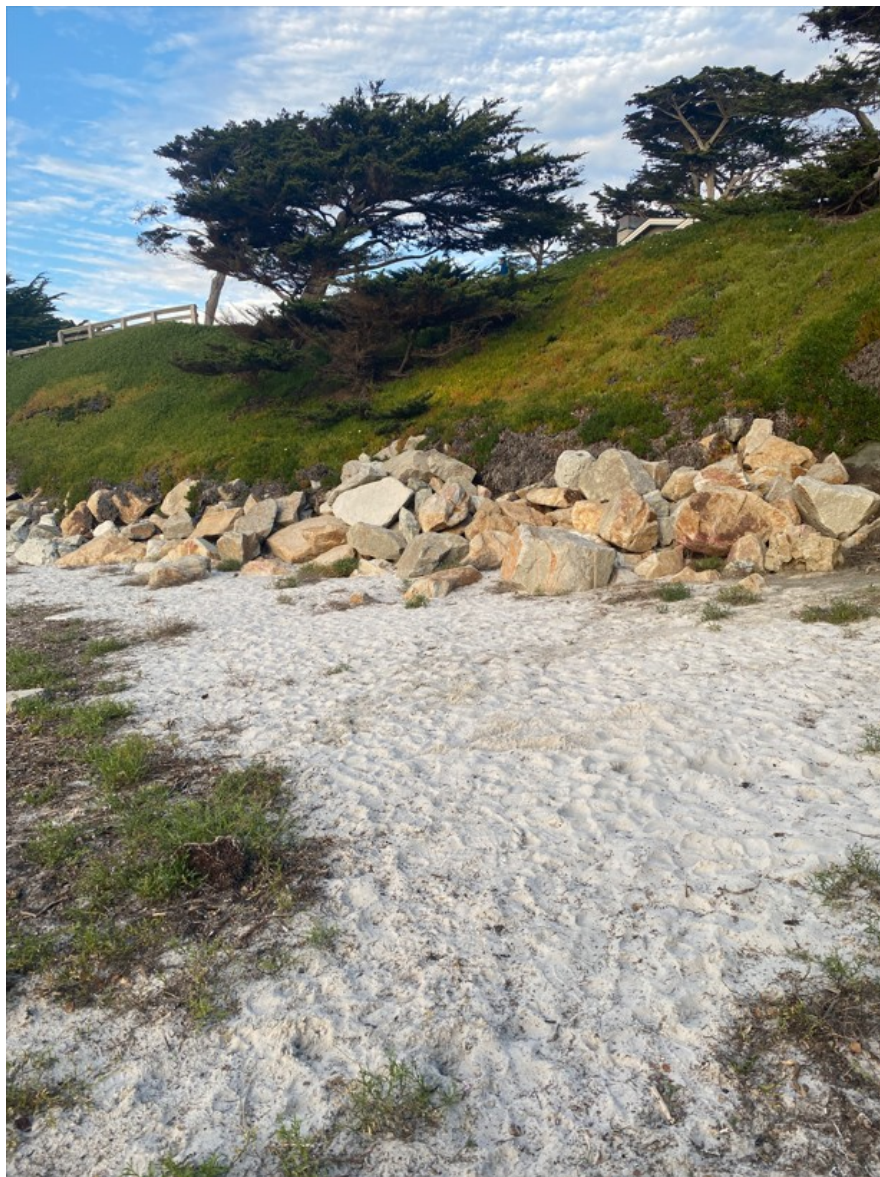
**Photograph 47: Revetment R3 Showing Scattered Rip-rap Boulders on December 22, 2022**

Photograph 47 shows Revetment R3 with scattered rip-rap boulders on December 22, 2022. We recommend that Revetment R3 be restacked to increase coastal protection and reduce the revetment footprint.

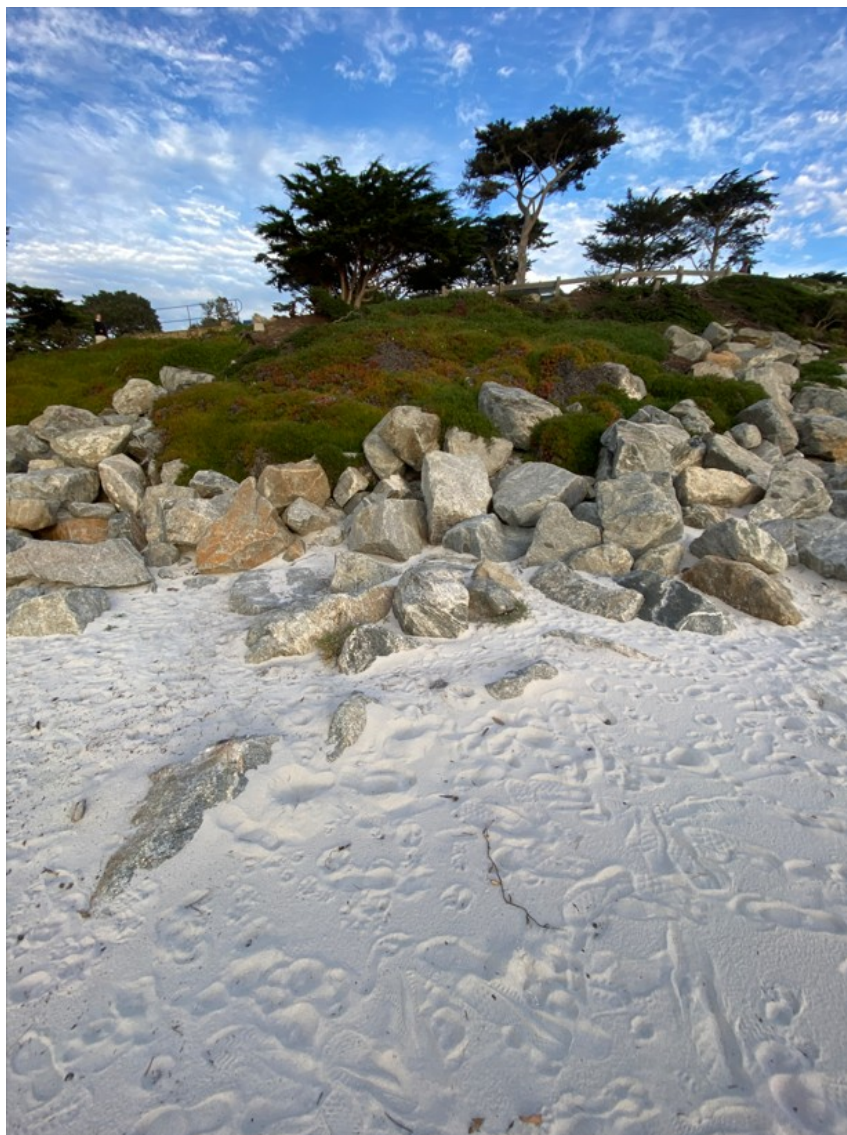
**Photograph 48: Revetment R3 Showing Area of Rip-rap on December 22, 2022  
Where the Public Could Benefit from Quarystone Re-stacking**

The southern 1/4 of the Revetment R3 riprap unstable, poses risks to beach users, and we recommend it as a high priority for repair. The over-steepened portion of R3 should be re-stacked to a lower gradient to increase its stability and provide better coastal protection.

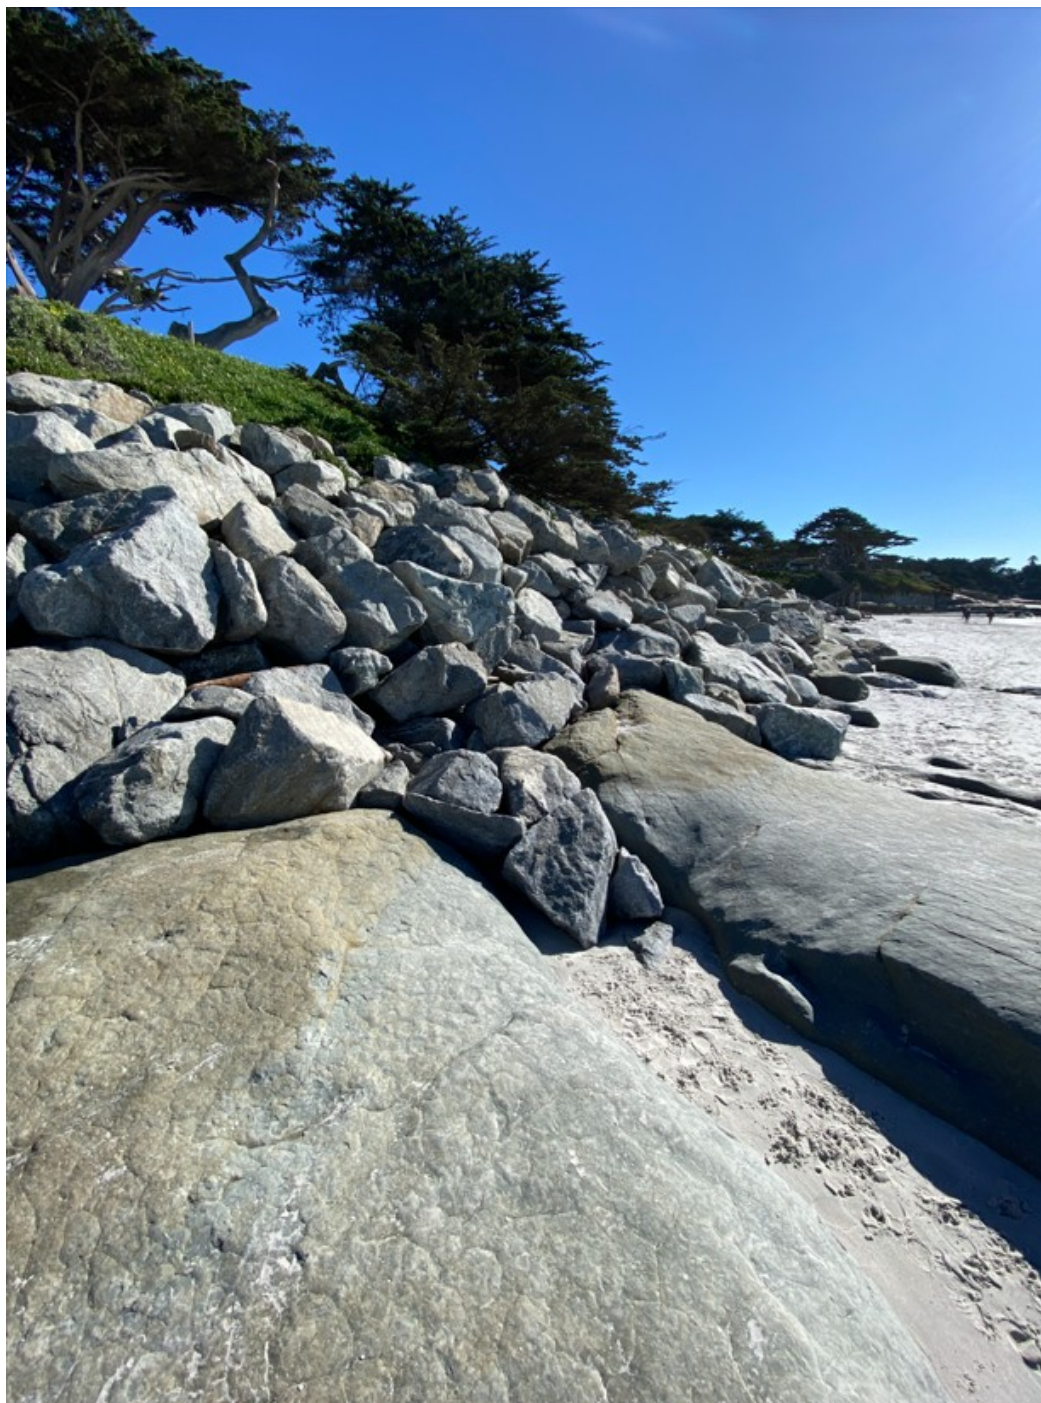
**Photograph 53: Profile View of Revetment R3 on January 30, 2023**

Photograph 53 is a profile view of Revetment R3. It was constructed following the severe 1983 storms with the toe of riprap revetment structure properly keyed into the bedrock platform, and still is performing well.

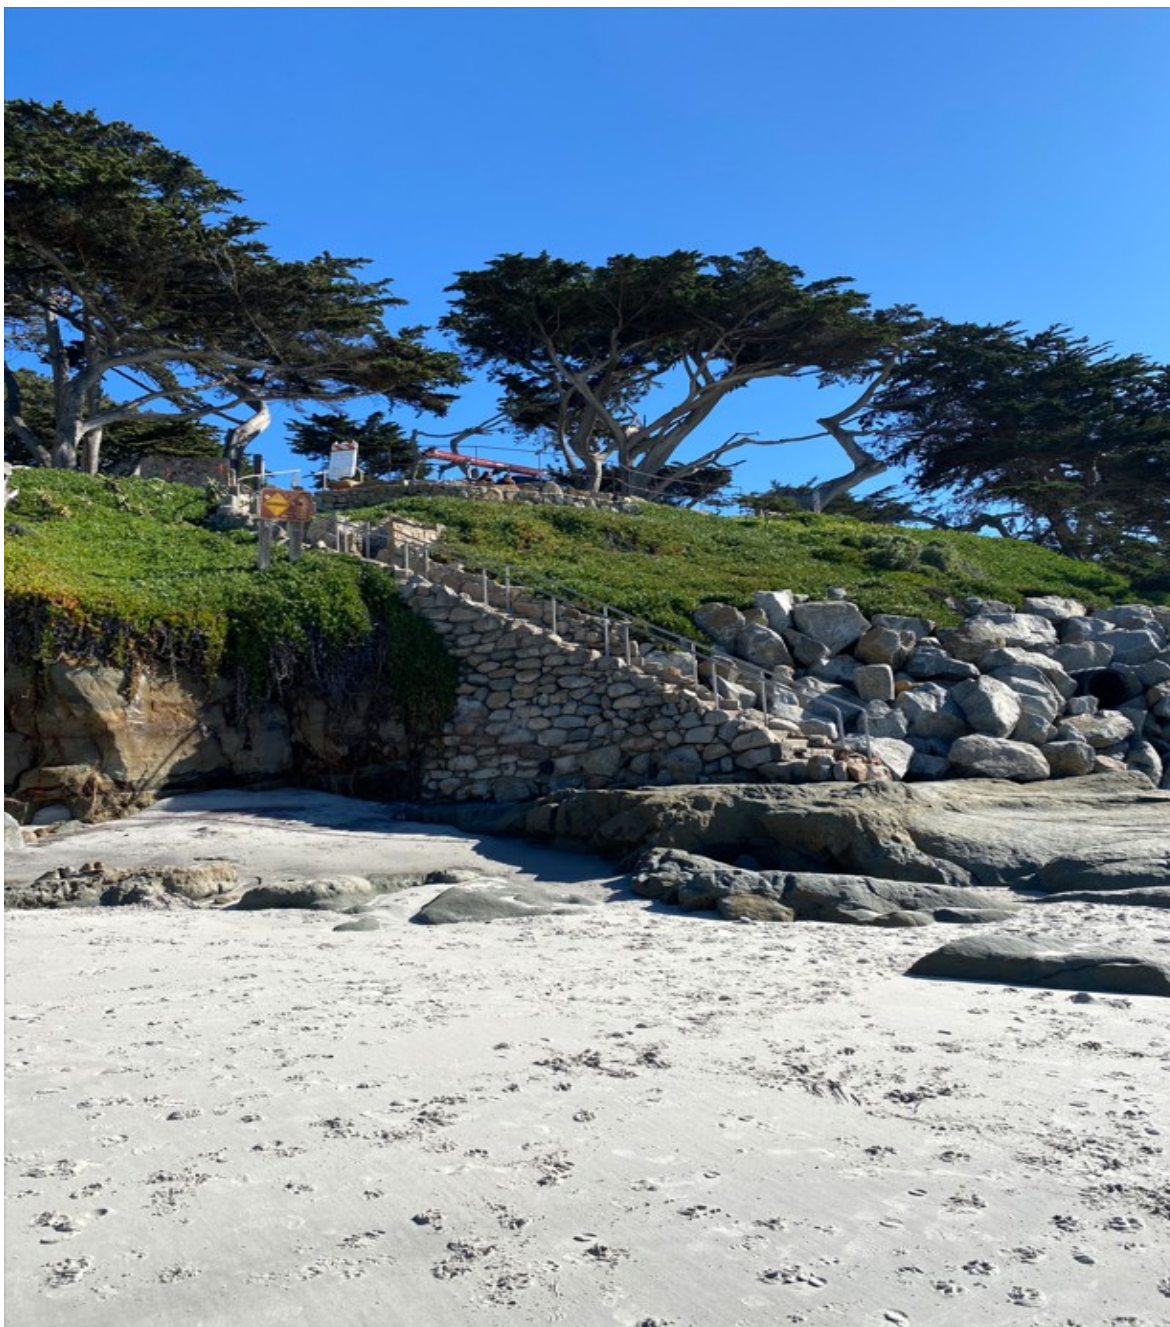
**Photograph 56: Showing Stairway ST5 on January 30, 2023**

Stairway ST5 is located at 11th Avenue and terminates on a bedrock platform, which is exposed when natural beach scour has lowered the beach elevation.

Stairway ST5 repairs are needed due to corrosion of the concrete reinforcing, concrete spalling, and worn irregular concrete tread surfaces. We rank the concrete repair as a medium priority to abate slip and fall hazards. There is risk to users of the stairs because they do not extend to beach level during sand scour events. Extension of the stairs appears to be prudent. We rank extension of the stairs to beach level as a low priority if they are securely closed off at both the top and bottom during times when beach sand
