Date: 27 April 2023  
Client: City of Carmel  
Subject: Carmel Beach Coastal Protection Assessment  
Reference: Carmel Beach Adaptation Plan  
Project No.: 12176

## **CARMEL BEACH COASTAL PROTECTION ASSESSMENT REPORT**

Coastal Protection Evaluation 22 December 2022 thru 30 January 2023

Carmel Adaptation Plan - Carmel Beach All Areas

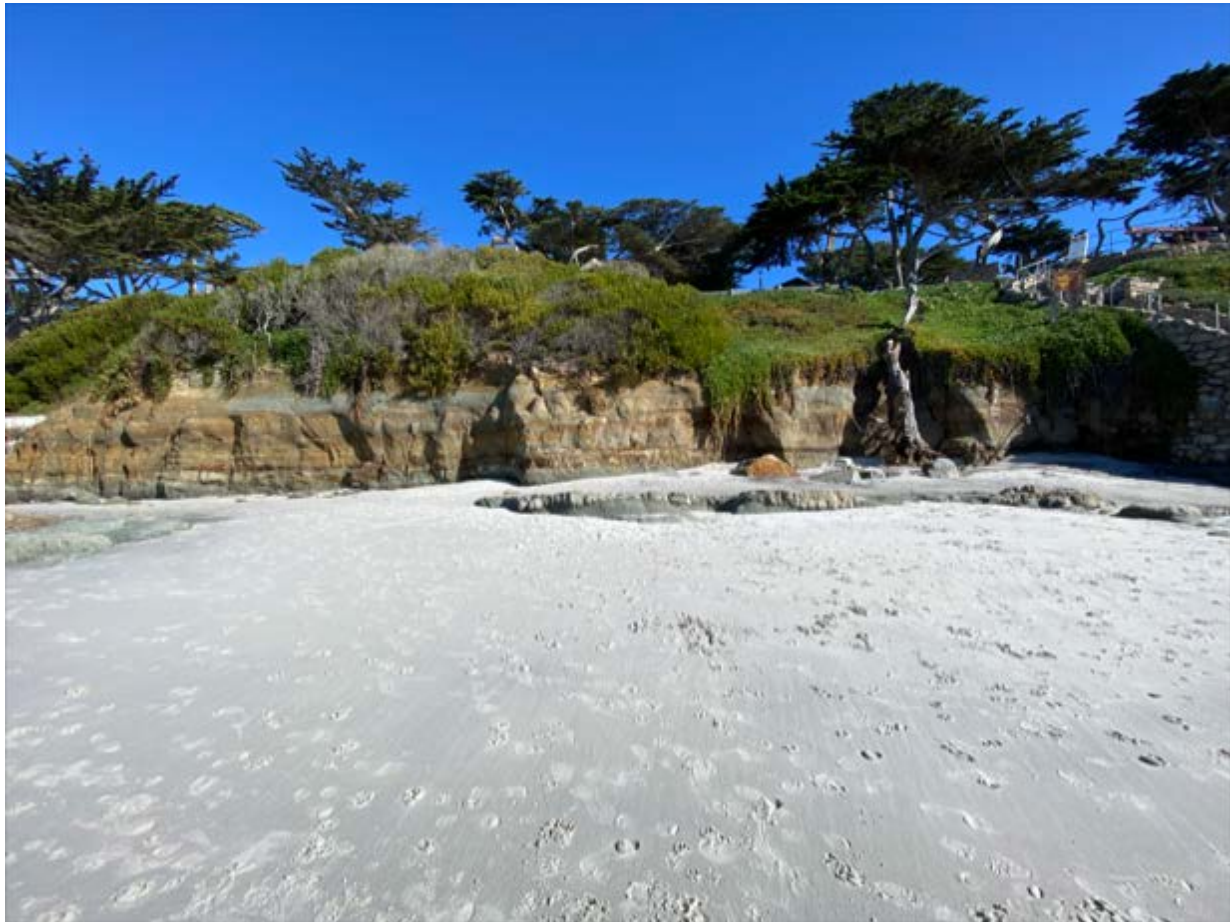
**Photograph 59: Showing Bluff South of Retention R4 on January 30, 2023**

At the time of our inspection along the bluff face between Stairway ST5 and Retention R4, a sandstone bedrock platform was discontinuously exposed, with very few fugitive riprap boulders exposed along the toe of the bluff at beach level. The bedrock exposed in the vertical lower bluff face appears to be erosion resistant and in good shape. No maintenance or armoring is necessary now. However, a future bluff face seawall with artificial rock fascia may be needed in the future to retard long-term erosion.

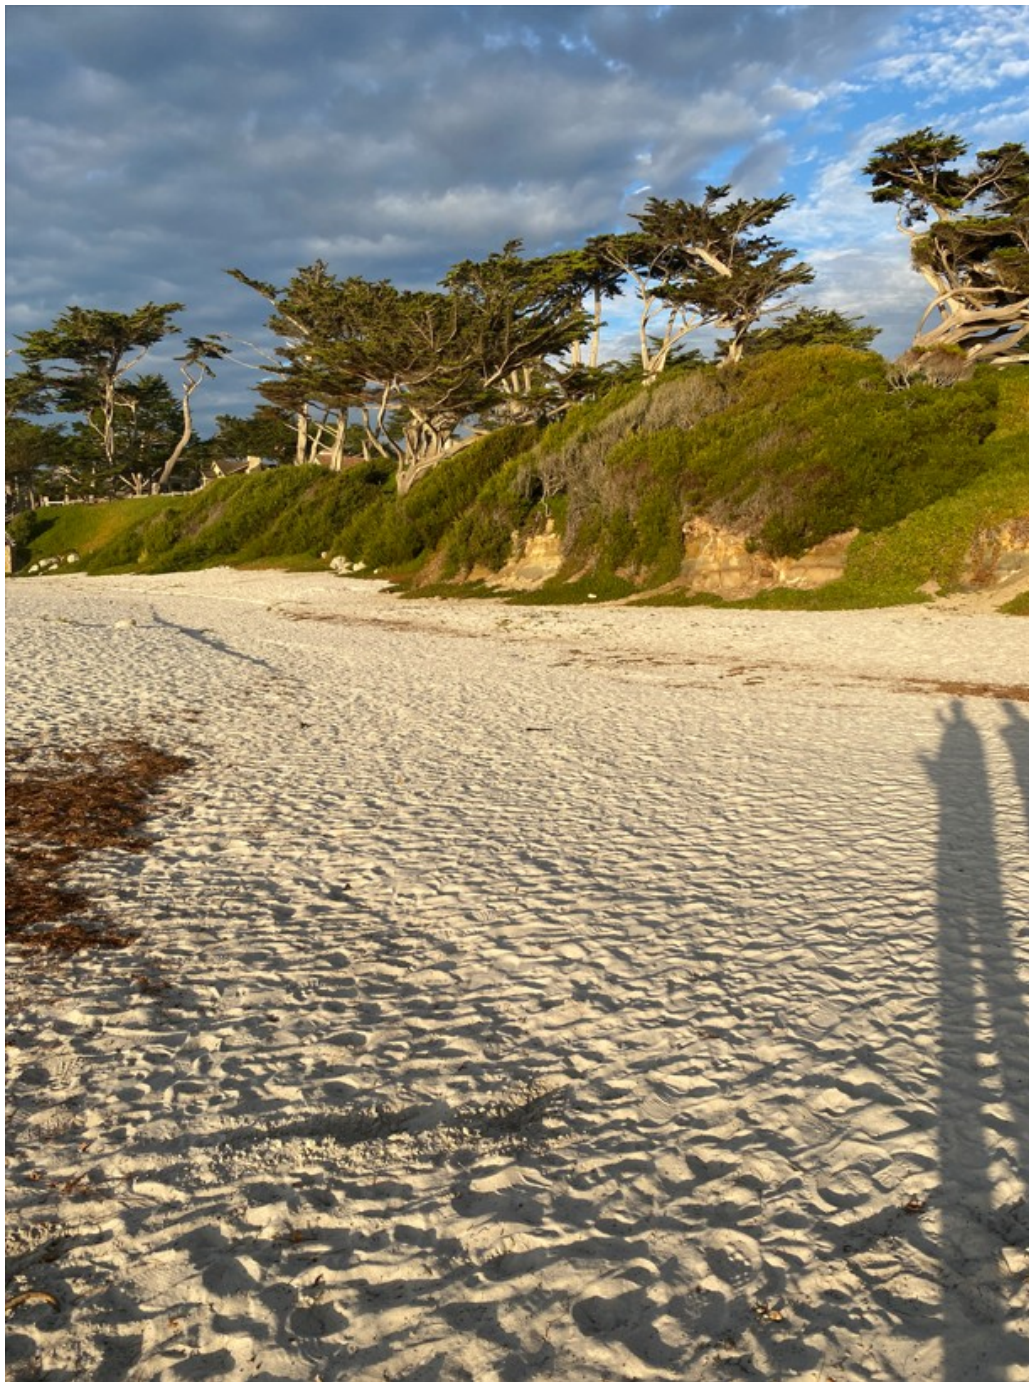
**Photograph 60: Showing Very Few Boulders Exposed in Revetment R4 Area on December 22, 2022**

Revetment R4 is located between 9th Avenue and 10th Avenue and was mapped by Integral Consulting extending from Stairway 5 and Stairway 6.

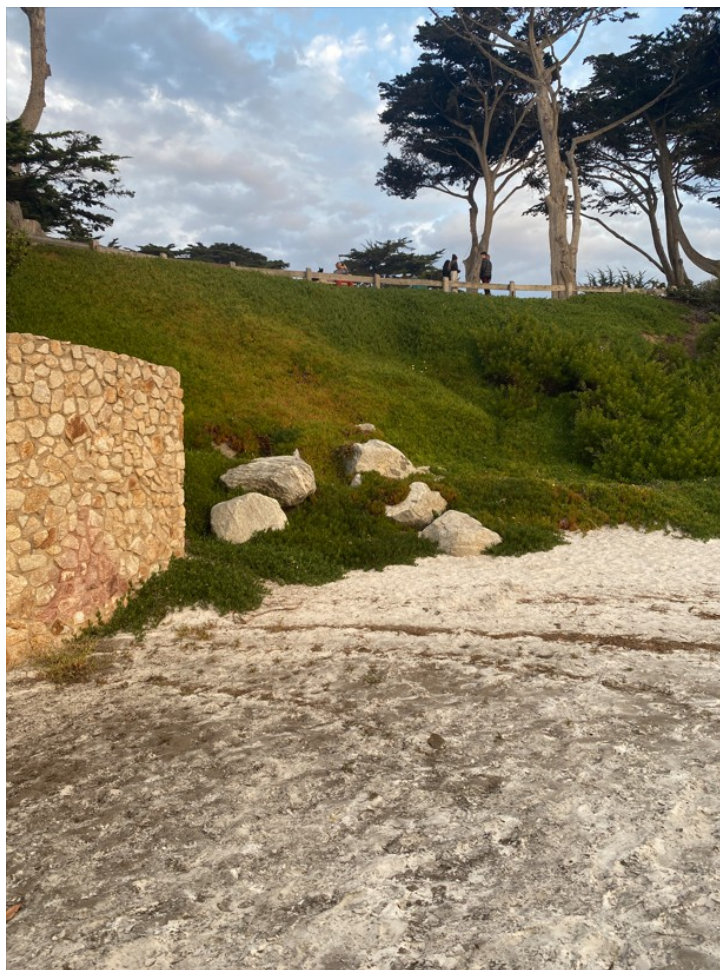
**Photograph 63: Showing Few Boulders Exposed at the North End of Revetment R4  
On December 22, 2022**

Photographs 61, 62 and 63 show Revetment R4, which is comprised of mostly undersized rock and broken concrete debris. The exposed portion of R4 where we observed substantially undersized scattered rock is approximately 225 feet in length and 8 to 10 feet tall. This structure has been undermined and has collapsed. Undersized riprap has been tumbling around in the wave action and is abrading the bedrock platform seaward of the riprap revetment structure toe. Future wave action could cause the steep slope below the path to slump, undermining the large cypress trees and public pathway along Scenic Road. A vertical concrete seawall at the toe of the bluff would be a preferred alternative here, as opposed to the riprap revetment structure, which requires more maintenance, and takes up a larger footprint.

Recommended maintenance and repair is to clean up the undersized riprap and replace it with a properly engineered, riprap revetment structure, founded into the bedrock platform. Alternately, this revetment could be removed, uncovering beach area, and a vertical seawall could be constructed at the toe of the bluff to prevent Scenic Road from being undermined.

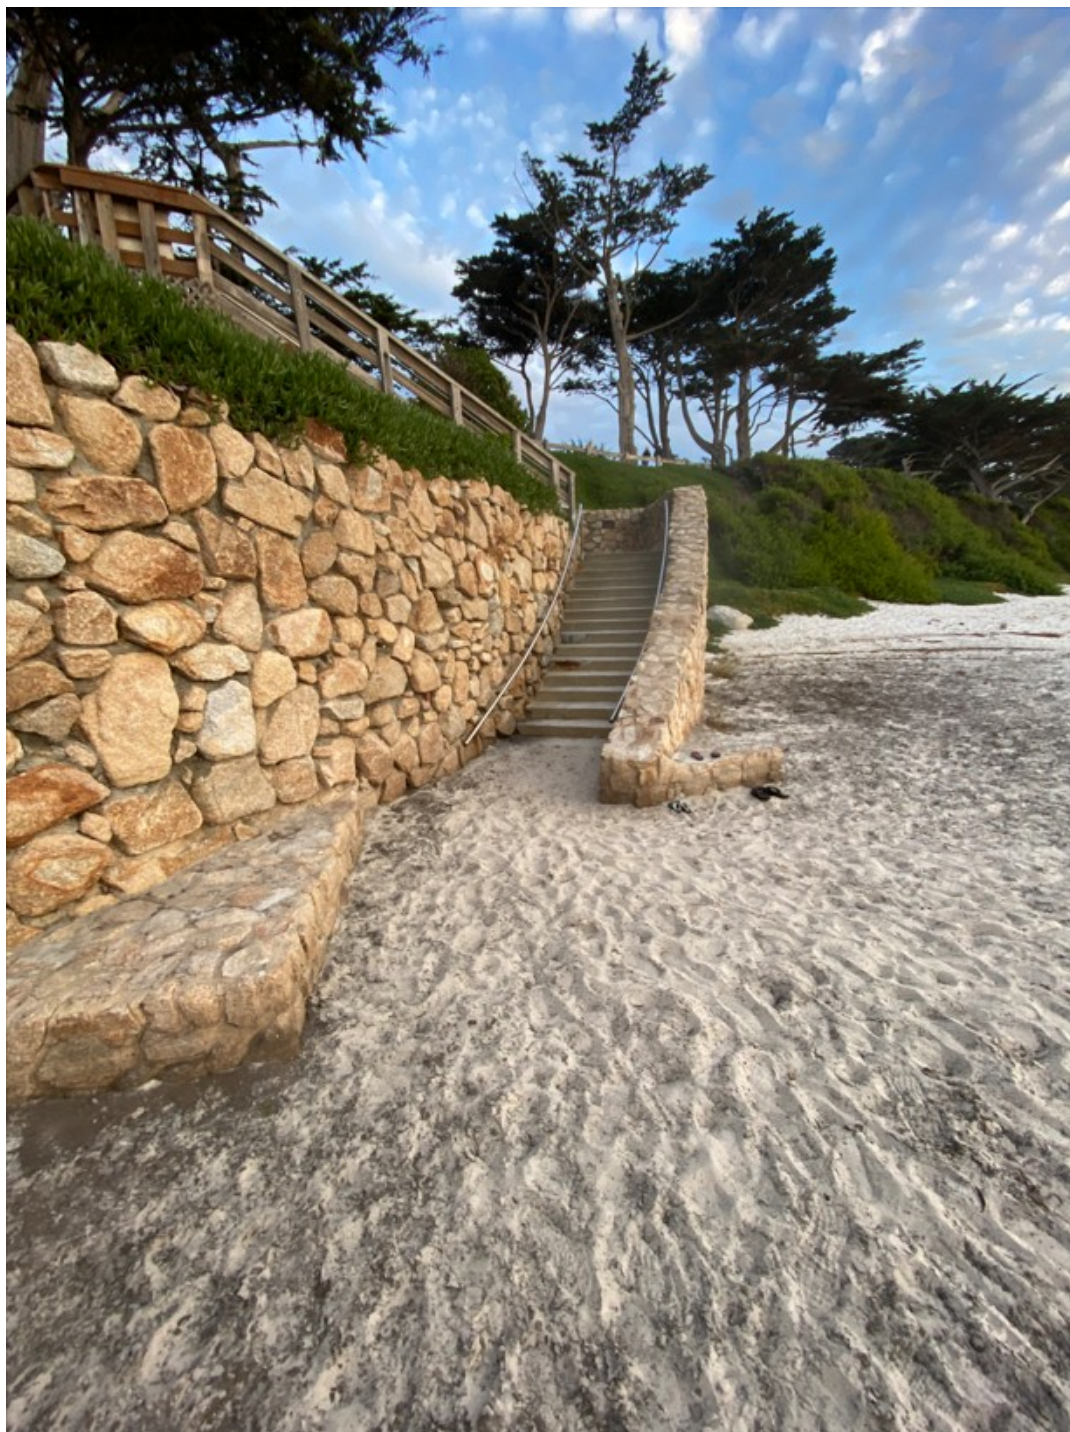
**Photograph 64: Showing Stairway ST6 on December 22, 2022**

Photograph 64 shows Stairway ST6 is located south of 10th Avenue. The base of the stairs was buried in beach sand.

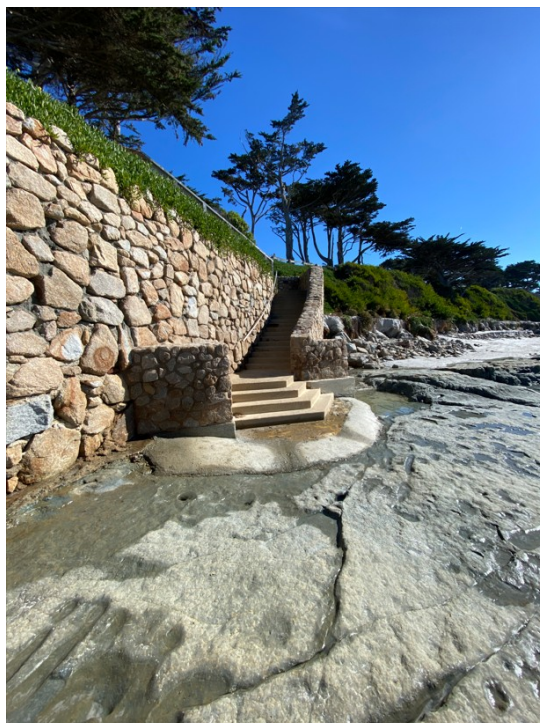
Photographs 65, 66 and 67 show Stairway ST6, which is a combination reinforced concrete (lower portion) to wooden (upper portion) public beach access staircase. The base of the staircase is founded on the sandstone bedrock platform below the beach sand. Several stair treads have spalled concrete areas, exposing highly corroded rebar, which is expanding, resulting in internal pressures within the concrete, which causes the stair treads to spall. This spalling creates a hazardous condition, and we recommend it be repaired and maintained to a safe standard for public use, using corrosion resistant reinforcing bar such as ChromX 4100 or 9100. Stairway ST5 repairs are needed due to corrosion of the concrete reinforcing, concrete spalling, and worn irregular concrete tread surfaces. We rank the concrete repair as a medium priority to abate slip and fall hazards.

**Photograph 66: Stairway ST6 Well Founded in Bedrock on January 30, 2023**

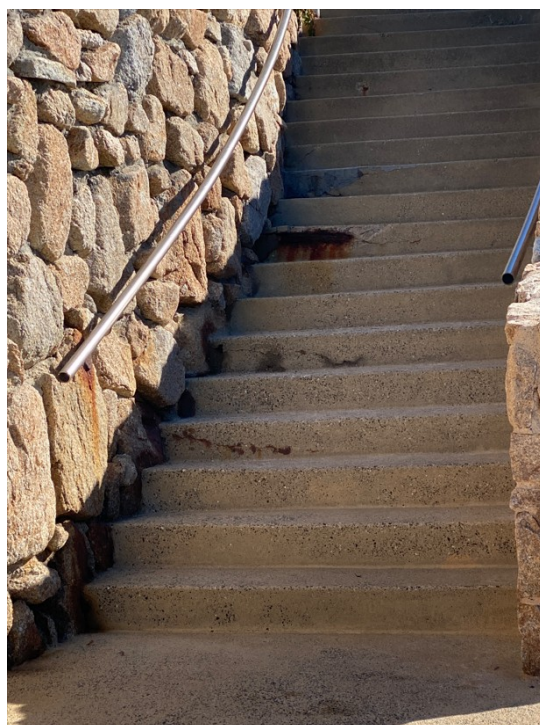
**Photograph 67: Stairway ST6 with Tread Deterioration on January 30, 2023**

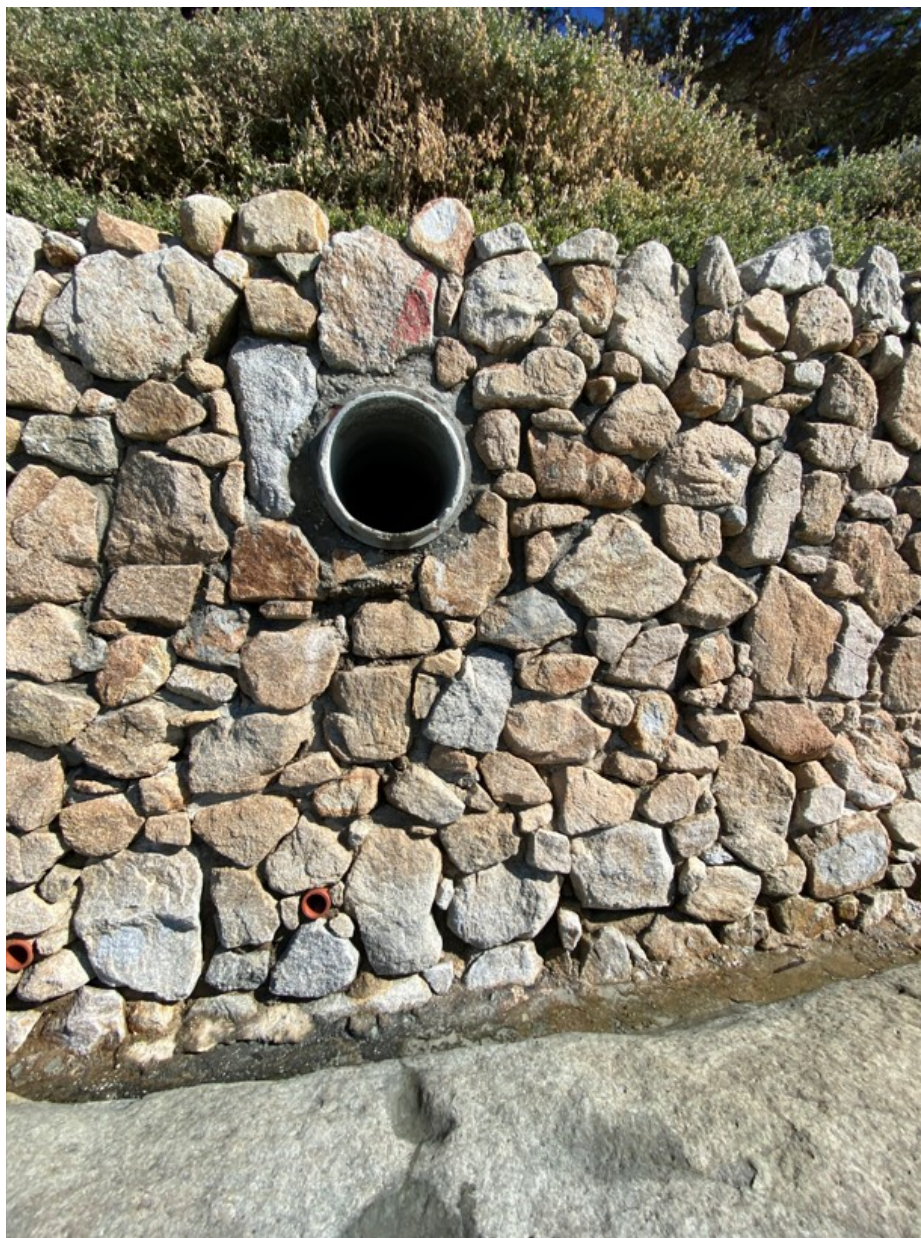
**Photograph 69: Storm Drain Outfall near South End of Seawall S7 on January 30, 2023**

Photograph 69 shows the south end of Seawall S7 where a 24-inch diameter concrete storm drain culvert outfall is in good condition. No maintenance is recommended here.

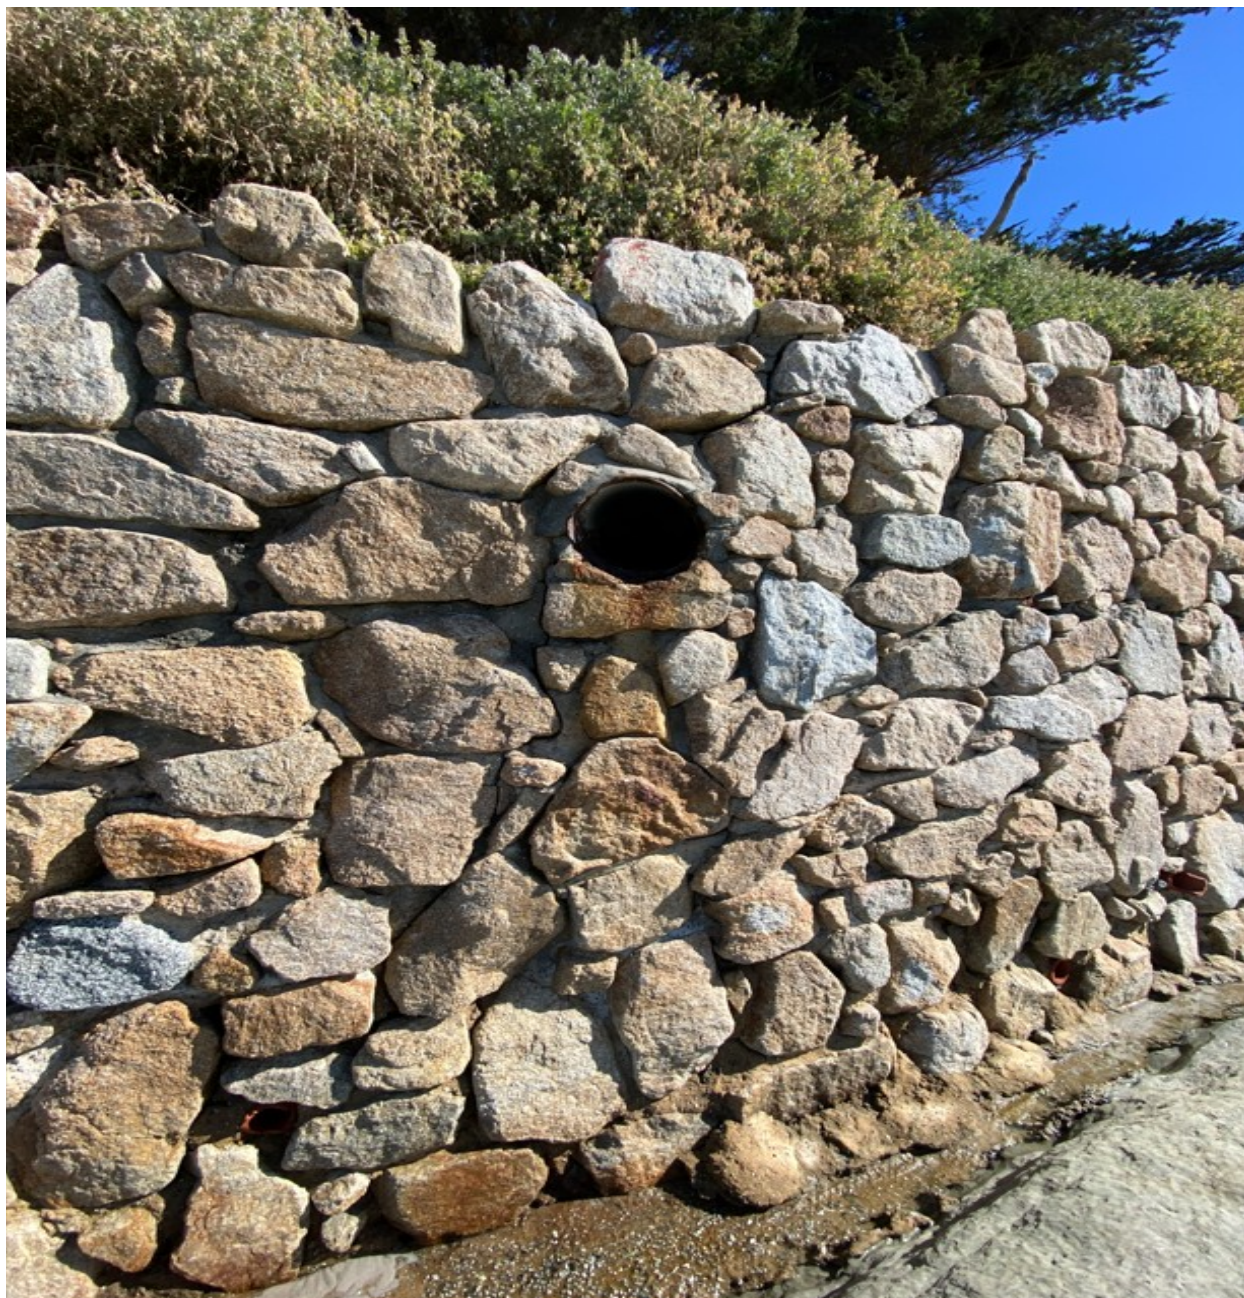
**Photograph 72: Storm Drain in Seawall S7 on January 30, 2023**

Photograph 72 shows a storm drain culvert projecting out of the top portion of S7. This culvert is composed of highly corroded corrugated metal pipe that is 16 inches in diameter and appears to be collapsed about 3 feet landward of the wall. We observed large cracks in the seawall just below the culvert outfall. We recommend replacing this corrugated metal culvert with watertight HDPE N-12 storm drainpipe. We classified this as a medium priority. Except for this area of recommended repair, Seawall S7 has 30 years of remaining life.

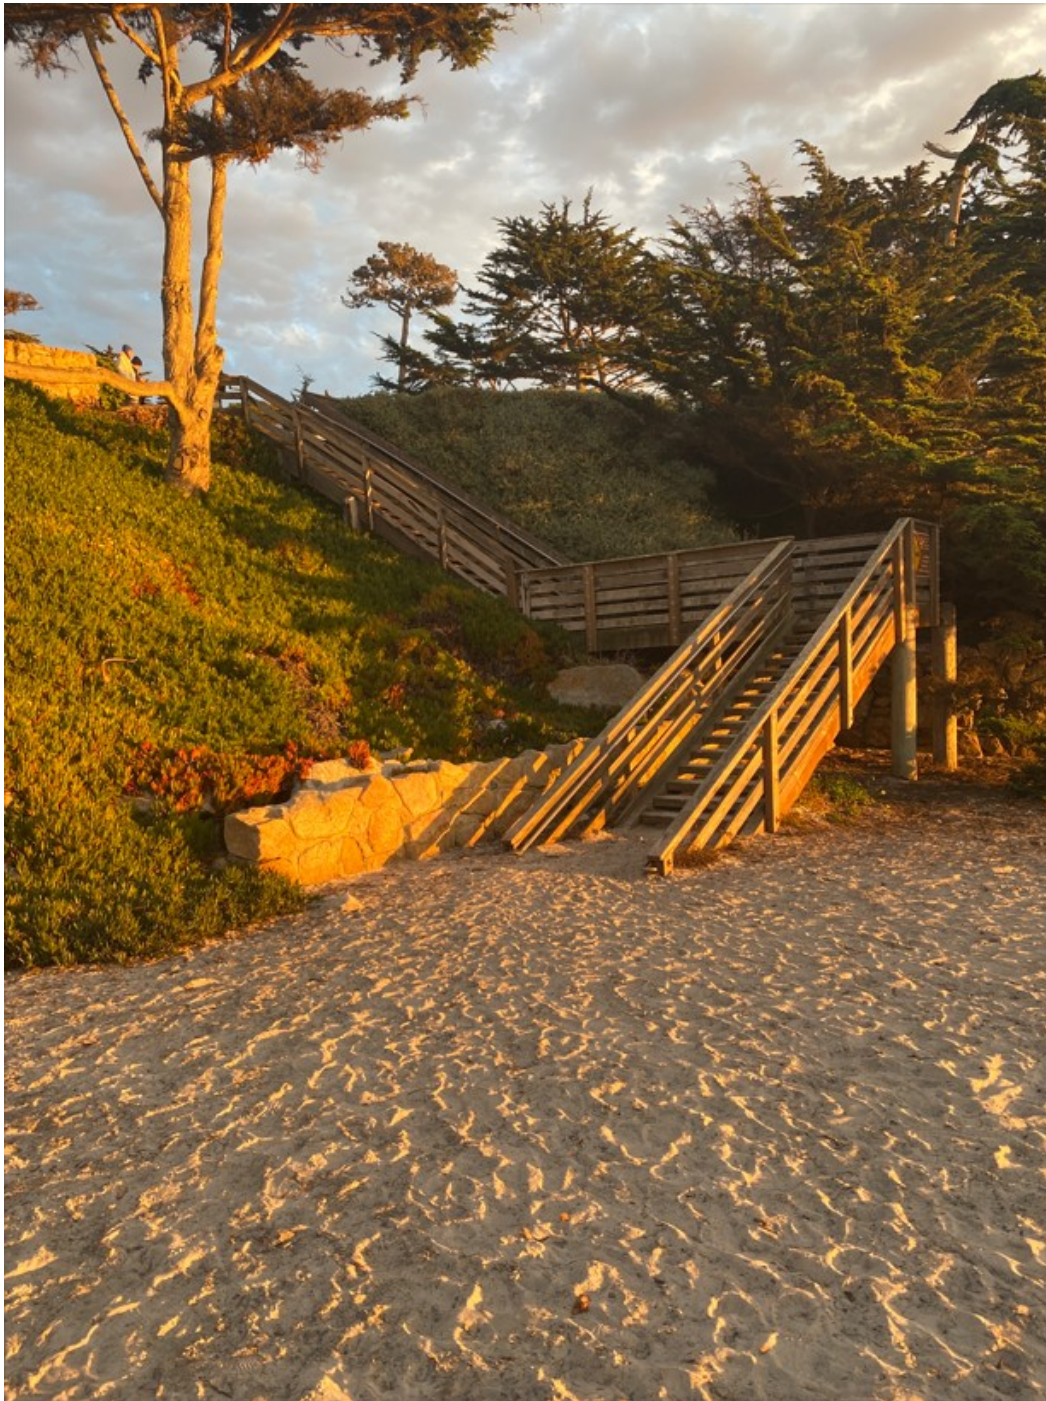
**Photograph 72: Stairway ST7 on December 22,2022**

Photograph 72 shows Stairway ST7, which is located north of 10th Avenue.

Photographs 72 and 73 show Stairway ST7 at different beach scour conditions. Photo 73 shows the lower end of the stairs ending in mid-air at the time of our January inspection. Stairway ST7 repairs are needed due to corrosion of fasteners and hardware, and the vertical drop off and lack of foundation support at the base of the stairs during times of low beach surface elevations from scour. We rank the repair as a high priority and recommend prompt structural and corrosion inspection. There is a high risk to users of the stairs.

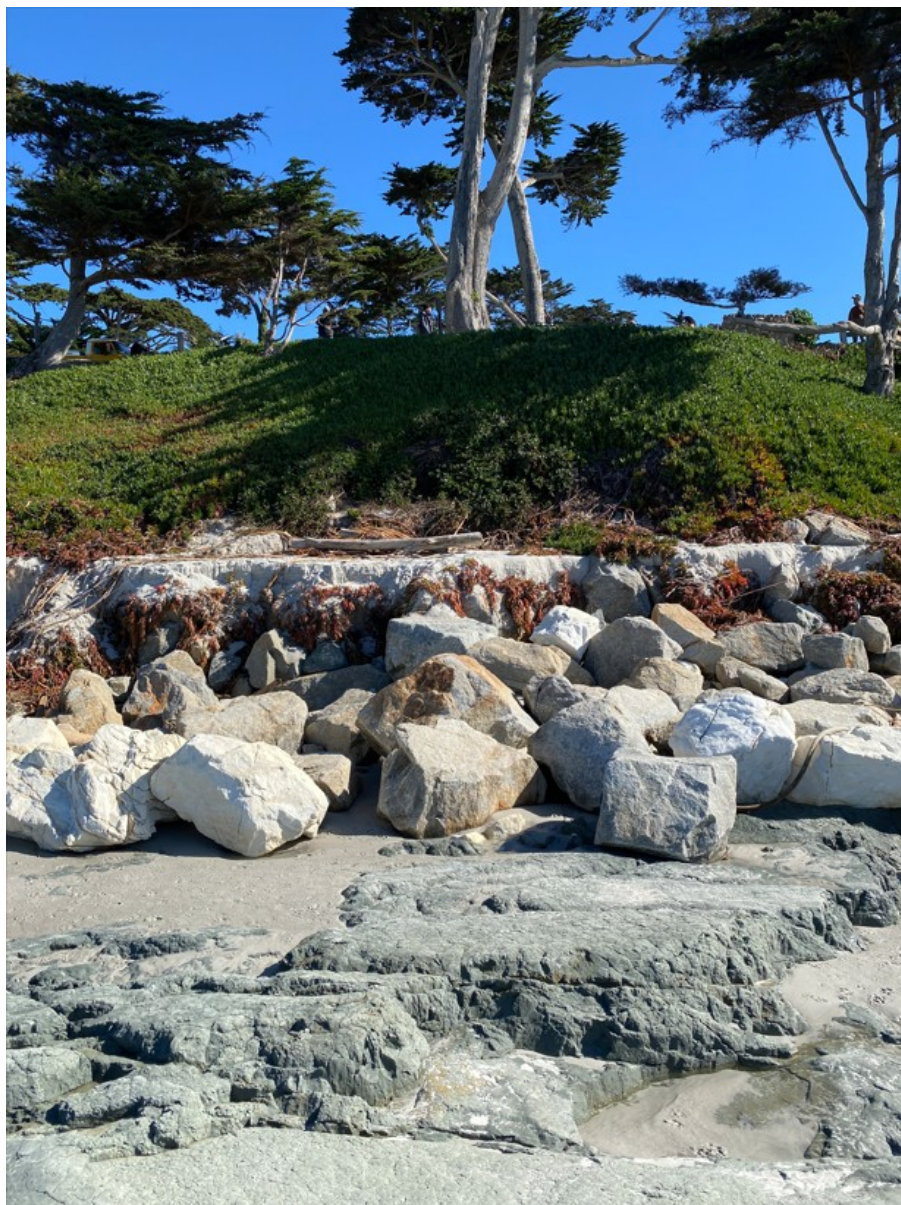
**Photograph 75: South Portion of Revetment R5 on January 30, 2023 Showing Bedrock Platform Below Beach Sand and Old Erosional Scarp in Ice Plant Above Revetment**

Photograph 75 shows the southern end of Revetment R5, which is located between 8th Avenue and 10th Avenue, and was possibly initially founded on beach sand in an emergency effort to buttress the bluff failure above it. The wave action then likely scoured away the beach sand, and undermined the emergency revetment, causing it to collapse, and spread boulders out onto the beach.

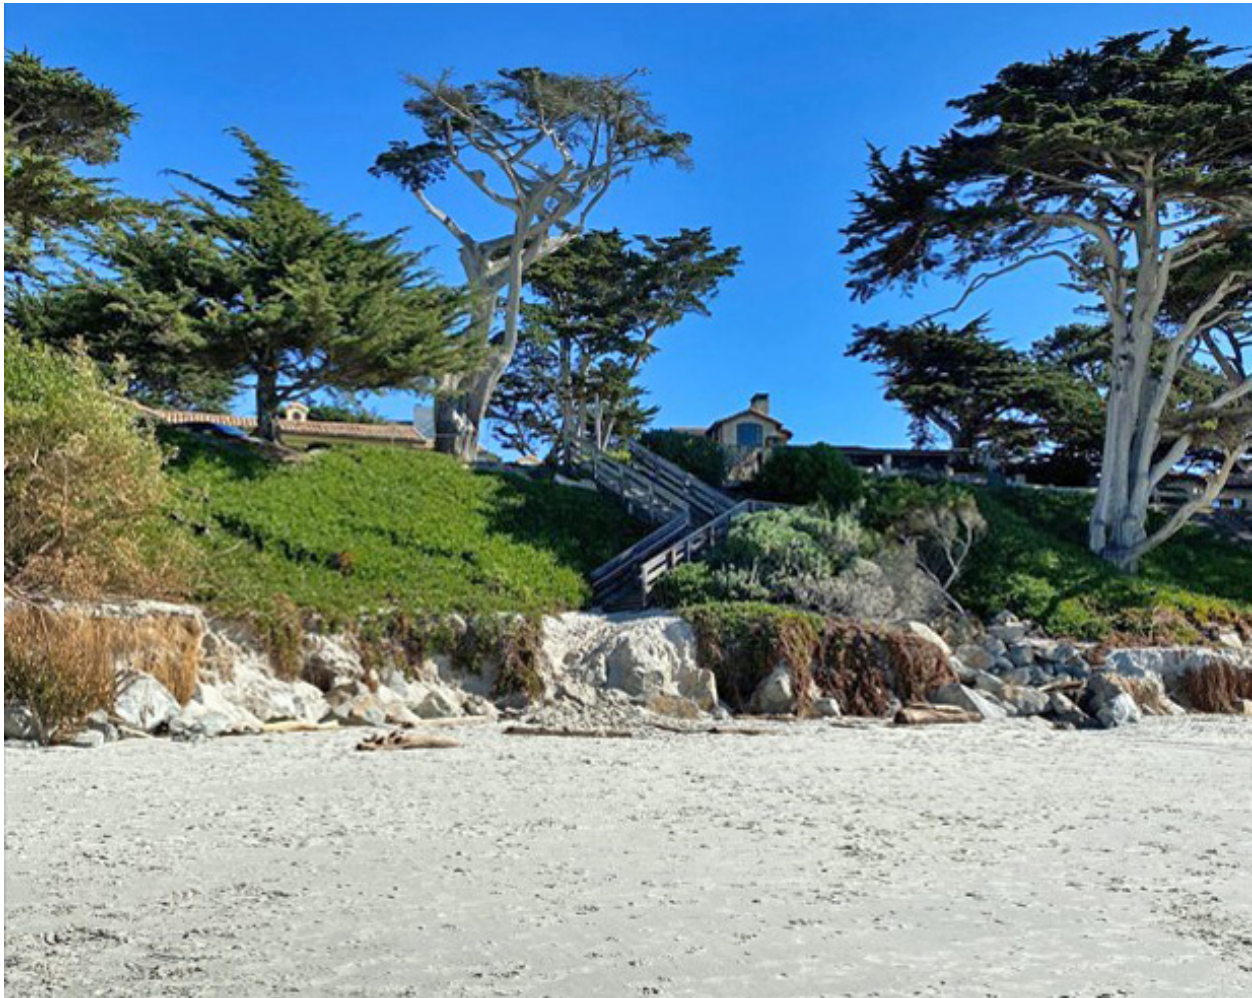
**Photograph 79: Showing Beach Access Stairway ST8 on January 30, 2023**

Photograph 79 shows Beach Access Stairway ST8, which is near 9th Avenue just south of the central part of Revetment R5. It is a wooden stairway that is in good condition; however, it terminates before reaching the beach when the beach sand levels are seasonally low. We recommend that that the stairway be extended approximately 12 vertical feet down to the bedrock platform (which is presently buried by beach sand) at beach level. The existing beach access path across the R5 rip-rap below these stairs is hazardous and poses risk to stair users attempting to cross the revetment. Extension of the stairs is a high priority. This stairway does not have any other maintenance recommended at this time. Extending the stairway across the rip-rap revetment should be done carefully. A detailed design study will be necessary to properly found the stairway in and seaward of Revetment R5.

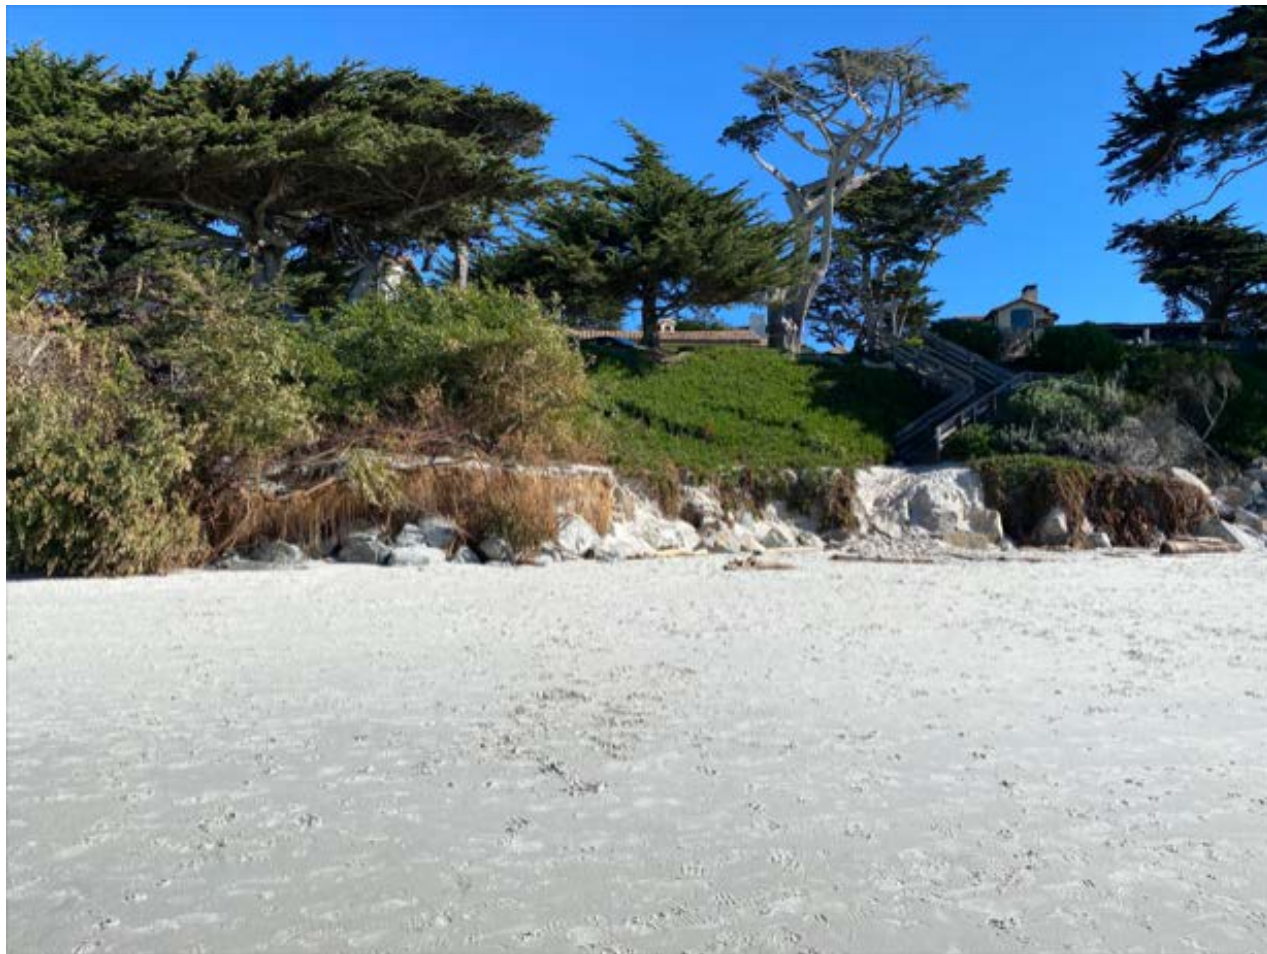
**Photograph 80: Showing South End of Central Portion of Revetment R5 on January 30, 2023**

Photograph 80 shows the south end of the central portion of Revetment R5 adjacent to Stairway ST8.

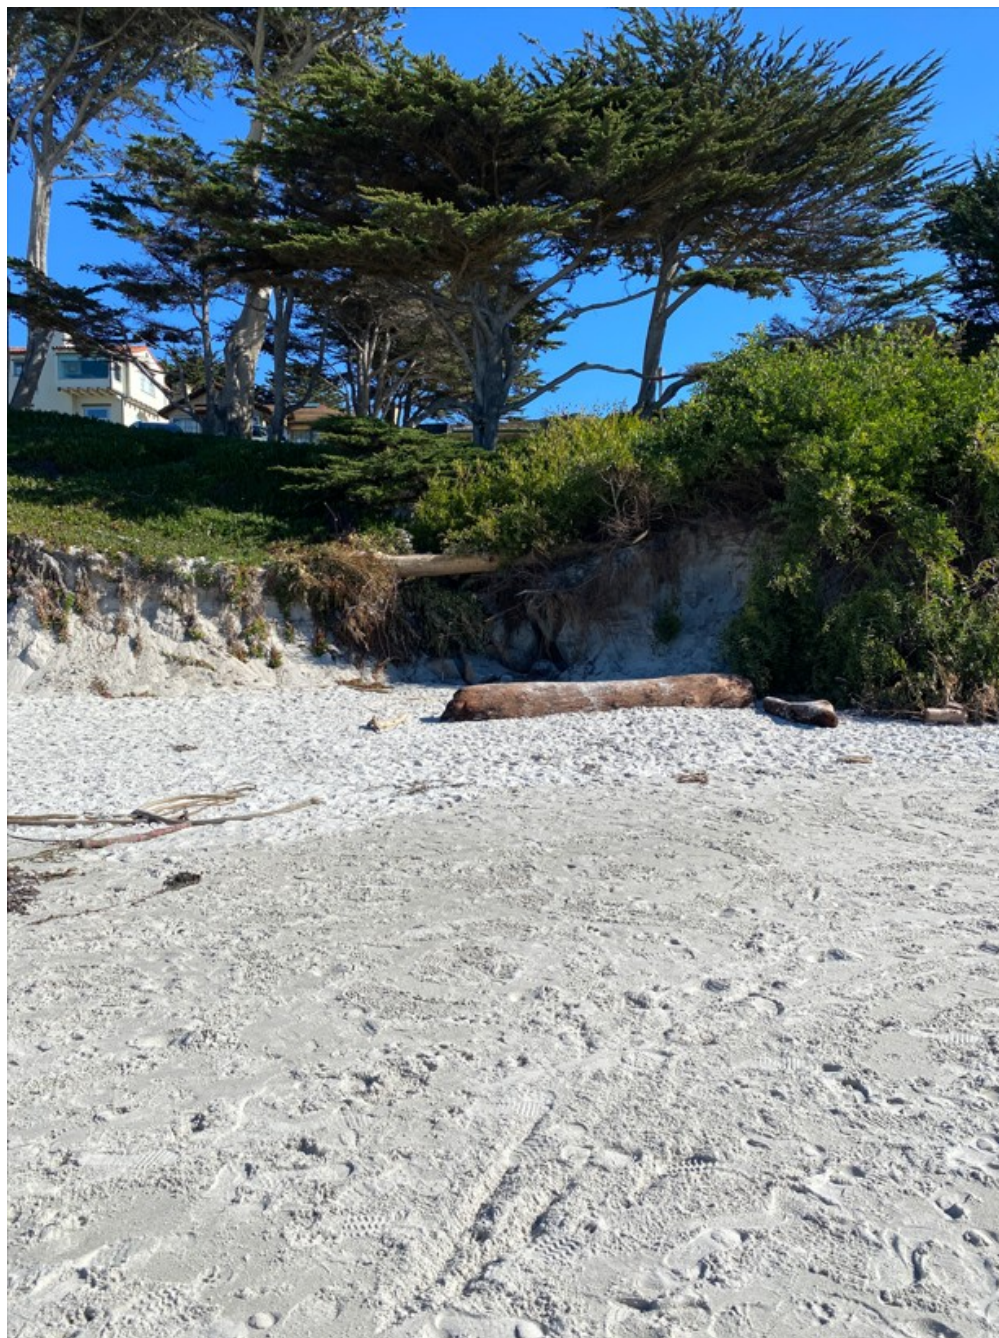
**Photograph 81: Small Amount of Revetment R5 Riprap on January 30, 2023**

As shown in Photograph 81, in the center portion of Revetment R5 we observed a small amount of visible riprap which was approximately 12 feet long and 6 feet tall. It was not possible to see enough riprap to draw meaningful conclusions regarding the extent, dimensions, condition and need for repair (if any) of this reported structure.

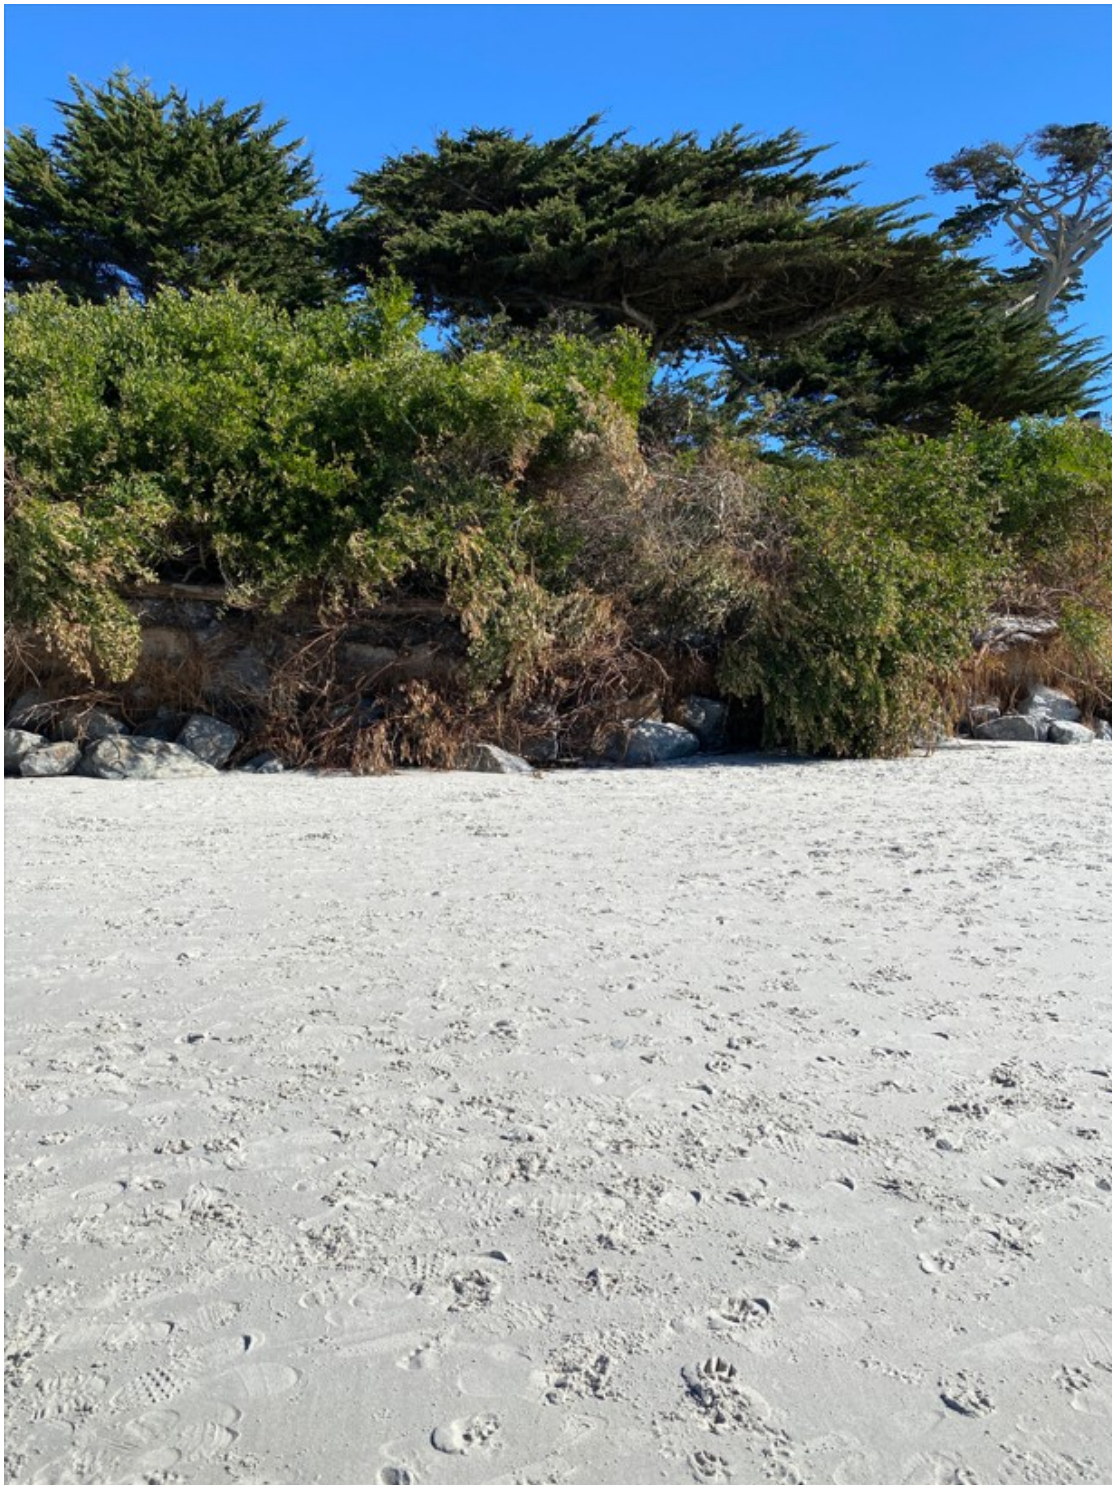
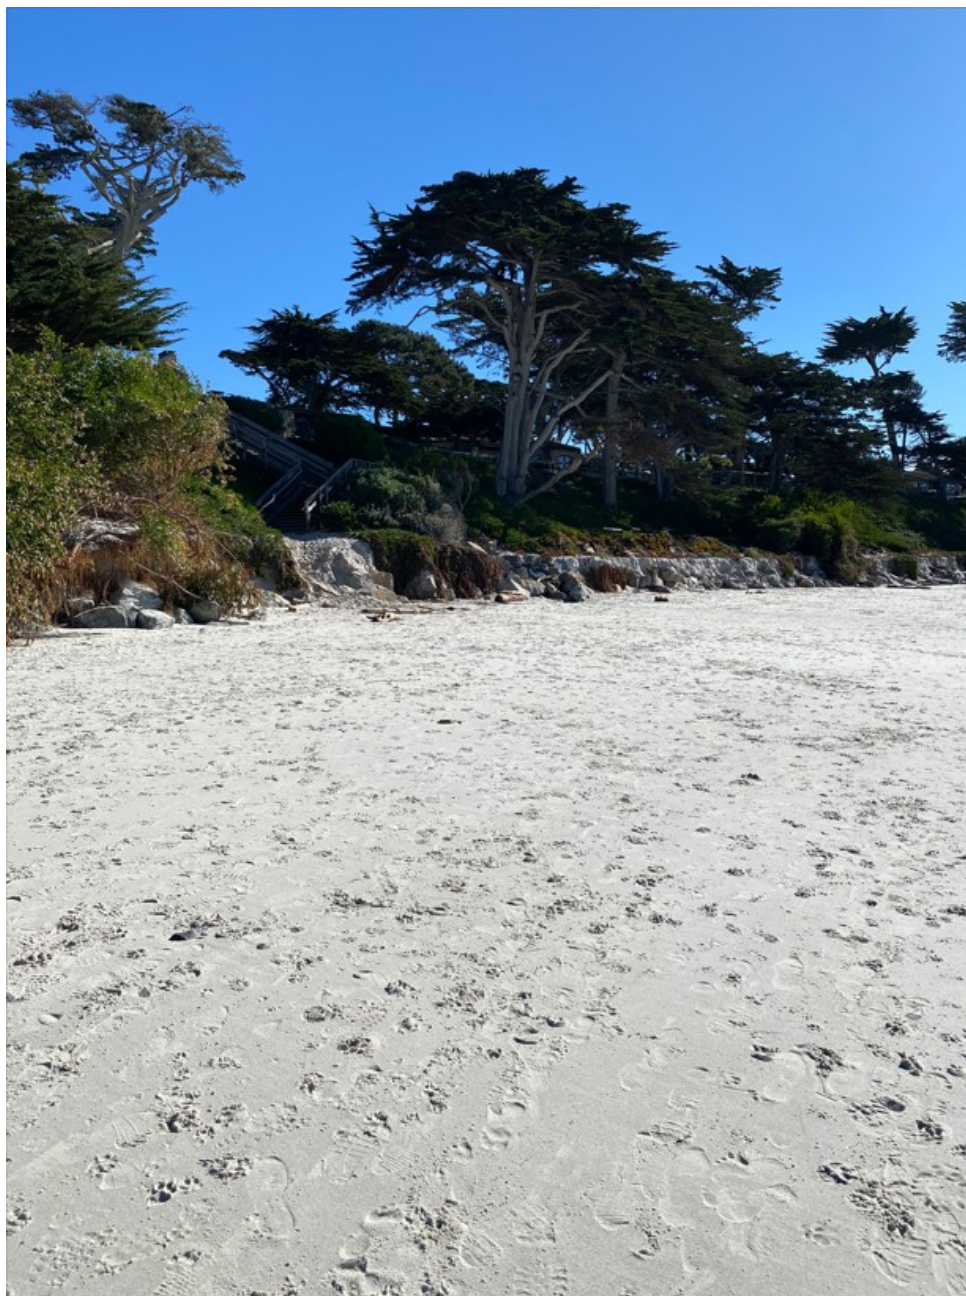
**Photograph 83: Showing Additional Revetment R5 Rip-rap on January 30, 2023**

**Photograph 84: Showing a Small Amount of Revetment R5 Riprap on January 30, 2023**

Photographs 82, 83 and 84 show the location of the center portion of Revetment R5 where we observed approximately 100 linear feet of 3- to 5-foot-high rip-rap that was exposed. It was not possible to see enough riprap to draw meaningful conclusions regarding the extent, dimensions and condition of this reported structure. We suspect most of this revetment structure is below sand level, not visible during our inspection.

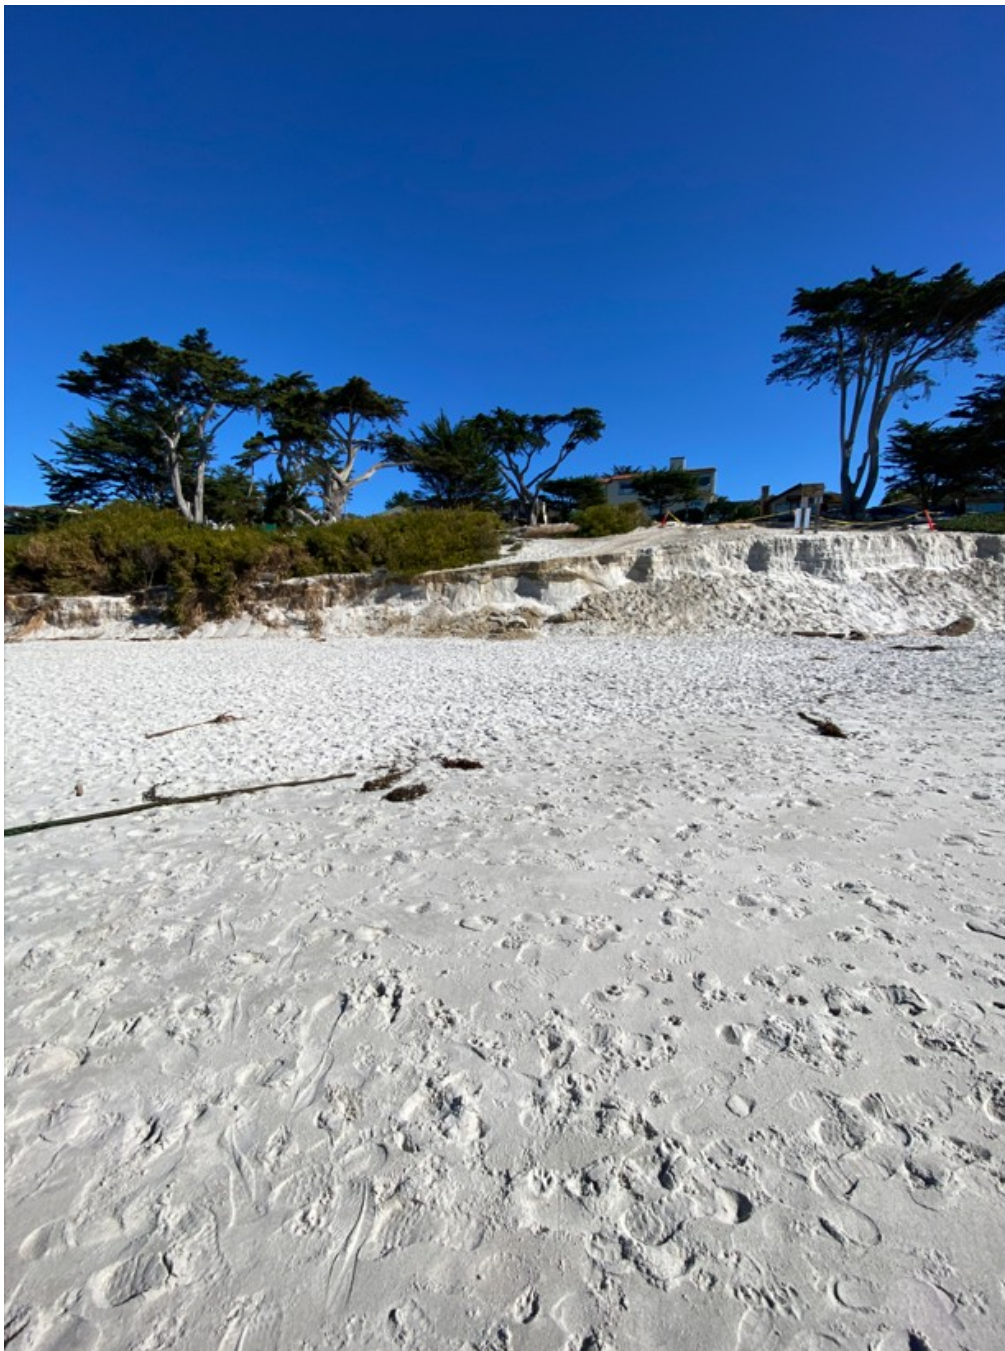
**Photograph 85: Location of North Area of Revetment R5 on January 30, 2023**

We observed the area where the north portion of Revetment R5 was mapped by Integral Consulting. No riprap was visible.

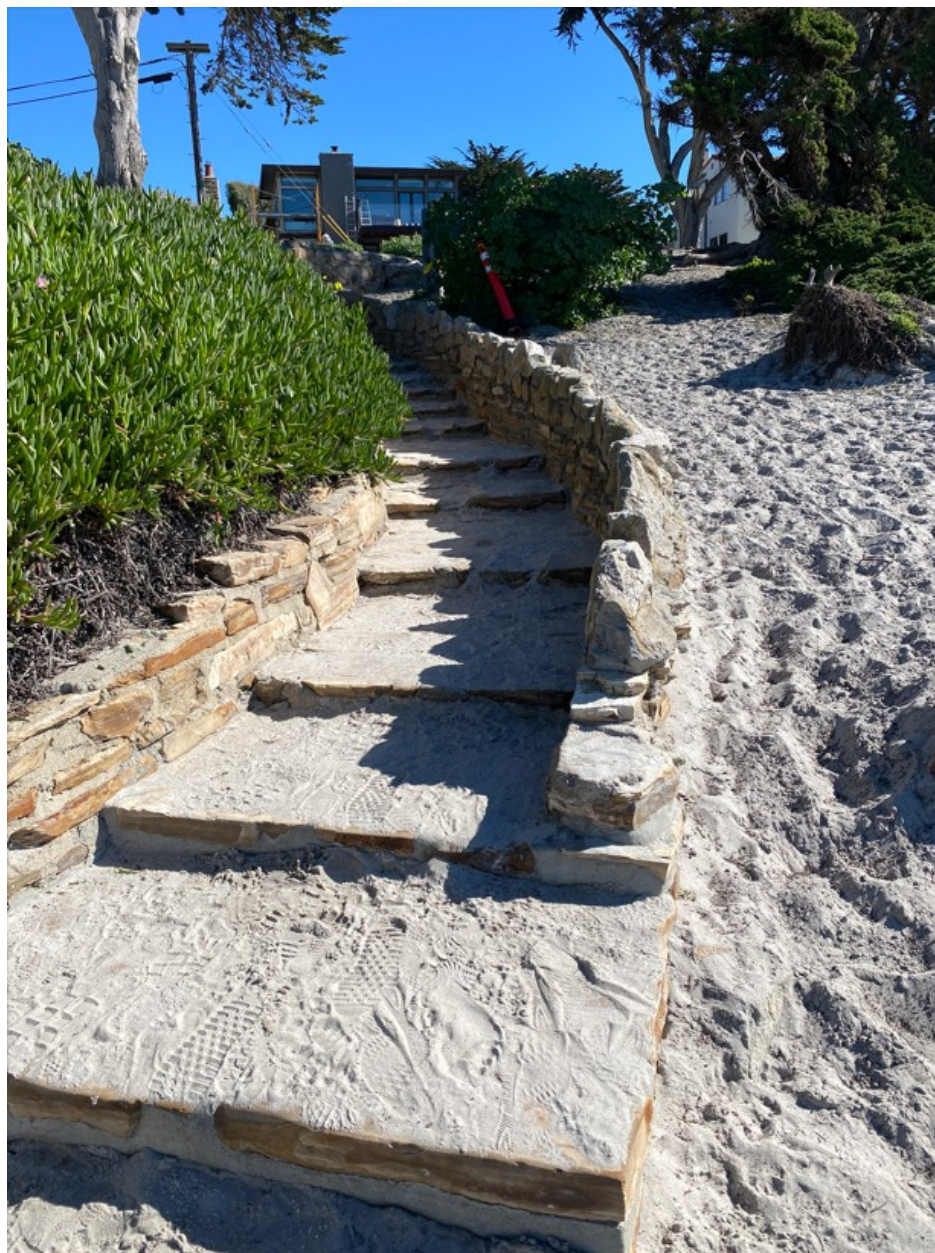
**Photograph 86: Stairway ST9 on January 30, 2023**

Photographs 86 and 87 show Stairway ST9, which is near 8th Avenue, is a set of rock and mortar landscape or decorative steps. No recommended maintenance at this time is needed. The natural rock (Carmel Stone) treads are becoming worn, and their irregular surface should be evaluated for safety and code compliance by a qualified professional. A detailed study would be required to assess how to protect the stairs from being undermined.

Because the treads of Stairway ST9 are worn and have an irregular (bumpy) surface that poses some slip and fall risks to stair users, we recommend they be repaired and classify that as a medium priority.
