Date: 27 April 2023  
Client: City of Carmel  
Subject: Carmel Beach Coastal Protection Assessment  
Reference: Carmel Beach Adaptation Plan  
Project No.: 12176

## **CARMEL BEACH COASTAL PROTECTION ASSESSMENT REPORT**

Coastal Protection Evaluation 22 December 2022 thru 30 January 2023

Carmel Adaptation Plan - Carmel Beach All Areas

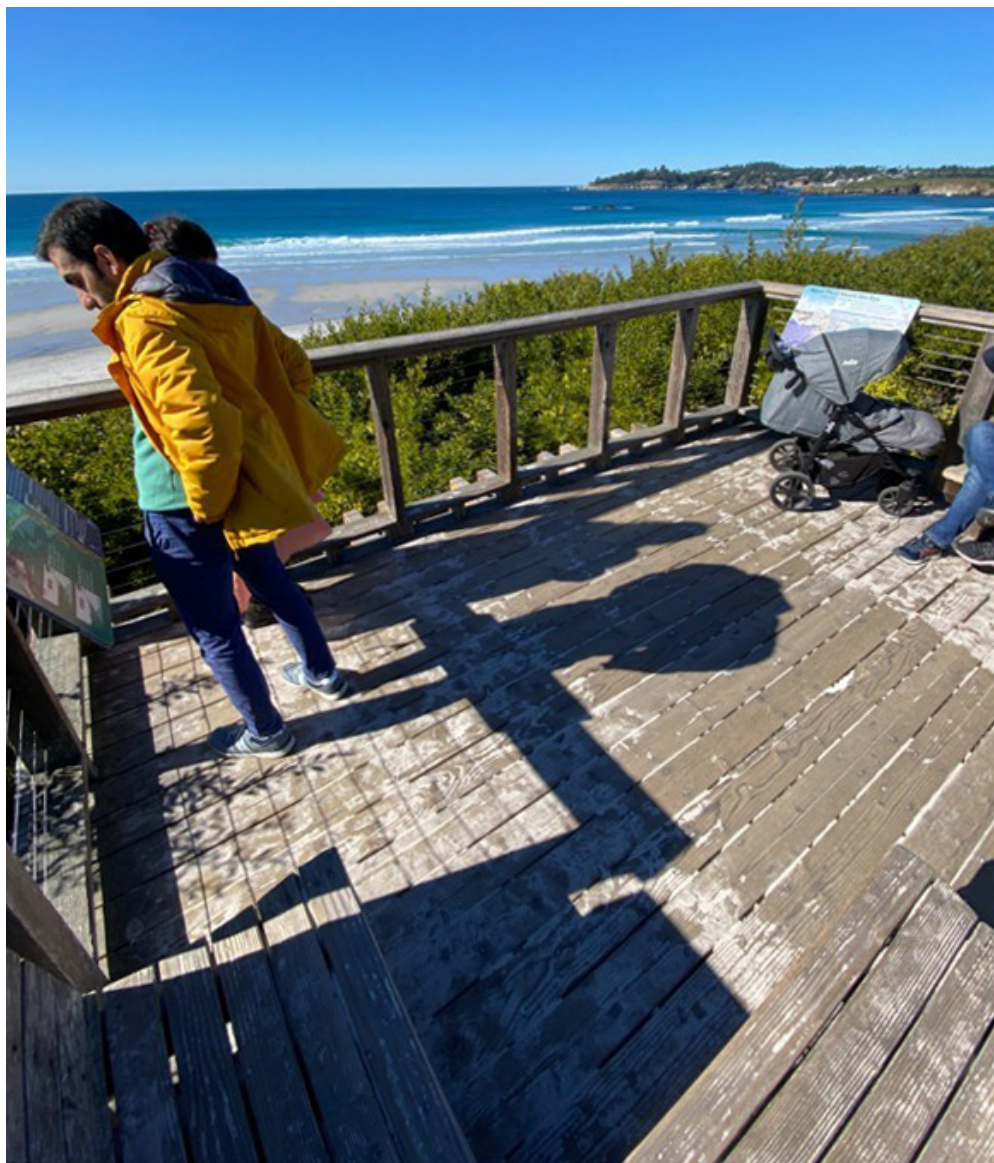
**Photograph 90: Stairway ST10 Overlook Platform on January 30, 2023**

Photograph 90 shows a Public Overlook Platform at the end of a boardwalk at the end of Ocean Avenue, we have named ST10, as seen on January 30, 2023. Our firm (Haro Kasunich and Associates Inc.) assisted in the design of this overlook in 2012. The ST10 wooden platform has reinforced concrete piers supporting it that appear to be performing reasonably well and we do not note the need for any maintenance at this time. We estimate the anticipated life of the structure is approximately 20 years. We recommend that the platform structure be monitored for deterioration of the wood and corrosion of the metallic hardware and reinforcing. If any problems are noted in the future, appropriate maintenance and repair should be done.

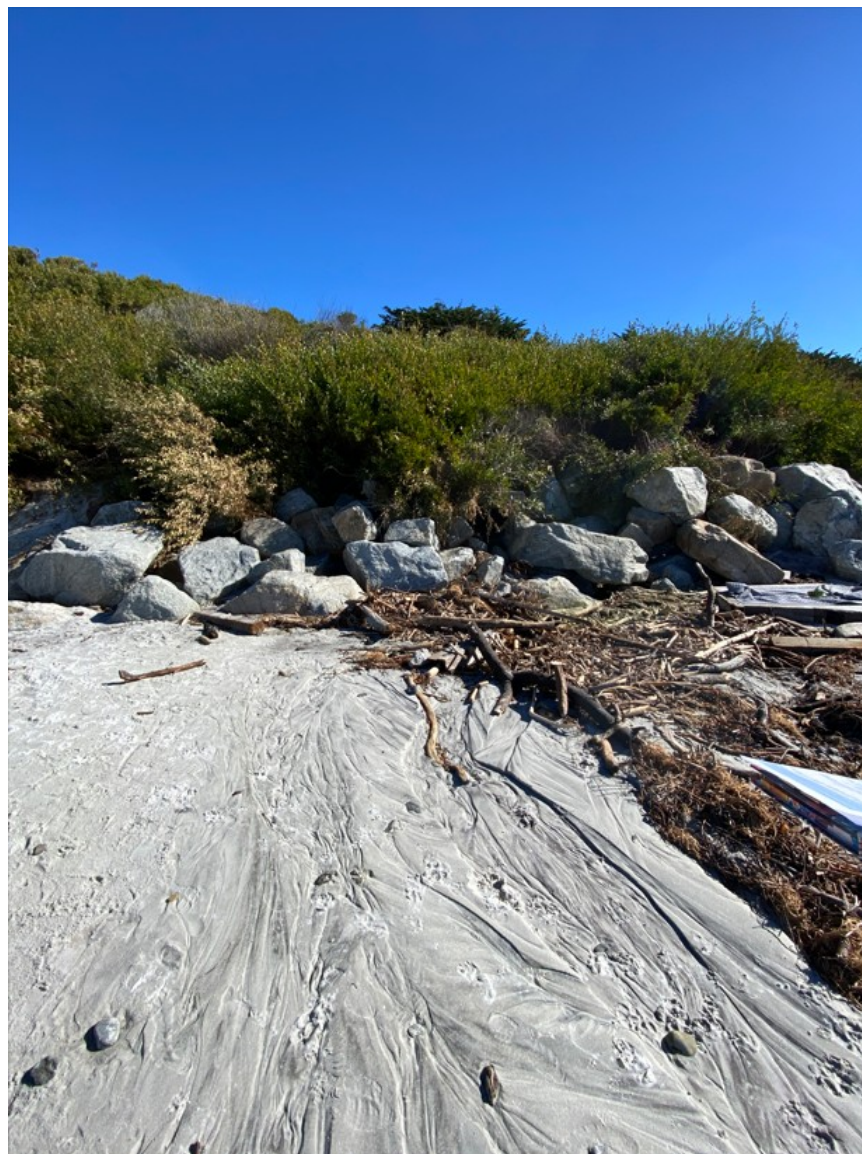
**Photograph 91: Revetment R6 Showing Small Amount of Rip-rap Boulders on January 30, 2023**

Photograph 91 shows riprap that forms part of the R6 Revetment structure seaward of the end of Ocean Avenue which incorporates a storm drain outfall, as seen on January 30, 2023. The rip rap has an approximately 2:1 (H to V) surface slope gradient and the exposed portion is 6 to 7 feet tall. The remainder of the revetment, including its foundation condition, is buried in sand and is unlikely to be visible until the next extreme scour event. Whenever it is next exposed by natural beach sand scour processes, it should be inspected. That may not be for a decade but could be possible during any winter. Based on what we observed, no maintenance is presently recommended. We estimate the lifespan of this structure is 10 to 30 years, depending upon its foundation condition.

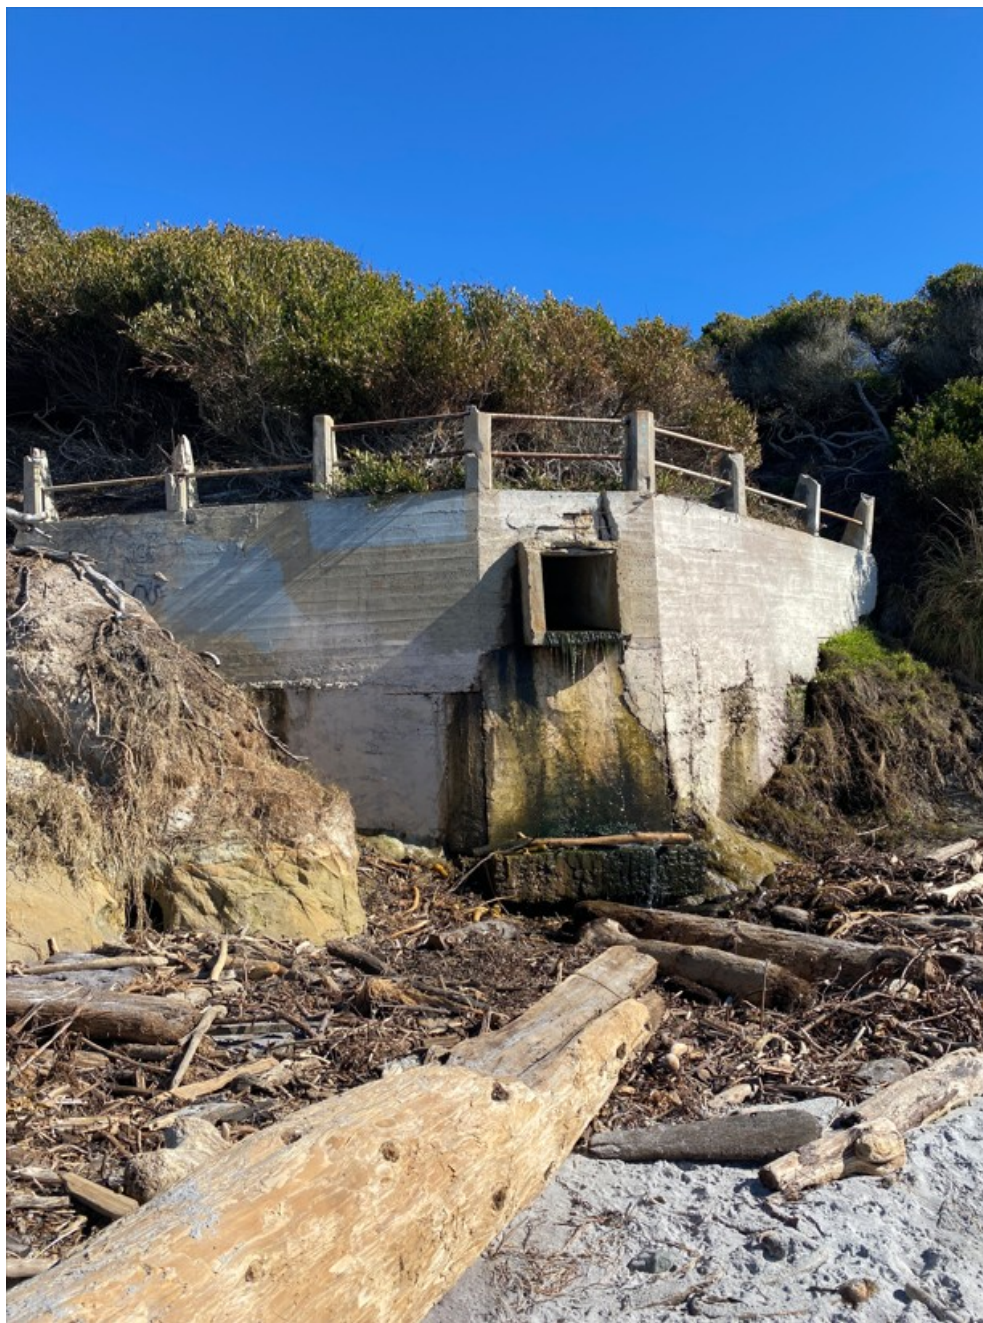
**Photograph 92: Seawall S10 on January 30, 2023**

Photographs 92, 93, 94 and 95 show Seawall S10 on January 30, 2022. This seawall is a storm drain headwall for a 3 by 3-foot reinforced concrete box culvert located in the dunes area north of Ocean Avenue. It is in poor condition. Photograph 92 shows that the central part of the Seawall S12 foundation is bearing upon sandstone bedrock. In adjacent areas the foundation is partially undermined horizontally up to 16 inches at the toe.

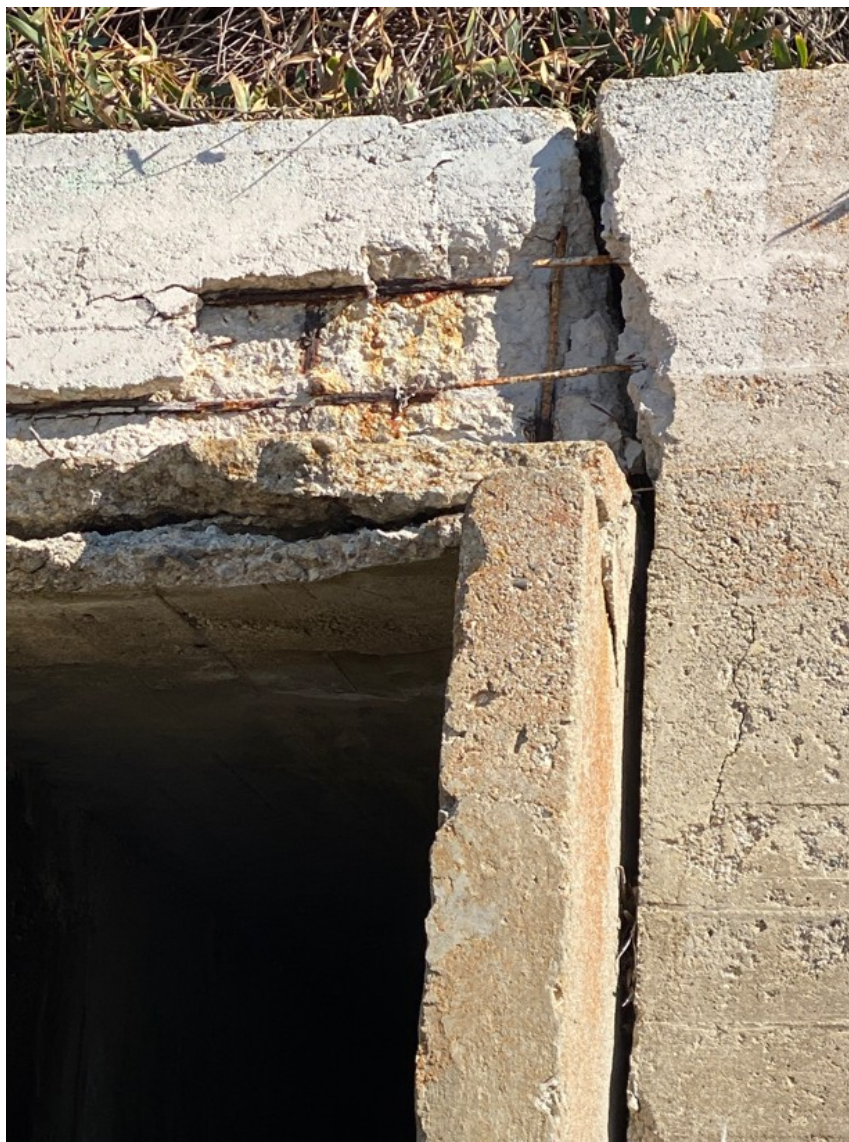
**Photograph 95: Seawall S10 on January 30, 2023**

Photograph 95 is a photograph that shows a large structural crack in Seawall S12 above the box. The crack is wider at the top than the bottom and the wall has been displaced. Reinforcing bars have been exposed by spalling concrete. It appears the south side of the seawall has rotated out in the seaward direction. The north side of the seawall appears to be vertical (plumb) and straight. Most of the rebar of the structure is corroded and not salvageable. We recommend reconstruction of the box culvert and seawall in its entirety. The down coast end of the seawall is outflanked and has been partially undermined, contributing to instability on that side of the structure. This structure has 0 to 10 years of remaining service life before it may collapse. It could collapse catastrophically this year. We do not expect it to survive 10 years. We recommend the City budget for and construct a new structure as soon as possible. This structure poses risks to beach users, and we recommend it have a high priority for replacement

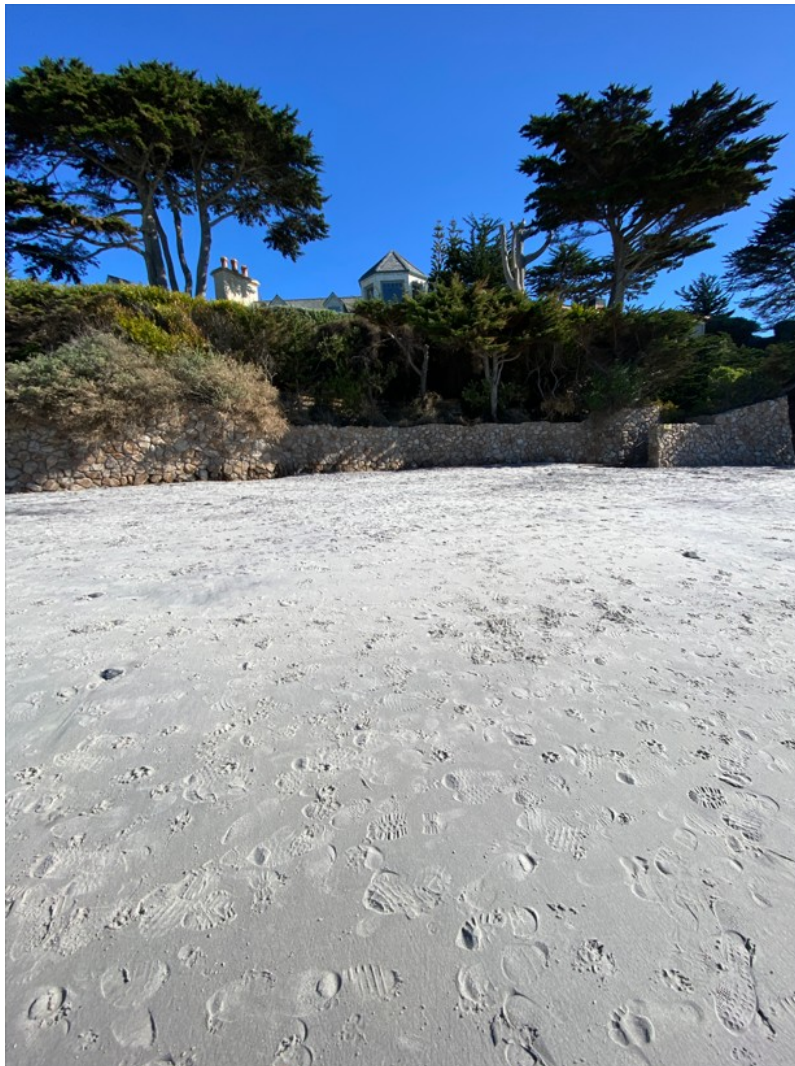
**Photograph 97: South Portion of Privately Owned Seawall S11 on January 30, 2023**

Photographs 97, 98 and 99 show Seawall S11 on January 30, 2022. This is a privately owned seawall and is the furthest north coastal protection structure protecting the furthest north home in the City of Carmel. The total height of the seawall is unknown. Photograph 71 shows the north portion. At the time of our inspection 6 to 10 feet of retaining wall was exposed above the beach sand level. The seawall appeared to be in good condition, and we did not observe any maintenance or repair that was needed.

Photograph 97 shows the south part of Seawall S11 on January 30, 2022. The south portion is approximately 6 feet high. This portion includes a private access stairway at the south end. The seawall appeared to be in good condition, and we did not observe any maintenance or repair that was needed.

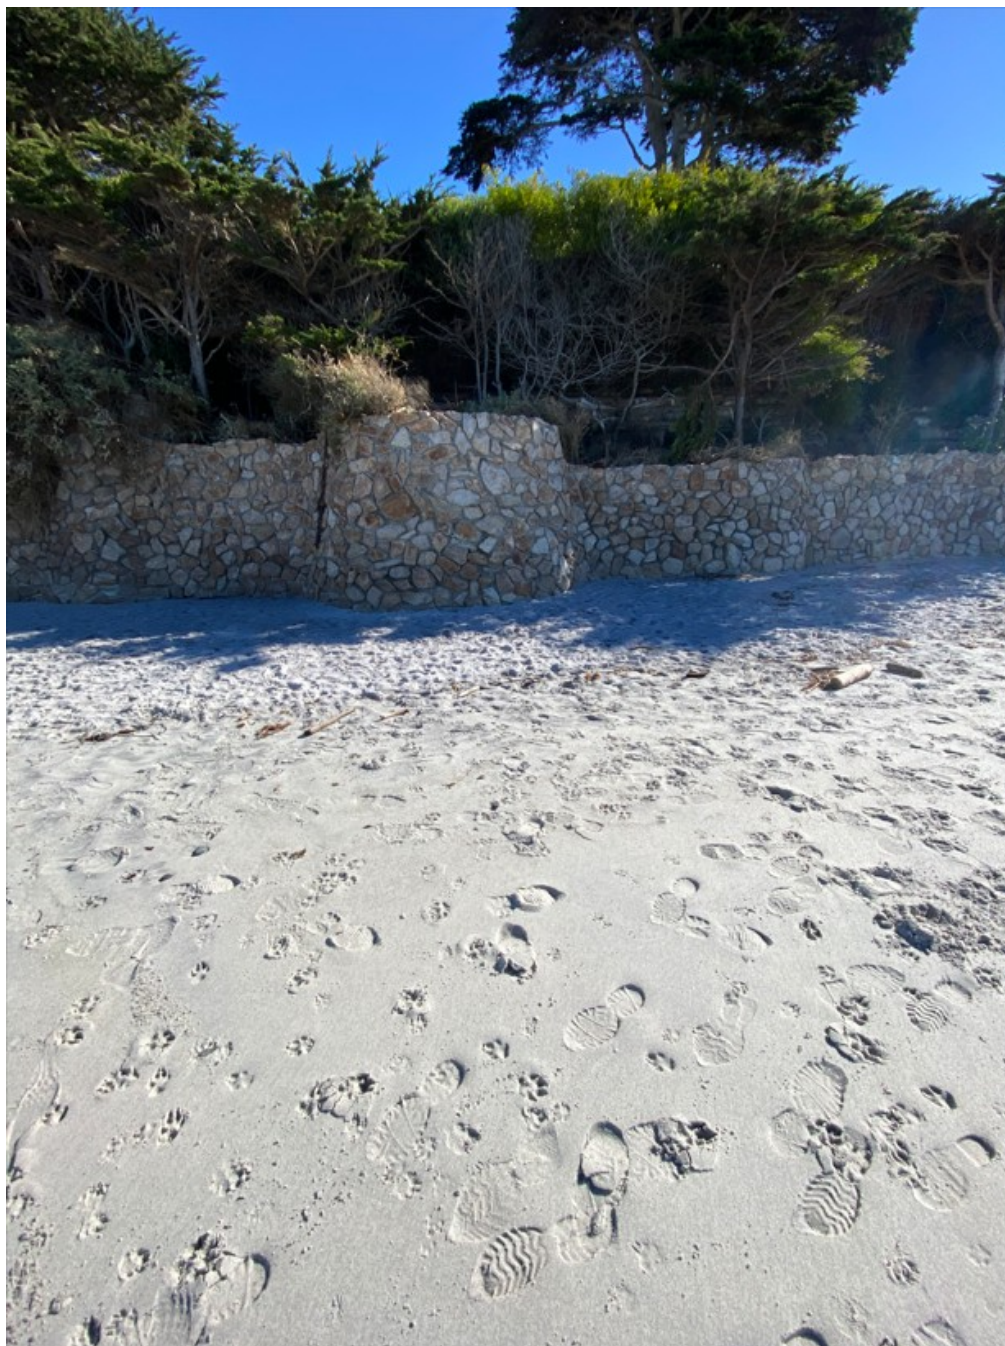
**Photograph 98: Central Portion of Privately Owned Seawall S13 Center on January 30, 2023**

Photograph 98 shows the central part of Seawall S11 on January 30, 2022. The center portion is approximately 6 feet high. The seawall appeared to be in good condition, and we did not observe any maintenance or repair that was needed.

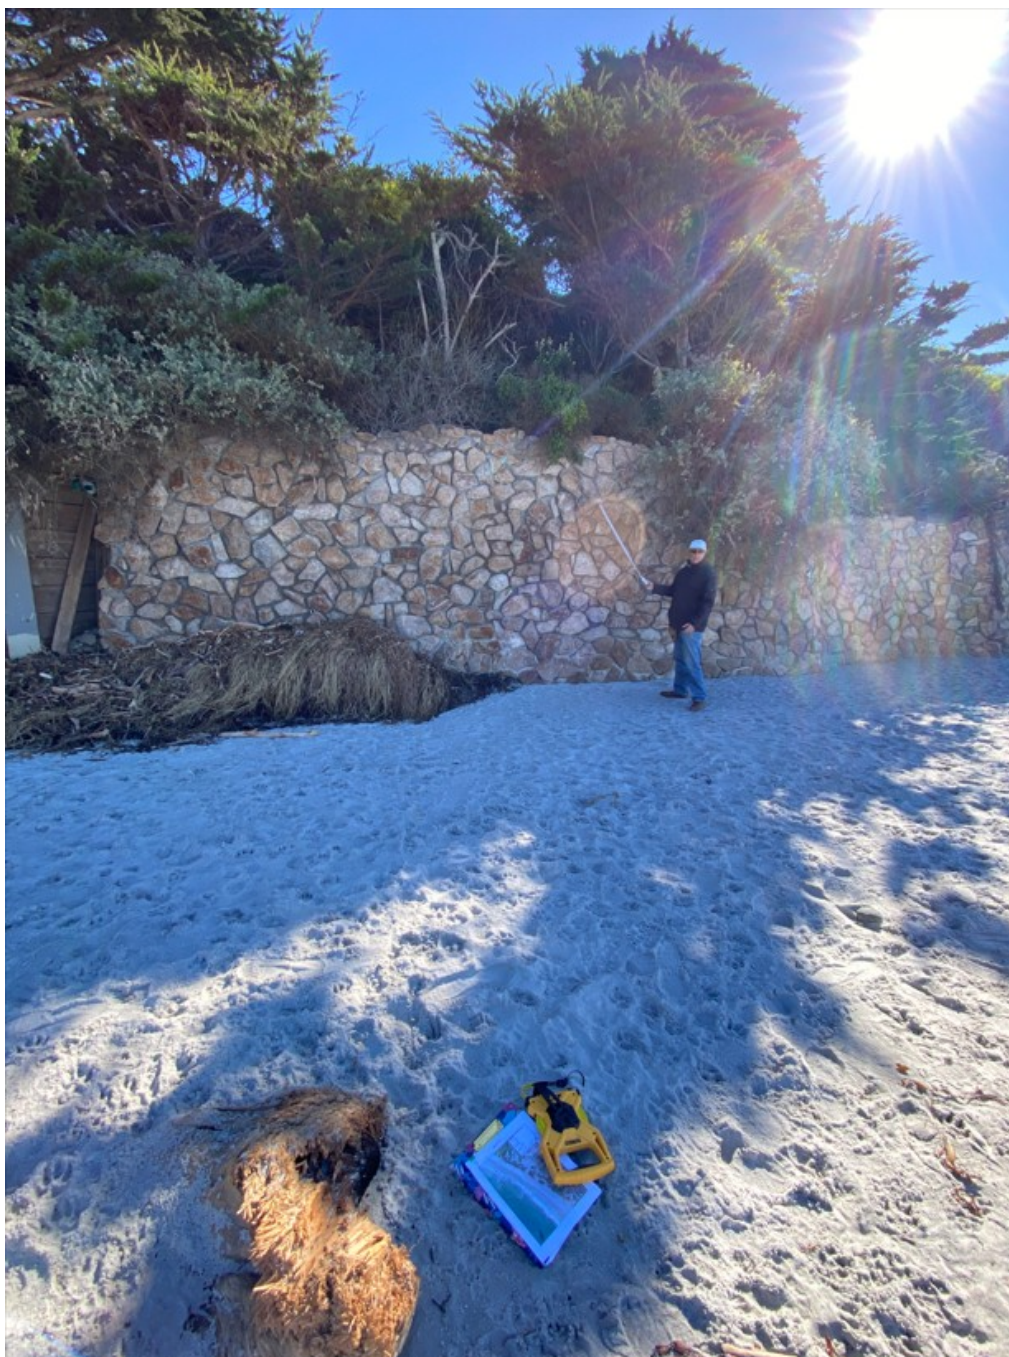
**Photograph 73: North Portion of Privately Owned Seawall S11 on January 30, 2023**

Seawall S11 connects to a retaining wall along the margin of Pescadero Creek that has steel H-beam soldier piles and wood lagging. Evaluation of it is outside of our scope of services.
